Detroit
Edison

Subject: Licensee Event Report (LER) No. 90-011

TITLE (4)
Reactor Scram Due to Reactor Water Level Discrepancy

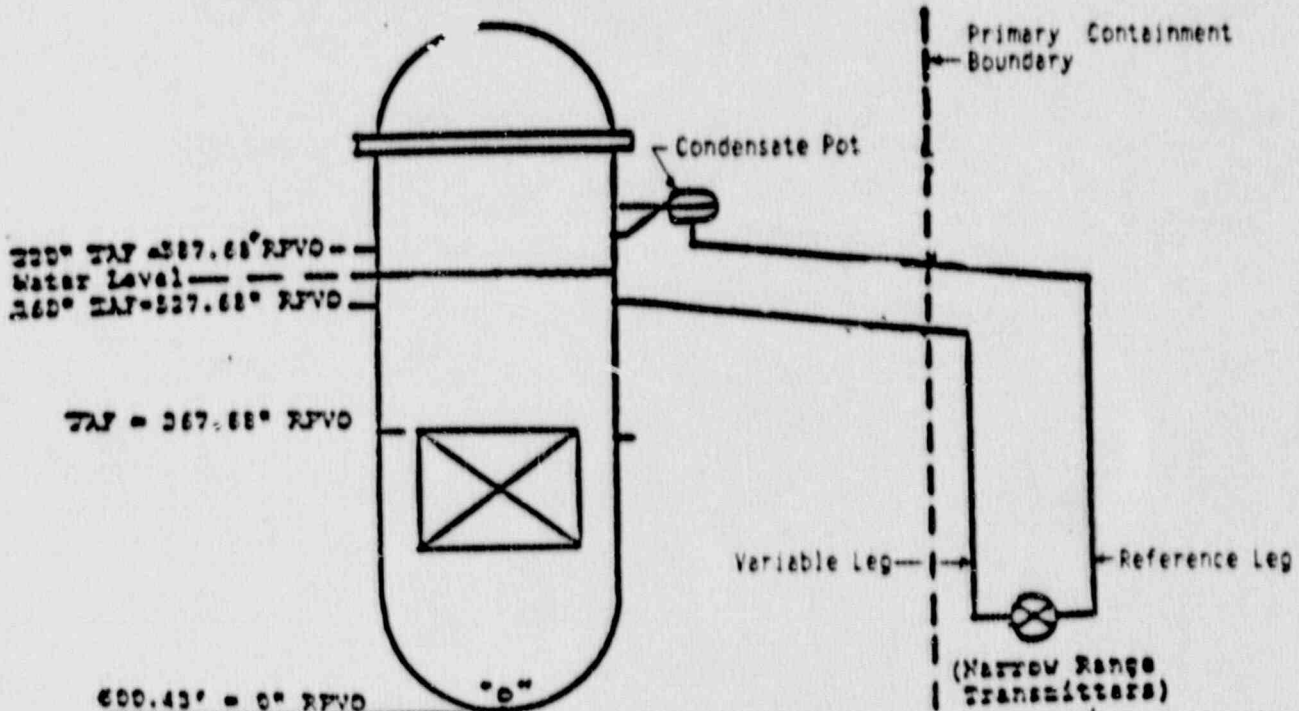
REACTOR VESSEL WATER LEVEL INSTRUMENT
NARROW RANGE - DIV 1

On October 6, 1990, Fermi 2 was in startup and holding while plant personnel were investigating Reactor Water Level indication (PDT) discrepancies as a result of a failed instrument channel check prior to heat-up. The instrument channel check indicated a 7 inch level difference for Reactor Water Level. The channel check acceptance criteria for this instrumentation is 5 inches. The Reactor Protection System (JC) (RPS) Reactor Water Level narrow range instrumentation is supplied from two reference legs. The RPS instruments supplied from the "A" reference leg are Division 1 RPS logic "A" and Division 2 RPS logic "B". The RPS instruments supplied from the "B" reference leg are Division 1 RPS logic "C" and Division 2 RPS logic "D" (see attached figure).

The cause of this event was attributed to air voids in the reference leg collapsing at a faster rate than the reference leg fill from condensing pot "A". This caused level instruments associated with the "A" reference leg to read a higher level than the instruments associated with the "B" reference leg, with the "B" level closer to the actual Reactor Water Level.
