NORTHEAST UTILITIES

Reference: Facility Operating License No. DPR-21
Docket No. 50-245
Licensee Event Report 90-016-00

LICENSEE EVENT REPORT (LER)

TITLE (4)
Manual Reactor Trip Due to Loss of Cooling

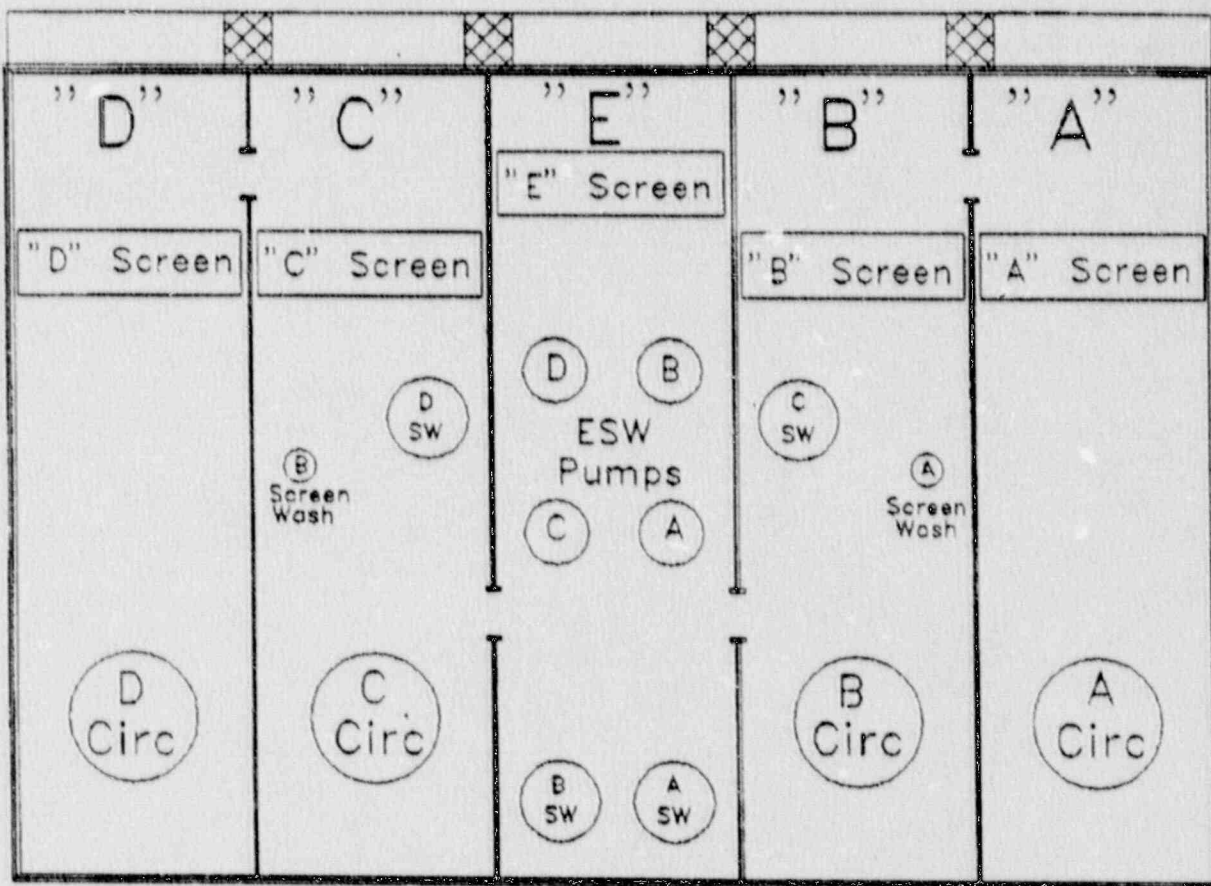
Figure 1

The root cause of this event was that the Traveling Screen fouling rate exceeded the Screen Wash System Cleaning capability during severely degraded weather conditions. On shore winds, high seas and an incoming tide combined to create a condition where the debris removal equipment (traveling screens, screen wash system, debris sluiceways) was unable to handle the debris volume.

At 1800 on October 4, 1990 the Traveling Screen fouling rate exceeded the Screen Wash System Cleaning Rate during severely degraded weather conditions. On shore winds, high seas and an incoming tide combined to create a condition where the debris removal equipment (traveling screens, screen wash system, debris sluiceways) were unable to handle the debris volume. Plant Equipment Operators engaged in manual cleaning of the traveling water screens elected to stop all screens to provide access to the interior of the screen housings for manual debris removal. At this time the Control Operator had not been informed of the new screen status. As debris continued to collect the traveling screen differential pressure rapidly increased. Control room personnel observed all five traveling screen differential pressure instruments off scale high. A rapid decrease in reactor power was initiated. It is believed that the traveling water screens were greater than 75% fouled at this time. Control Room personnel questioned the off scale differential pressure and did not elect to trip all Circulating Water Pumps per Operating Procedure 323. 'A' and 'D' Circulating Water Pumps were stopped at 1838 hrs, relieving the strain on the associated screens. 'B' and 'C' Circulating Water Pumps continued to pump, lowering level in the bays and increasing differential pressure on 'B' and 'C' screen as well as the interconnected 'E' screen. The level decrease cavitated the operating Service Water Pumps. 'B', 'C' and 'E' screen baskets and support structure yielded to the strain. 'C' Circulating Water Pump was stopped and started and the 'B', 'C' and 'E' bays of the Intake Structure reflooded, ending the cavitation but, introducing debris to the Service Water pump suction. Seaweed (Genus *Codium*) then fouled the Service Water Self Cleaning Strainer pores and was not expelled by the strainer blowdown.

Intake Structure

The Circulating Water Pump trip logic was modified to reinstate a 30 inch screen differential pressure trip. Operating Procedure 323 "Circulating Water System", was revised to instruct Control Operators to verify Circulating Water Pump trips at 30 inch screen differential pressure.

Off Normal Procedure 514A, "Natural Occurrences" will be revised to terminate Screen Wash debris/fish return capability and begin intercepting debris cleaned from the Traveling Screens at sustained winds of greater than or equal to 30 mph. This is to minimize the debris load in front of the Intake Structure during degraded weather conditions.

A design review has been commissioned to evaluate Traveling Screen performance in severe weather with respect to debris removal methods and equipment.

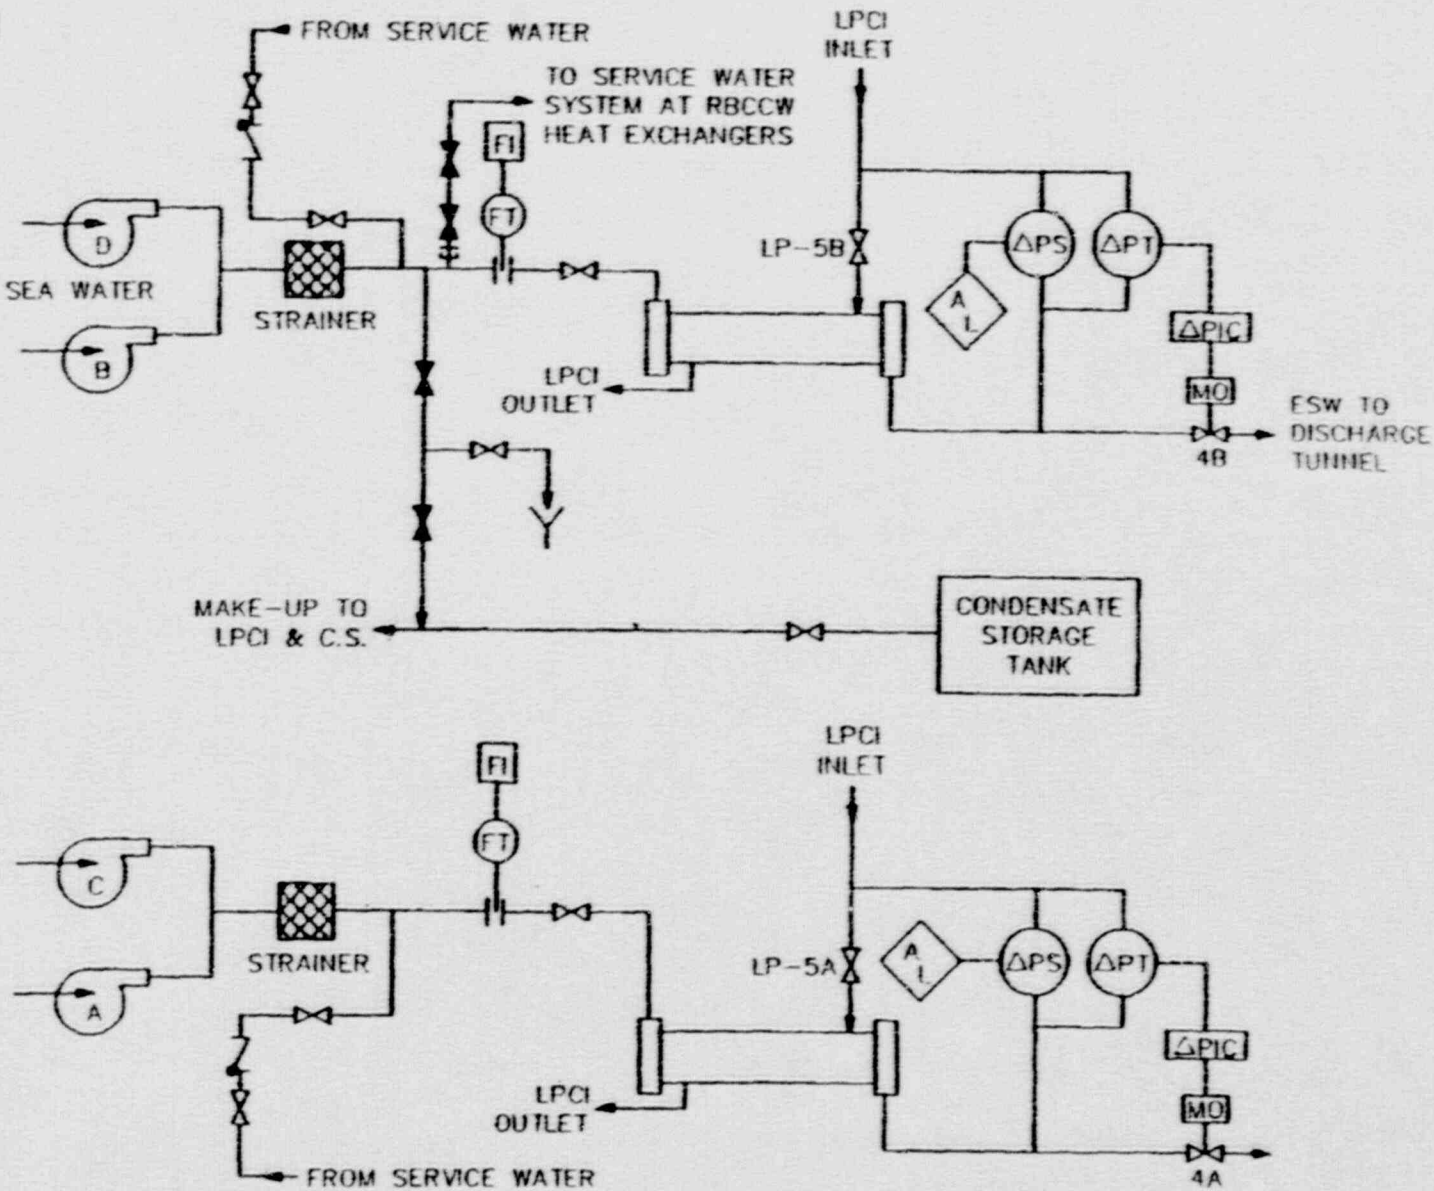
FIGURE 2
EMERGENCY SERVICE WATER SYSTEM

This event had the potential to result in degradation of the Service Water and Emergency Service Water to a condition where available flowrates from those systems could have been ineffective. The Service Water System provides cooling to the Turbine and Reactor Building Closed Cooling Water Heat Exchangers and to the Diesel Generator Heat Exchangers. The Emergency Service Water System provides a long term source of cooling water to remove heat from the Suppression Pool during both LOCA and non-LOCA conditions (refer to the attached system diagrams). Millstone One Off Normal Procedures 524D "Loss of Service Water", and 525G "Degraded Fire in the Intake Structure", provide operator guidance for more severe events of this type. In this case, operation of the Service Water Strainer Bypass Valve maintained service water header pressure and flow to heat exchangers during the event such that adequate cooling remained available.

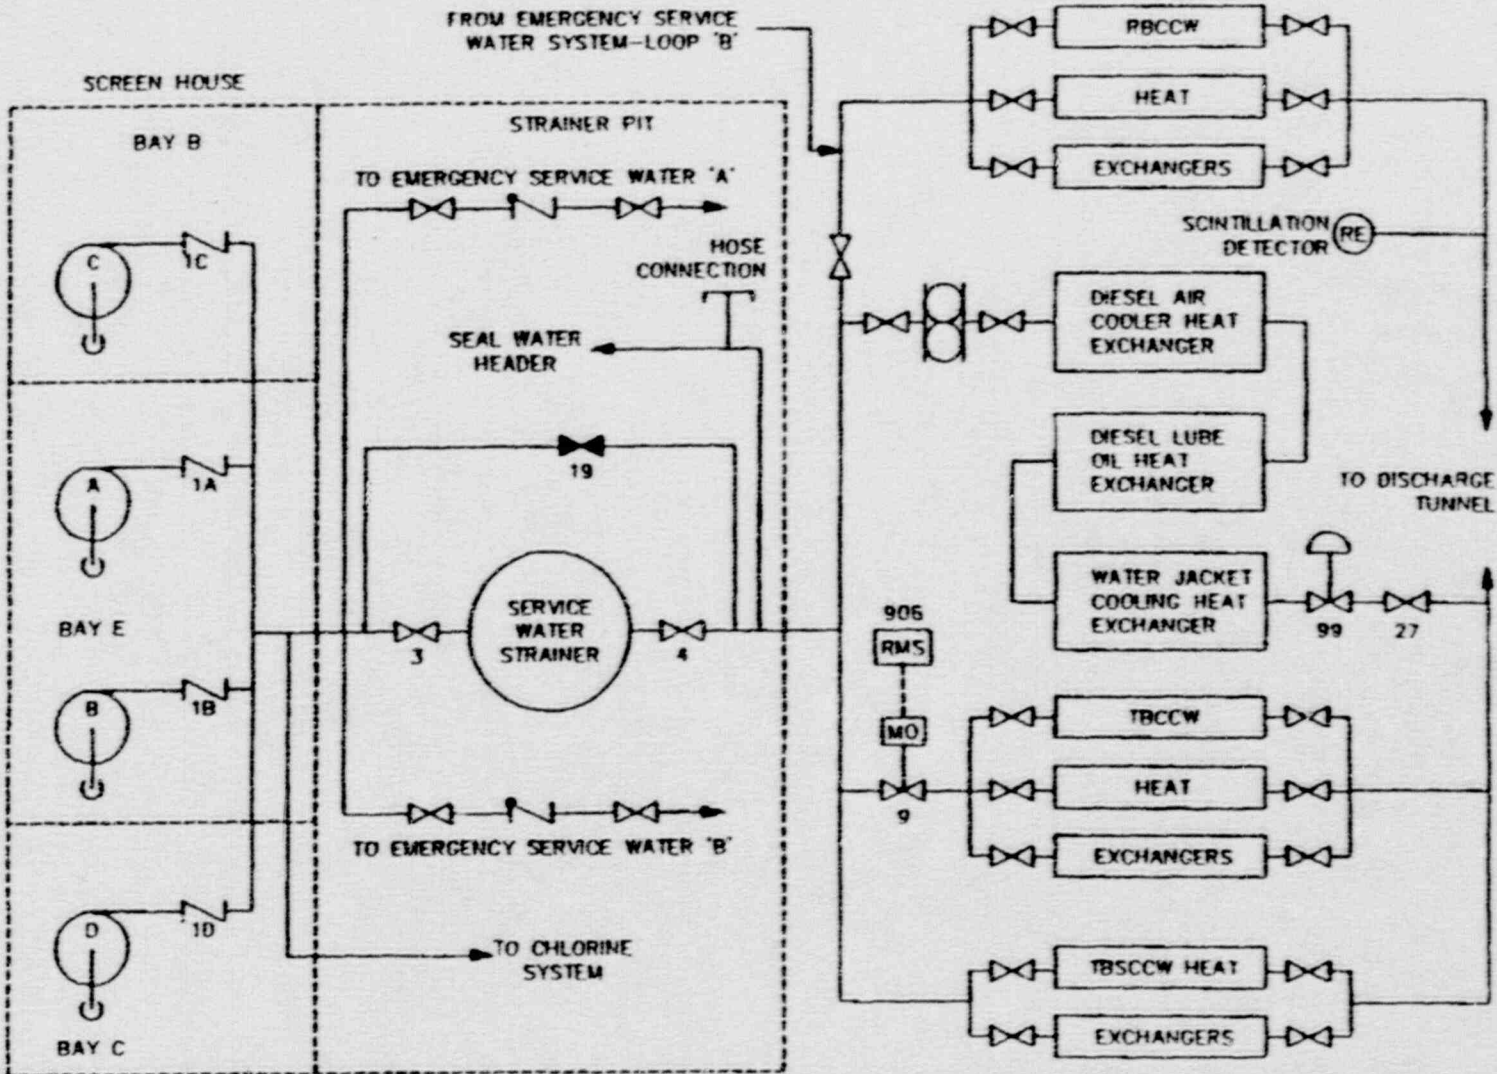
FIGURE 3
SERVICE WATER SYSTEM

The low Service Water Pressure reduced Reactor Building Closed Cooling Water Heat Exchanger capacity. These heat exchangers are located at the 42'6" elevation of the Reactor Building. Drywell Temperature and Pressure began to increase and a high Drywell pressure alarm was received in the Control Room. The drywell was vented through the Standby Gas Treatment System. During the evaluation of the containment pressure increase, Service Water pressure was observed to be 7 psig in the Control Room. An additional service water pump was started to increase header pressure. A Manual Scram was initiated at 1849 hrs. Service Water pressure was restored by throttling open the Service Water Strainer Bypass Valve.
