November 2, 1990
MP-90-1167

Reference: Facility Operating License No. DPR-65
Docket No. 50-336
Licensee Event Report 90-019-00

FACILITY NAME (1) Millstone Nuclear Power Station Unit 2	DOCKET NUMBER (2) 0 5 0 0 0 3 3 6 1	PAGE (3) OF 0 3
---	--	----------------------

TITLE (4)
Combined Leakage Rate Exceeded

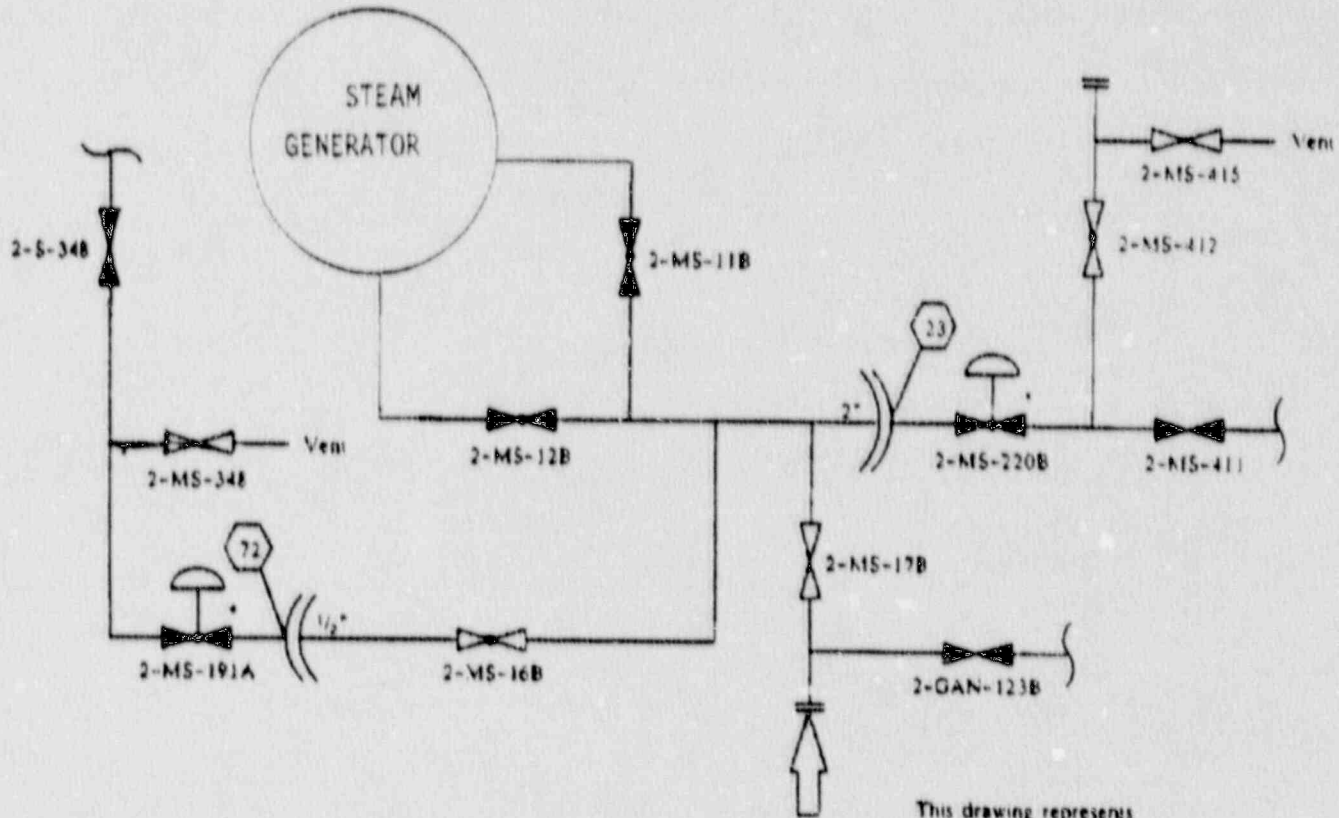
LOCAL LEAK RATE TEST VALVE LINEUP	
Penetration 23/72 2-MS-220B & 191B	
PAID 26/02	Figure 9 6

The plant was in Mode 6, shutdown for refueling operations. Reactor Coolant System (RCS) temperature was 92 degrees Fahrenheit and pressure was 0 PSIG. Type B and C leakage rate testing of containment penetrations was in progress. On 10/05/90 the #2 Steam Generator Blowdown Penetration Isolation valves were being leakage rate tested. (See the diagram attached for the valve line-up). An attempt was made to pressurize the penetration volume to accident pressure (Pa-56 PSIG) thru the flange at valve 2-MS-17B. Test pressure could not be attained and the source of the leakage was investigated. Inspection of the vent paths thru 2-MS-348 and 2-MS-415 indicated leakage thru 2-MS-220B. When the vent path valves 2-MS-412 and 2-MS-415 were closed the test pressure was almost immediately achieved and the leakage rate was essentially zero. This indicates the source of the leakage to be 2-MS-220B.

The root cause of the event is due to steam cutting of the valve seating surfaces.

The valve was disassembled and inspected. The inspection revealed a worn seat and plug. These items along with the valve stem and various gaskets were replaced. Since this valve is located on the secondary side of the plant the necessity for Appendix J Leakage testing requirements will be reviewed.
