PEACH BOTTOM ATOMIC POWER STATION

SUBJECT: Licensee E Report
Peach Bott Atomic Power Station - Unit 3

Reference: Docket No. 50-278
Report Number: 3-90-013
Revision Number: 00
Event Date: 10/09/90
Report Date: 11/07/90
Facility: Peach Bottom Atomic Power Station
RD 1, Box 208, Delta, PA 17314

TITLE (4)
Core Spray Pump Actuation During Testing Due to Personnel Error

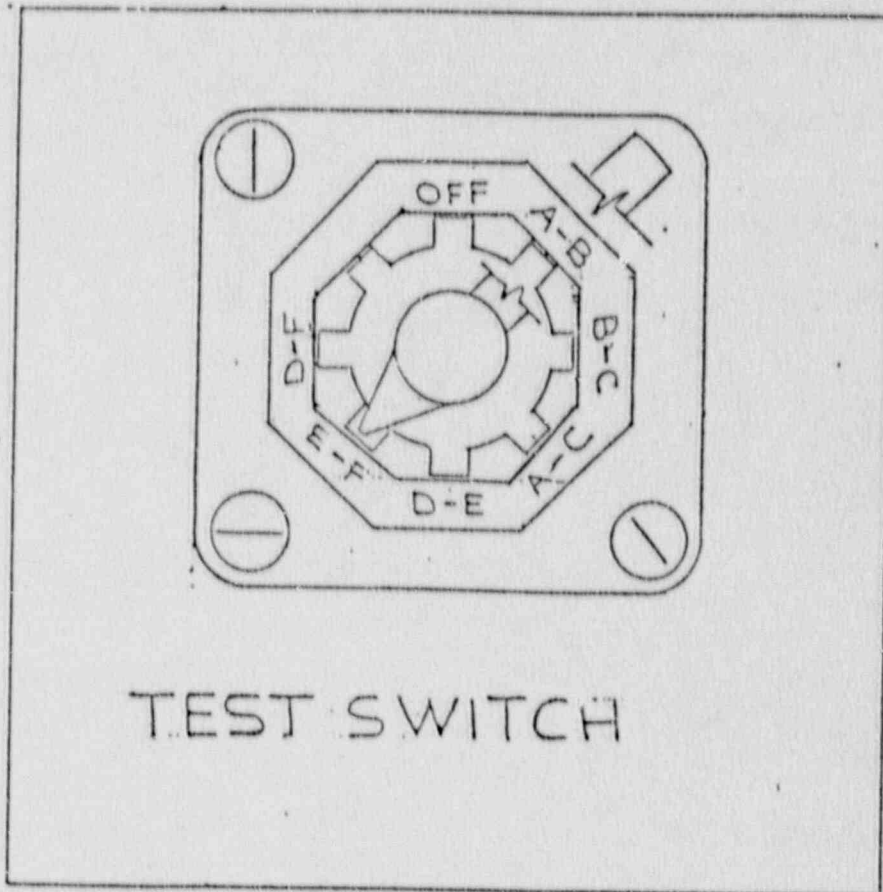
FIGURE 1

On October 9, 1990, at 10:30 am with Unit 3 at 100% power, the A & C Core Spray pumps (EIIS:P) inadvertently started while technicians were performing ST 1.4, "Core Spray 'A' Logic System Functional". The start occurred when a maintenance technician (Non-licensed, Utility) moved a portable test switch (EIIS:HS) being used as part of the test to the wrong position (see Figure 1). The sequence of events was as follows:

The test switch was in the "E-F" position and inserted into a test jack. Negative checks of the reactor pressure permissive logic were to begin by rotating the test switch position from "E-F" to "D-E" to "A-C" as stated in the procedure. Both technicians read the step aloud and then one of the technicians proceeded to rotate the switch in a clockwise direction to position "D-F". Test position "D-F" simulated LO-LO-LO reactor water level to the "A" Core Spray logic. The A & C Core Spray pumps automatically started approximately 10 seconds later. When the technician realized what had happened he asked another technician (non-licensed, Utility) if he could rotate the switch in a counterclockwise direction. Upon confirmation he immediately rotated the switch counterclockwise back to position "E-F", and the reactor operator (Licensed, Utility) secured both pumps.

The primary cause of the event was personnel error (failure to self-check) prior to repositioning the test switch. Three contributing factors of the incident were (1) the lack of familiarity with using the test switch, (2) inadequate understanding of the Core Spray system test, and (3) the confusing labels of the test switch.

The two technicians both read the test step aloud prior to moving the switch, yet when the technician repositioned the switch he moved in the wrong direction. If a self-check would have been performed to ensure that actions were correct prior to manipulation of the switch, the technician would have recognized two "flags" that could have prevented the incident; 1) That "D-F" was in fact position "D-F" and not "D-E", and 2) that to continue in a clockwise rotation he would have had to move the

switch through positions "off", "A-B" & "B-C" prior to reaching the end position "A-C".

To prevent recurrence of this event, logic system functional testing will be turned over to Instrumentation and Controls (I&C) personnel. I&C personnel have been trained in the self checking process and have more experience with surveillance testing and its implications to the plant. The appropriate system engineer will provide a pre-job briefing and act as a temporary test leader, until an adequate amount of tests have been performed by I&C. At that time, I&C will be responsible for pre-job briefings and assuring personnel are qualified to participate in the tests. Self-checking has been re-emphasized to the maintenance technicians. The human factors of the test switch is being evaluated.
