DEPARTMENT OF NUCLEAR ENGINEERING AND ENGINEERING PHYSICS  
REACTOR FACILITY

September 27, 1982

RE: Minor Modifications in Emergency Core Spray System Piping

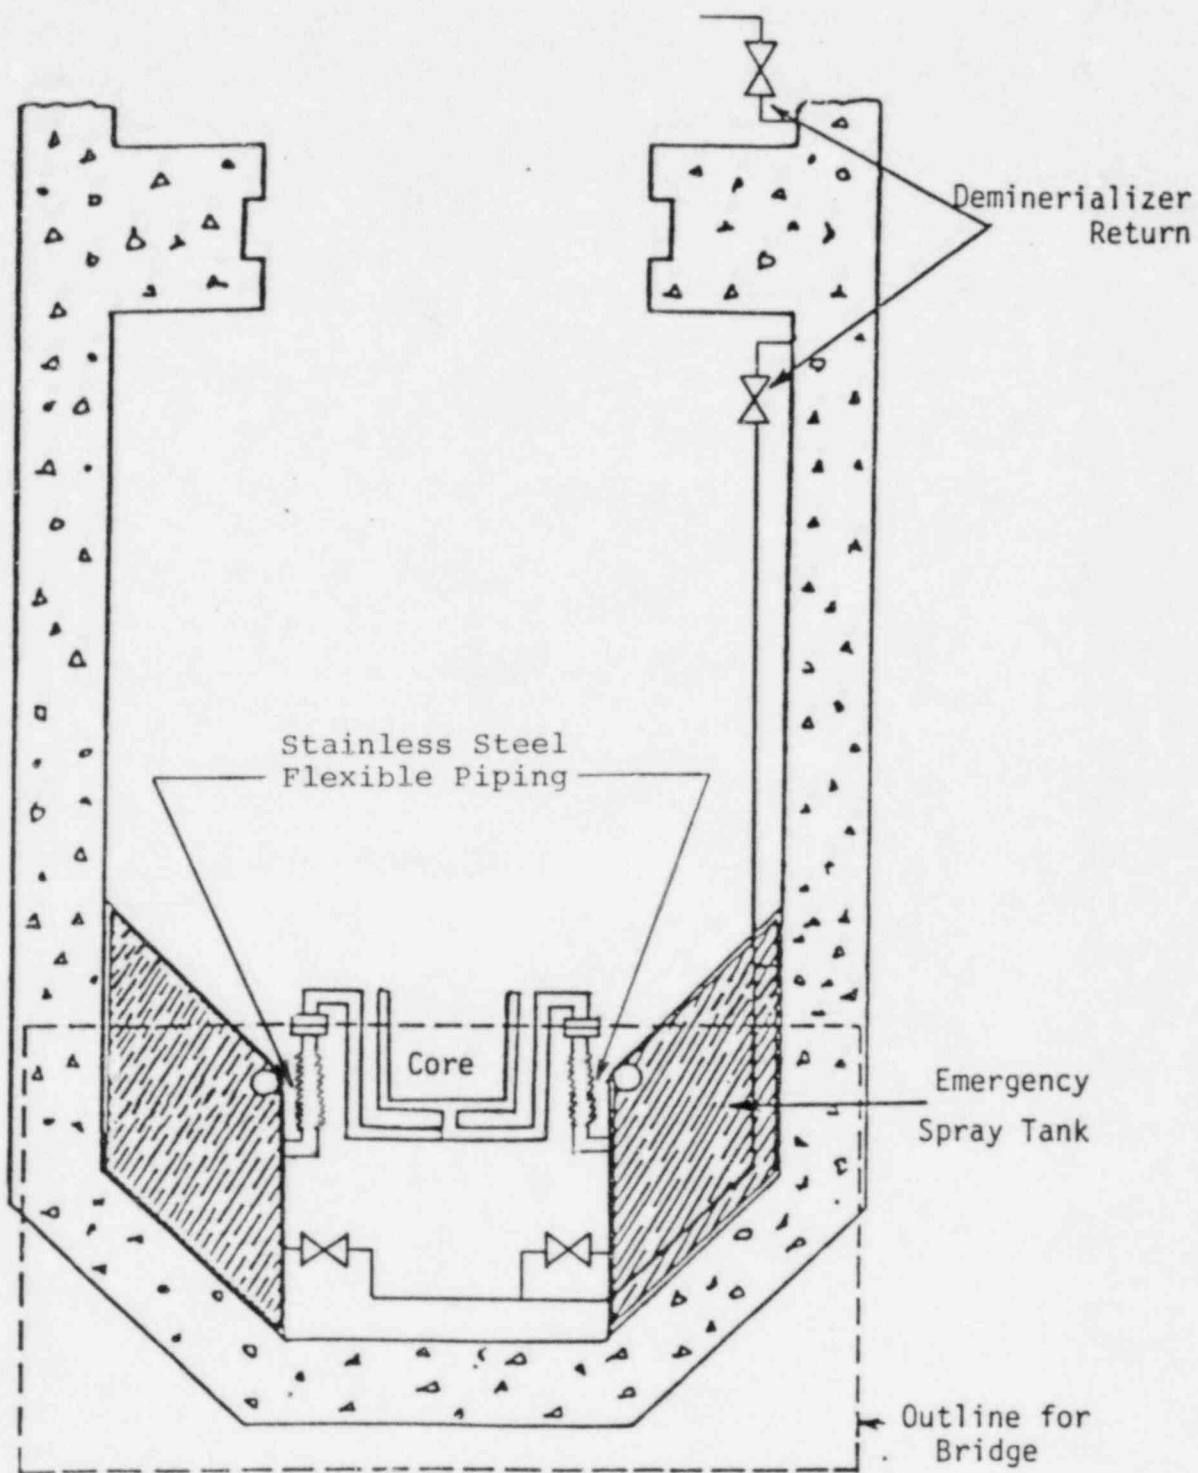
FIGURE 3

On September 16, 1982, the repair and updating of the ECSS tank piping was completed. Figure 3 illustrates the position of the section of flexible pipe. The reactor bridge was moved into the high power position. The remote couplings mated and were locked together with no alignment problems whatsoever. An air pressure test of both tanks indicated that the couplings and connecting piping had no leaks. The ECSS was tested for coolant flow rate to ensure that the piping changes had not caused any deviation in flow rate which would violate the Technical Specifications. The flow rate from the south east tank was unchanged. The initial flow rate from the south west tank system was 3.1% higher than the previous test with the original piping (from 13.0 gpm to 13.4 gpm). Test data over a four year period (March 1979 to January 1982) indicated that the south east tank system had a  $\pm 3\%$  deviation in initial flow rate while the south west had a deviation of 1.1% over the same period. Thus, the staff concluded that the flow rate from the south west tank system will have no effect on the ability for the ECSS to meet the Technical Specification requirements.

The reactor staff concluded that a section of flexible stainless steel piping should be placed on the tank side of the remote coupling to provide the necessary movement for coupling alignment. The University Reactor Safety Committee met on September 7, 1982, to review this proposed change. It was concluded that the crack had been caused by the manipulation of the piping to achieve alignment and that the staff's proposed insertion of the flexible pipe would rectify the problem. It was decided that the proposed change should be made in both spray tank pipings to avoid future alignment problems.
