Maine Yankee

Subject: Maine Yankee Licensee Event Report 94-005-00, Reg. Guide 1.97
Containment Hydrogen Monitoring Instrumentation Outside Design Basis

TITLE (4)
Reg Guide 1.97 Containment Hydrogen Monitoring Instrumentation Outside Design Basis

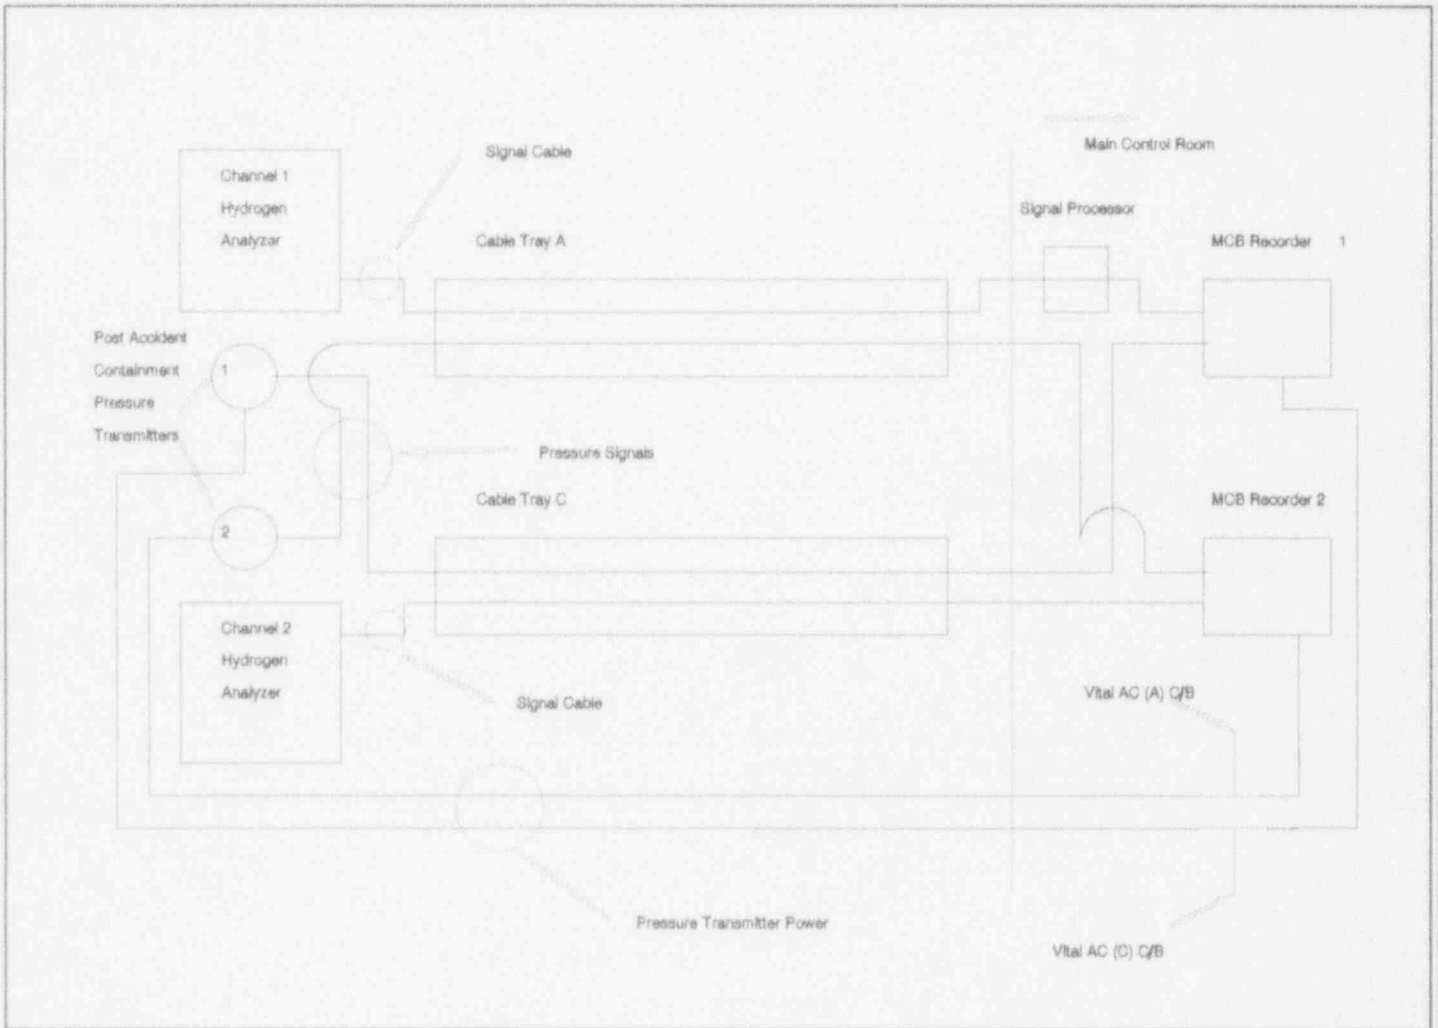
TEXT (If more space is required, use additional copies of NRC Form 366A) (17)
As Found Cable Configuration:

During field cable verification, conducted in preparation for planned facilities upgrades, signal cables for post accident containment pressure monitoring instrumentation were found routed in opposite channel cable trays (A in C, C in A). The cables were labeled correctly for the tray they were in, but incorrectly for function. An analysis of the incorrect configuration was conducted to determine the potential effects of a fault involving either tray.

The analysis concluded that the only redundant plant functions which were adversely affected by the cable separation problem was HMI. (The affected post accident containment pressure monitoring instrumentation, despite the mis-routed signal cables, continued to meet single failure criteria.) A fault in either tray would not result in loss of all HMI, however both channels of Main Control Room remote indication, including the data recorders, could be lost. Due to the signal processing differences, a fault in the A tray could result in a loss of all remote indication and one local indication, while a fault in the C tray could result in a loss of all remote indication, but both local indications would remain available. In either case, at least one local HMI indication remains available at all times. The safety consequences of either case are minimal since both HMI analyzers are located in plant locations which are accessible during accident conditions.

Maine Yankee reconfigured the affected cables to their correct trays on April 5, 1994.
