U. S. NUCLEAR REGULATORY COMMISSION

Report No. 50-373/94010(DRSS); 50-374/94010(DRSS)

Type of Meeting: Enforcement Conference

Enforcement Conference on April 5, 1994 (Report No. 50-373/94010(DRSS); 50-374/94010(DRSS))

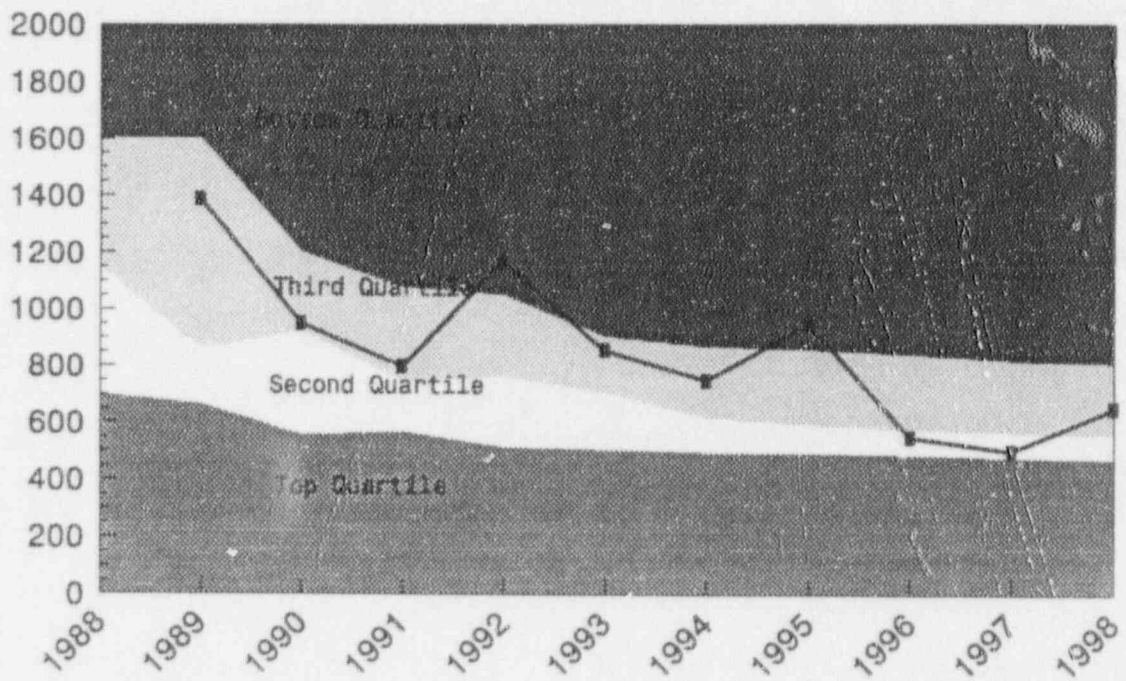
LaSalle Station Radiation Exposure

LaSalle's total radiation exposure goal for 1996 is 550 person-REM. These goals are shown on Figure 1. The accumulated exposure shown for years 1989 through 1993 represent actual plant data (year of exposure) plotted against the actual INPO industry quartiles. The projected exposure shown for years 1994 through 1998 (also year of exposure data) are plotted against the INPO industry quartiles which have been extrapolated based on the rate of industry improvement seen over the last three years. The exposures shown for 1989, 1992, 1995 and 1998 represent exposures received during dual-unit outage years.

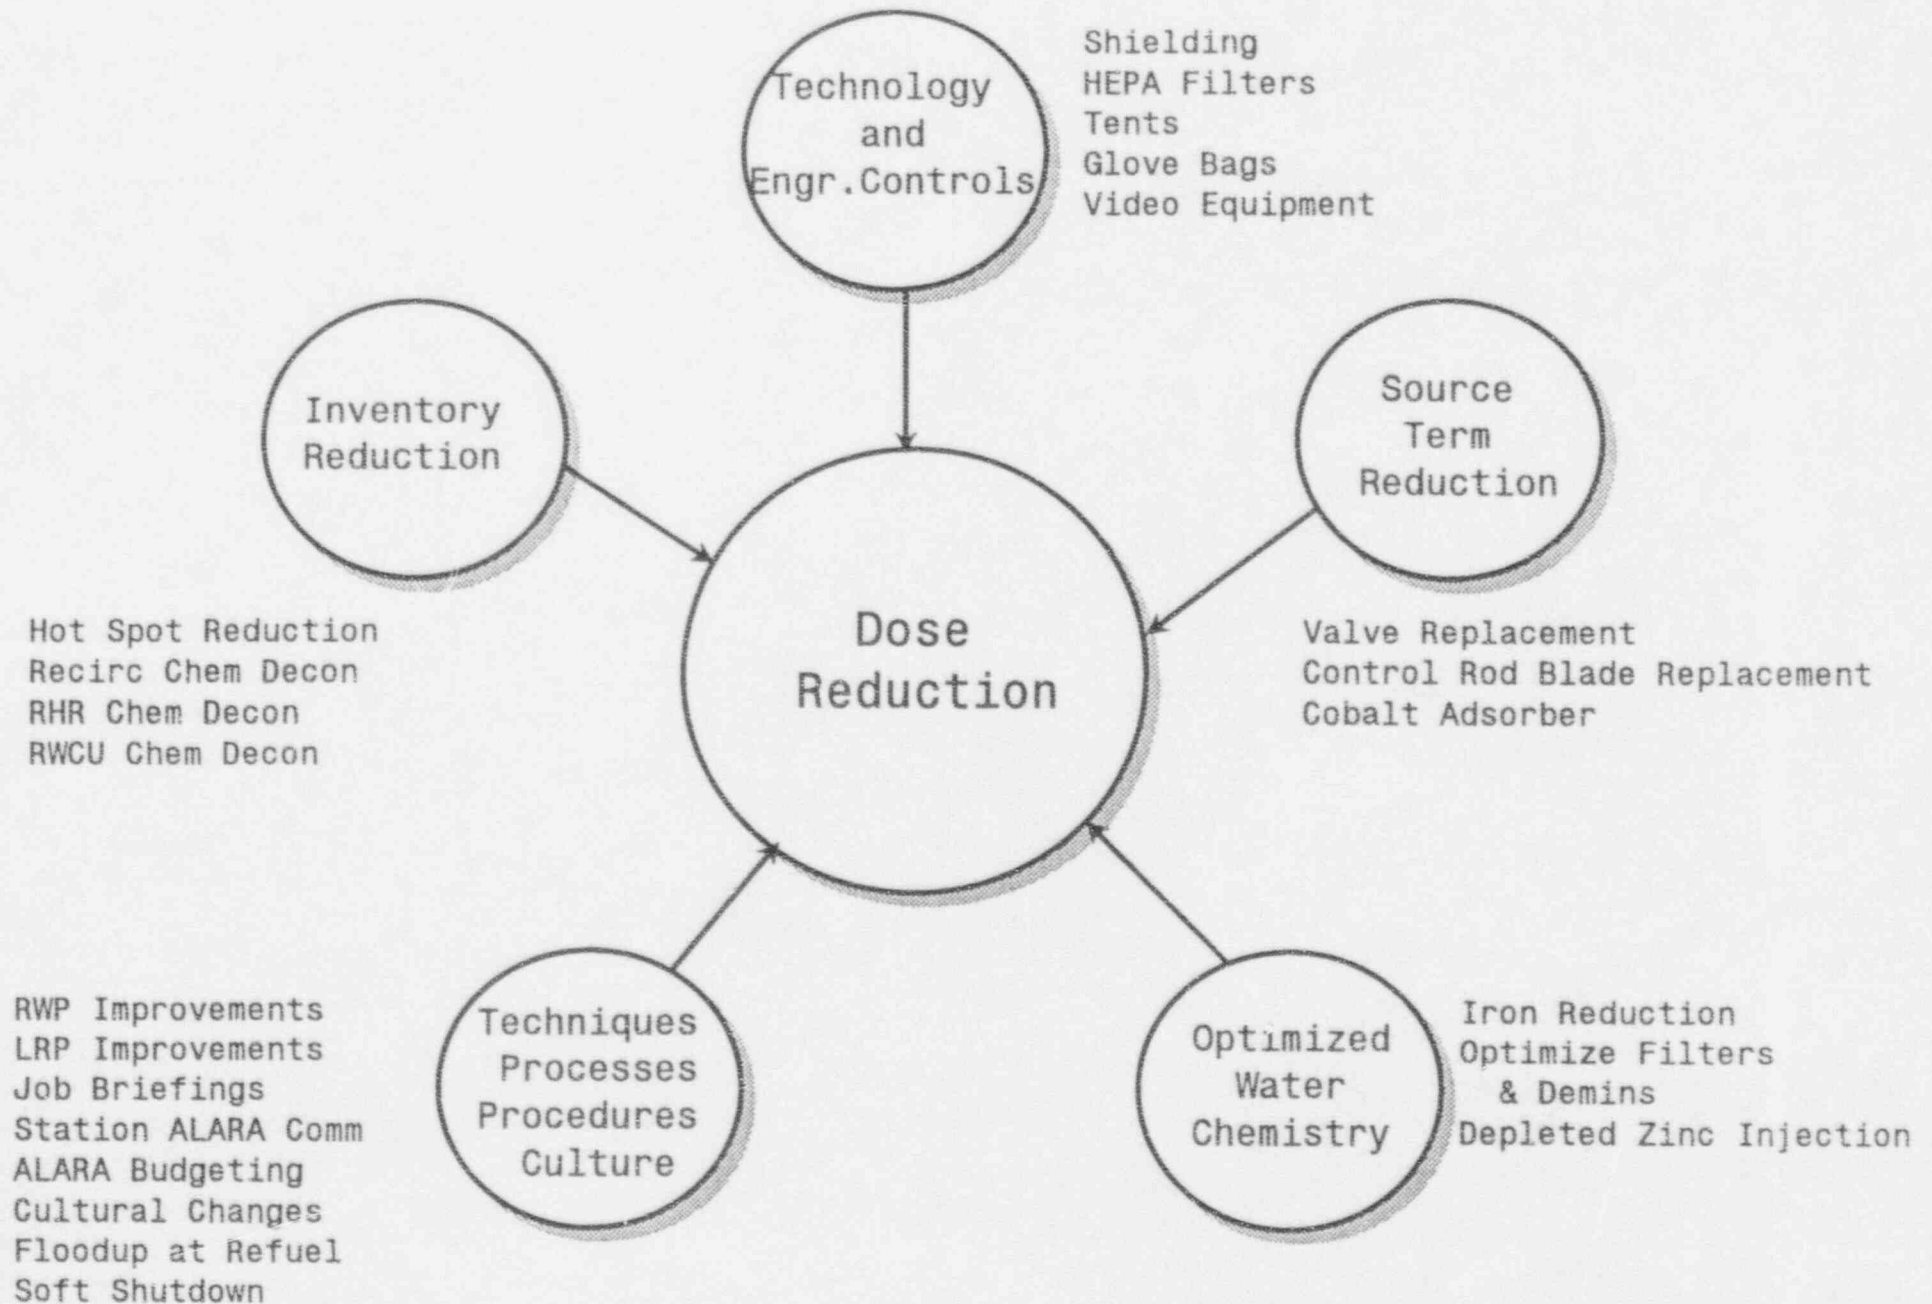
Plant Dose Reduction Techniques

In order to achieve our desired end state, there are many actions that we will carry out which address improvements in both the Program and Rad Worker Practices areas. Detailed action plan steps are delineated in the LaSalle Business Unit Plan (BUP), and were summarized in a meeting with the Region III staff which was held on Tuesday, March 29th. An overview of LaSalle's Dose Reduction Program is shown on Figure. 2.
