Northeast
Nuclear Energy

LICENSEE EVENT REPORT (LER)

FACILITY NAME (1) Millstone Nuclear Power Station Unit 2	DOCKET NUMBER (2) 05000336	PAGE (3) 1 OF 05
---	-------------------------------	---------------------

TITLE (4)
Failure to Perform Adequate ASME Leakage Test

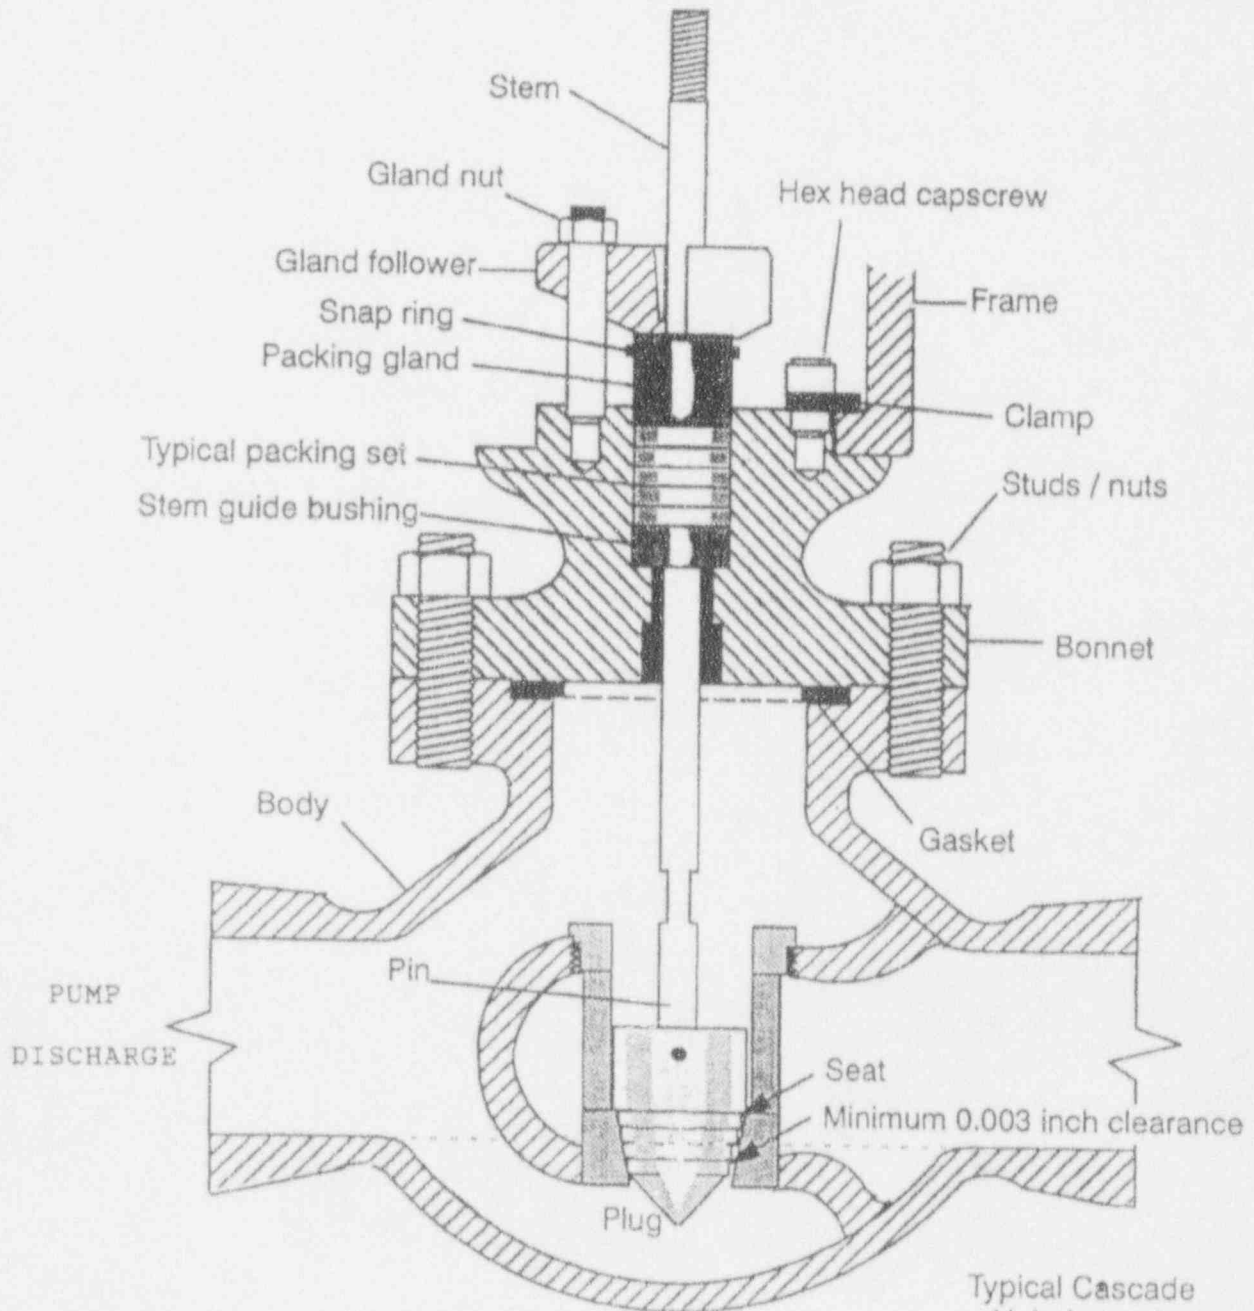
EXISTING DRAWING

The root cause of the event is considered to be a combination of personnel error and procedural deficiency. A personnel error occurred when the Shift Supervisor and the Test Coordinator changed the test method without consulting the test plan originator. Although this is not required by procedure, good work practices dictates that the originator and approvers of the test plan be consulted. The inaccurate drawing in the Maintenance procedure is considered a procedural deficiency, in that this component specific procedure contained a "typical" valve drawing that was not representative of the actual valve.
