James A. FitzPatrick
Nuclear Power Plant
P.O. Box 41
Lycoming, New York 13093
315 342-3840

SUBJECT: DOCKET NO. 50-333
LICENSEE EVENT REPORT: LER-93-022-01:

Vendor Design Deficiencies Allowing Exposed Resistors
in the RPS Panels

TITLE (4)
Vendor Design Deficiencies Allowing Exposed Resistors in the RPS Panels

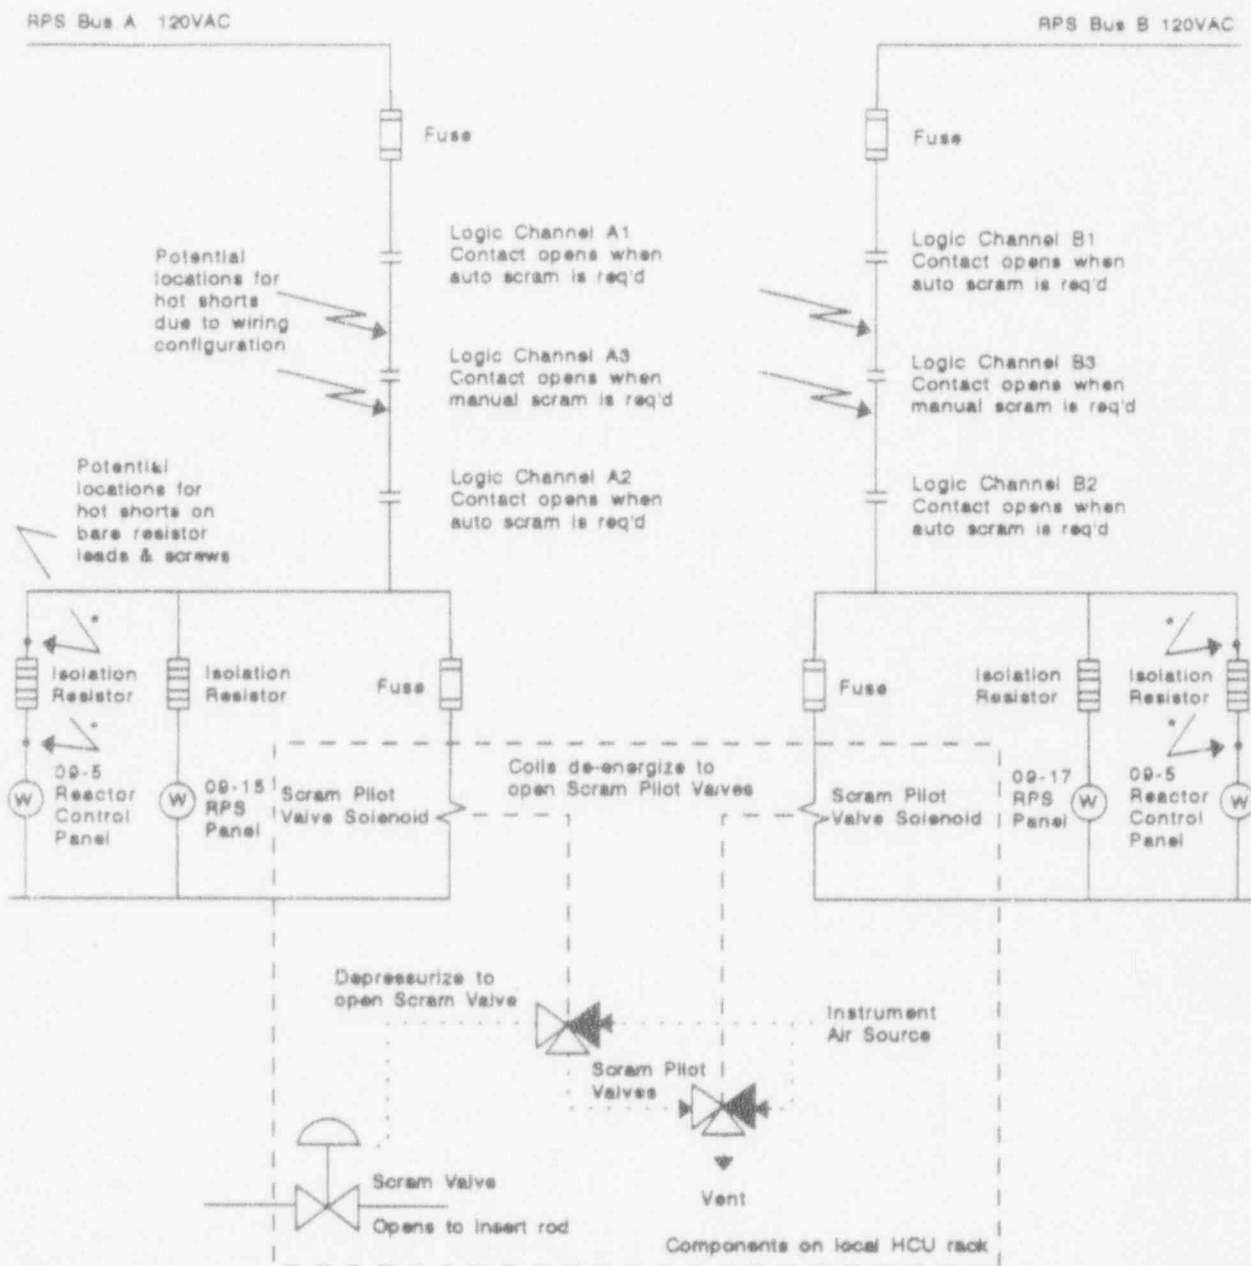
FIGURE 1
SIMPLIFIED PORTION OF THE RPS LOGIC

A portion of the RPS logic arrangement is shown on Figure 1. There are two separately powered trip systems (A and B), each one having three trip logics. Two trip logics in each system (A1 and A2, B1 and B2) monitor the critical parameters for an automatic scram. The third trip logic is a manual trip (A3 and B3). At least one channel actuation is needed to actuate a trip system (a half scram) and both trip systems have to be actuated for a full scram (1-out-of-2 taken twice logic).

After further evaluation, engineering determined that the wiring configuration between the scram contactors could (however unlikely) allow a hot short to the wiring between the scram contactors (a single failure), thus bypassing one of the two automatic trip logics and the manual trip logic for either trip system A or B for one of the four groups of control rods. However, a full scram would still be generated from a second set of contacts from the A2 or B2 trip logics. On October 29, engineering issued a Design Document Open Item to document the deviation.

Engineering determined that the exposed resistors (and their associated terminal blocks and wiring) could potentially allow a single failure (specifically a 120VAC hot short across the common lead of the additional resistor) to bypass certain relay contact actuations and prevent the automatic insertion of some of the control rods into the reactor core if a scram was required at the same time. A modification was implemented to relocate the resistors inside the contactor enclosures like the originally installed resistors.

Although highly unlikely due to the limited access to Control Room panels and the static nature of these panels, a postulated 120VAC hot short on one of the two bare resistor leads, on one terminal screw, or on one wire within the wire bundle, could potentially superimpose 120VAC on the electrical circuit without detection (until the next weekly surveillance test). If the RPS channels detected a condition requiring a scram, the appropriate relays would de-energize, but the superimposed 120VAC source would prevent the de-energizing of the scram pilot valve solenoids in one of the four groups of control rods. Only about three-quarters of the control rods would insert, resulting in an incomplete scram, although reactor power would be reduced significantly.

1. The eight resistors were relocated to the contactor enclosures, like the originally installed resistors. Completed November 18, 1993.
2. The exposed wires between the contactors were rewired inside conduit. Completed November 18, 1993.
3. The design conditions described above have been reviewed by General Electric, the designer of the additional circuits, for potential 10CFR21 reportability. GE concluded that a reportable condition does exist and notified all GE BWR owners and the NRC in December, 1993.
4. The Design Basis Document for the Reactor Protection System was issued on December 22, 1993.
