DOCKET NUMBER 50-483
CALLAWAY PLANT UNIT 1
FACILITY OPERATING LICENSE NPF-30
SPECIAL REPORT 90-02-01
INVALID DIESEL GENERATOR FAILURE DUE TO
IMPROPER OUTPUT BREAKER PLUNGER CLEARANCE

SPECIAL REPORT 90-02, REV 1
INVALID DIESEL GENERATOR FAILURE DUE TO
IMPROPER OUTPUT BREAKER PLUNGER CLEARANCE

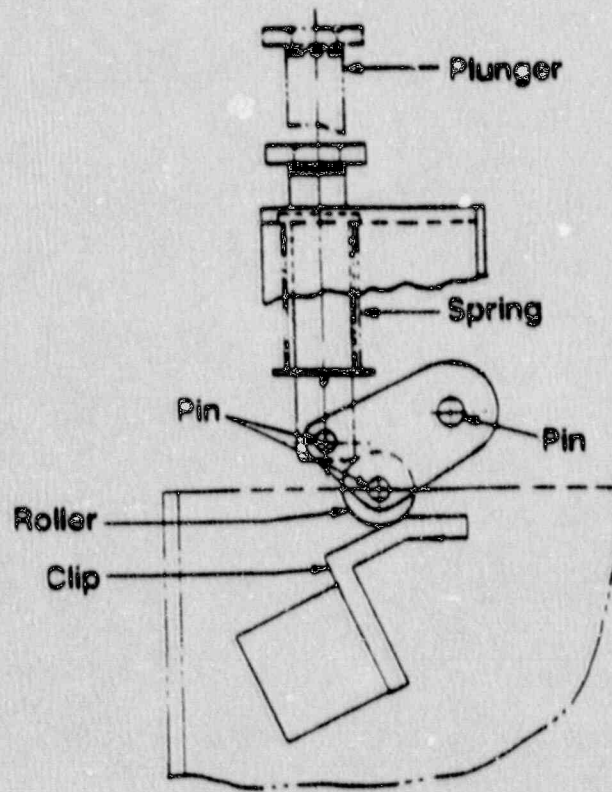
Attachment
Special Report 90-02

The root cause of this failure has been determined to be improper movement of the test link during breaker testing. An evaluation revealed that use of the test link, in some cases, caused the plunger clip to bend. See attached drawing. This bending results in an increase in the gap between the plunger and the operating rod, preventing the operating rod from moving sufficiently to actuate the switch upon breaker closure. An engineering evaluation verified that the affected breakers are operable in their existing condition provided that the plunger interlock gap distance is maintained within vendor specifications.

PLUNGER INTERLOCK

1. The gap between the plunger and the operating rod will be verified following each breaker rack-in on the D/G output breaker and other similar safety-related breakers.
2. An evaluation of the design and use of the test link will be performed.
3. An evaluation will be performed to determine 10 CFR Part 21 reportability.
4. The bent clips will be replaced at the first available opportunity following receipt of parts.
