# Maine Yankee

Subject: Maine Yankee Licensee Event Report 90-008-00 - Failure of Environmentally Qualified Limit Switch

Title(4)  
Failure of Environmentally Qualified Limit Switch

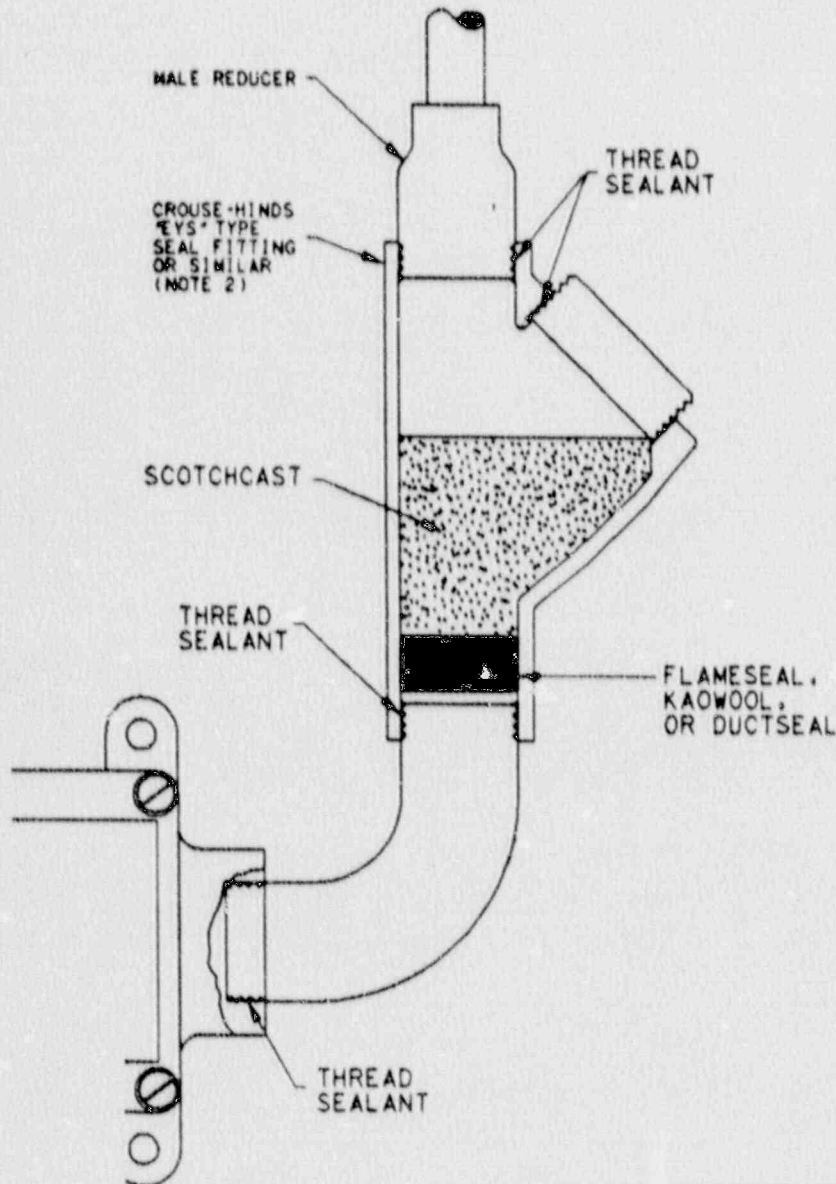
FIGURE 1

On October 17, 1990, while performing a safeguards valve surveillance procedure, the closed position lamp did not illuminate when the containment sump pump discharge valve was taken to the closed position. The problem was referred to maintenance for repair. On October 17, 1990, an Instrumentation and Controls technician identified a moisture corroded terminal inside the limit switch. Moisture had entered the limit switch due to inadequate sealing of the conduit (CND).

The NAMCO Model EA 180 limit switch entry is sealed with 3M Scotchcast #9 conduit sealer (potting compound), a two part epoxy (refer to attached sketch). The epoxy is injected into the conduit fitting while still liquid, and contained with a dam while curing. In this case the epoxy did not form a tight seal. Moisture entered the fitting and collected in the limit switch, eventually corroding a terminal and causing the switch failure. The conduit orientation with respect to the switch aggravated the problem; the conduit ran vertically down to the limit switch, such that any large amount of moisture in the conduit could collect in the switch should the seal fail.

SCOTCHCAST NO. 9 SEAL CONFIGURATION

Maine Yankee replaced the remaining 42 EQ conduit seals that used Scotchcast #9 as a moisture seal with the new NAMCO Model EC 210 pre-sealed connectors prior to restarting operations on October 26, 1990. During the replacement program no other limit switches were found with any moisture.
