50-317
AEOD/C105

REPORT ON THE
CALVERT CLIFFS UNIT 1
LOSS OF SERVICE WATER
ON MAY 20, 1980

Office for Analysis and Evaluation
of Operational Data

December 1981

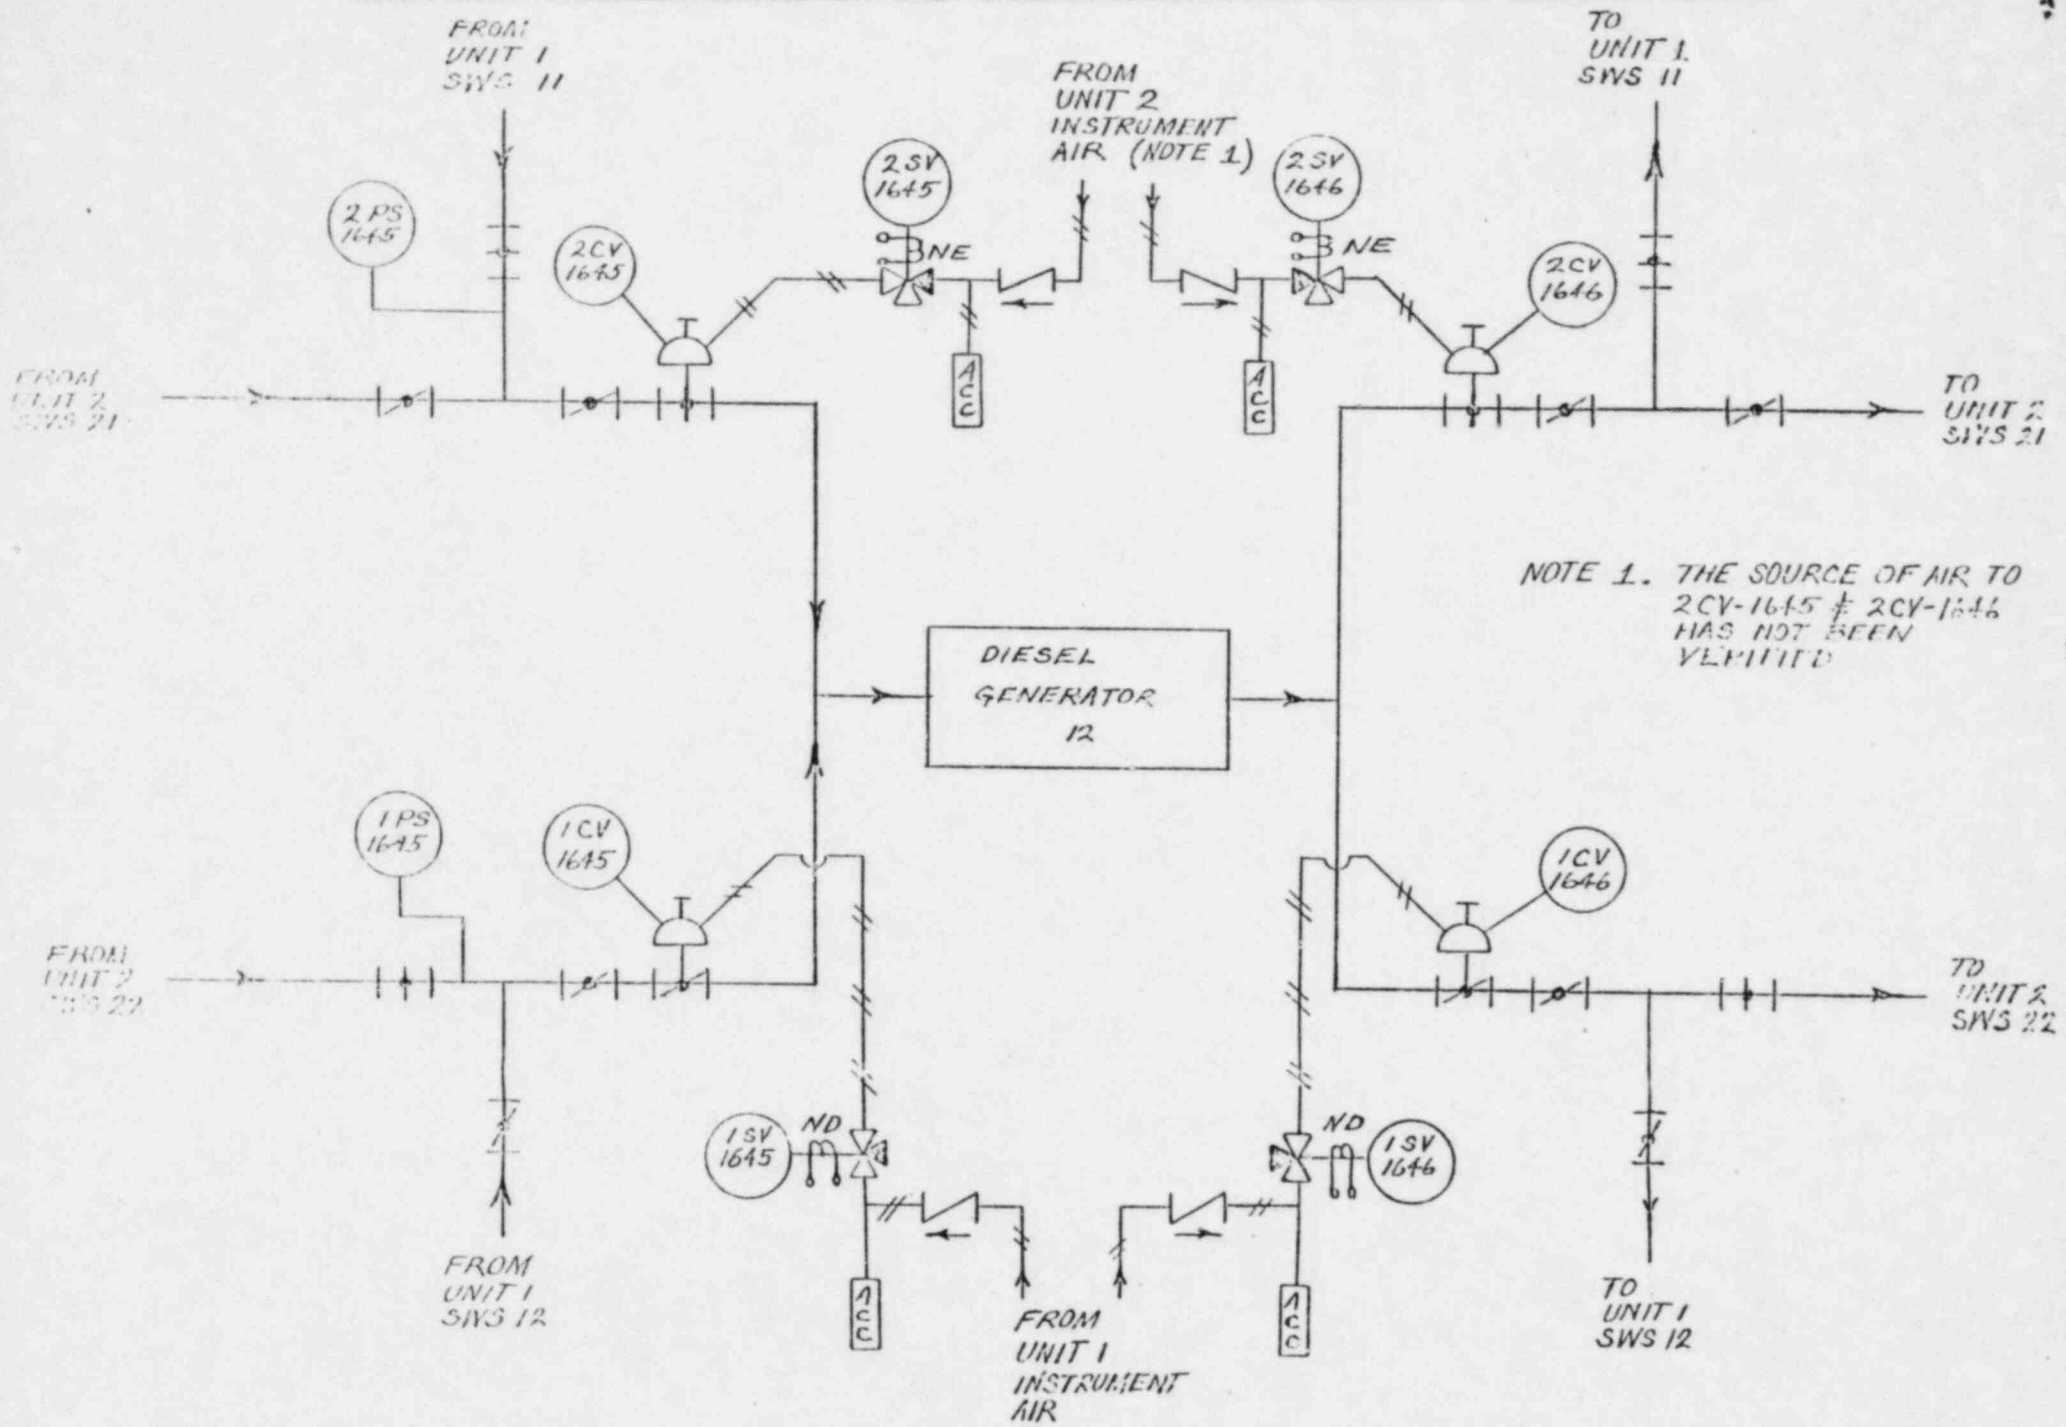
FIGURE 2 SERVICE WATER SUPPLY TO DIESEL GENERATOR 12

A major seismic event, comparable to the design basis earthquake (DBE), could result in the loss of offsite power and a loss of instrument air. The four service water inlet and outlet valves to diesel generator 12 are air operated and fail closed on loss of instrument air. Since air is required to keep the valves open, safety-grade air accumulators and check valves have

been provided to maintain a limited air supply following a loss of the instrument air system. If these check valves leak or there is leakage across the vent ports of the solenoid operated 3-way valves allowing the air to escape, the service water valves will drift closed causing diesel generator 12 to trip.

g. Leaking check valves or leakage of the solenoid operated 3-way valves in the instrument air supply to diesel generator 12's air-operated service water supply and return valves would cause these valves to go to their fail closed position if initially open or remain closed on loss of instrument air. This would isolate all service water from diesel generator 12, making it inoperable until operators manually opened the appropriate valves, aligning the diesel to Unit 1 or Unit 2, by means of the handwheels provided.

- (2) It is recommended that the four check valves and the four solenoid operated three-way valves in the instrument air lines that provide control air for the four diesel generator 12 service water supply and return valves be added to the IST program. (Refer to Figure 1.) These check valves are necessary to prevent the control air stored in the

seismically designed accumulators from being lost through a break in the non-seismically designed instrument air system. The solenoid operated three-way valves are also part of the same seismically designed pressure boundary as the check valves described above. The service water supply and return valves fail closed on loss of instrument air. Therefore, the inability of these check valves or the solenoid operated three-way valves to maintain a leak-tight pressure boundary will result in service water isolation to the 12 diesel generator. Handwheels are provided for the service water supply and return valves and valve position is indicated in the control room by open/close status lights; therefore, these valves can be manually repositioned, allowing for some delay due to operator action, following a loss of instrument air.
