REPORT ON THE  
MILLSTONE UNIT 2 LOSS OF 125 V DC BUS  
EVENT ON JANUARY 2, 1981

OFFICE FOR ANALYSIS AND EVALUATION  
OF OPERATIONAL DATA

November 1981

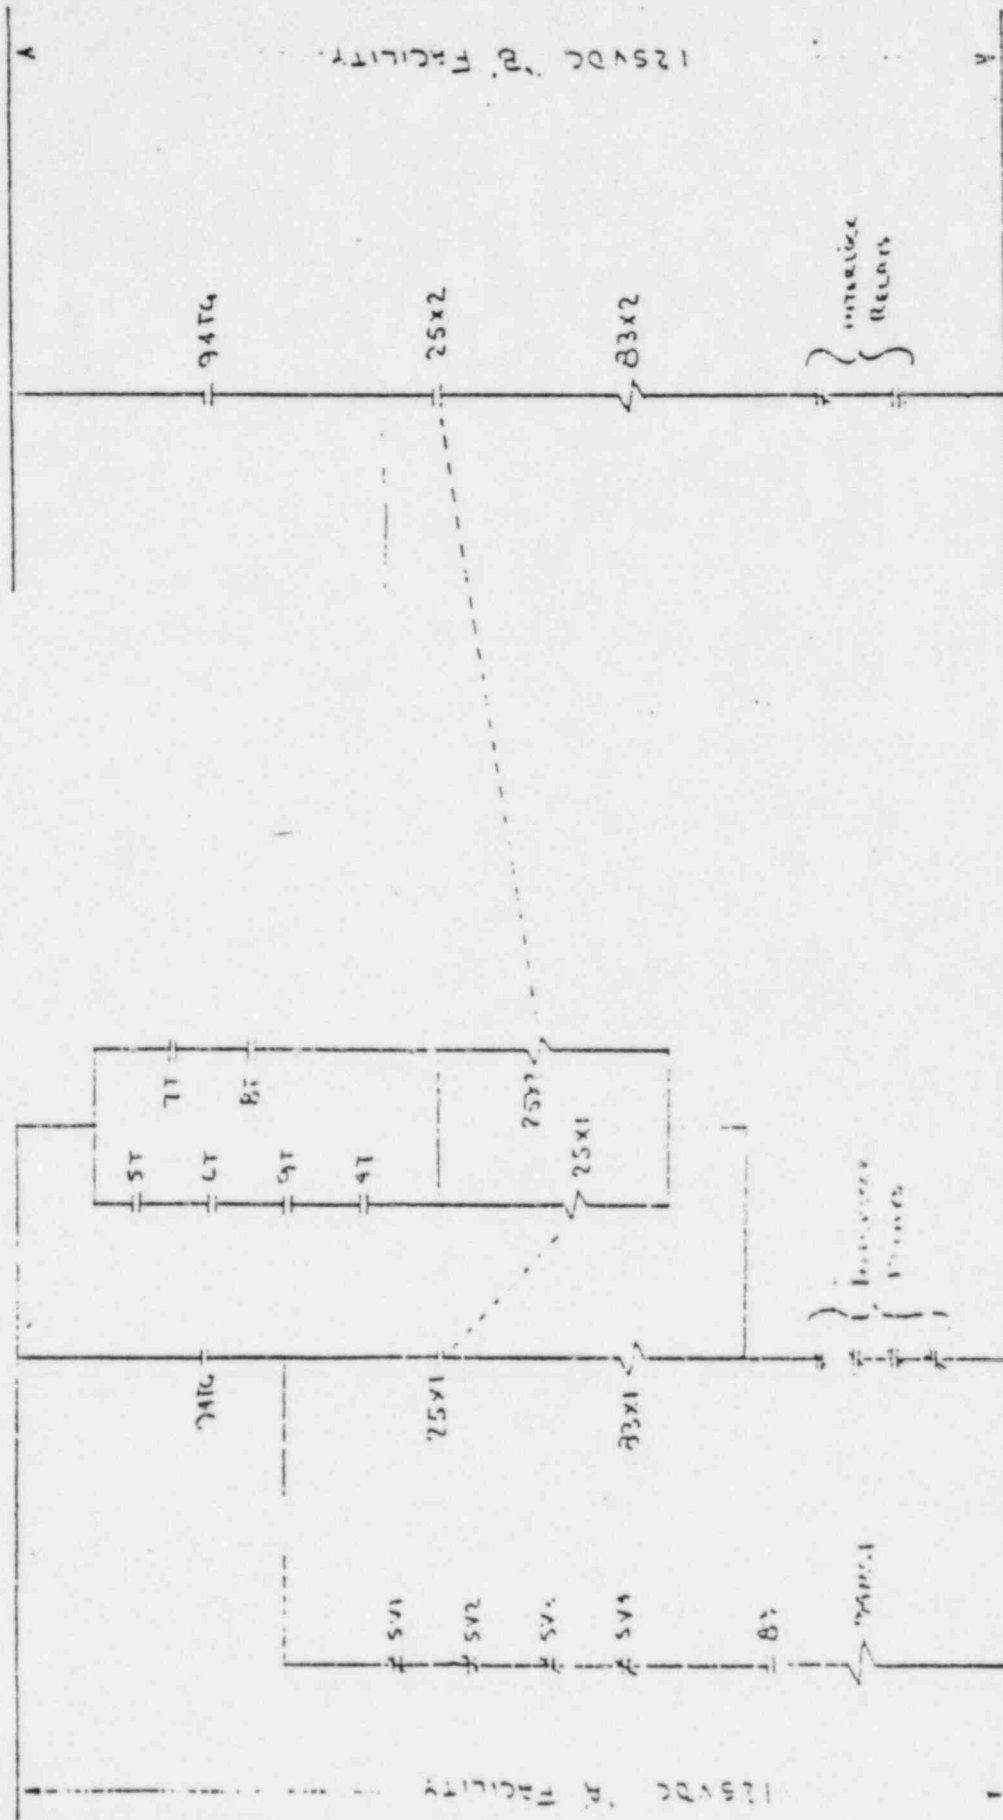
FIGURE - 3

During the event, however, only relay 94TG, which is connected to the "B" facility 125 V dc system, operated on the turbine trip from the 24 V dc logic. Relays 83X1 and 83X2, which are connected to the "A" facility 125V dc, did not operate. Contacts of the 94TG relay normally trip the four NSST breakers (two 6900 V bus breakers and two 4160 V bus breakers).

Since relays 83X1 and 83X2 did not operate (see Figure 3), the RSST supply breakers for buses 24D and 25B did not receive a close signal. With 4160 V bus 24D remaining de-energized, the emergency safeguards actuation system (ESAS) detected a loss of normal power (LNP), which caused load shedding

The licensee has initiated a study of the turbine and generator trip schemes and the NSST to RSST fast-transfer schemes to evaluate the need for redundant relays and power supplies so that these functions would occur with one dc bus de-energized; i.e., with one dc bus lost, normal offsite power would be automatically supplied to station auxiliaries associated with the other dc bus.

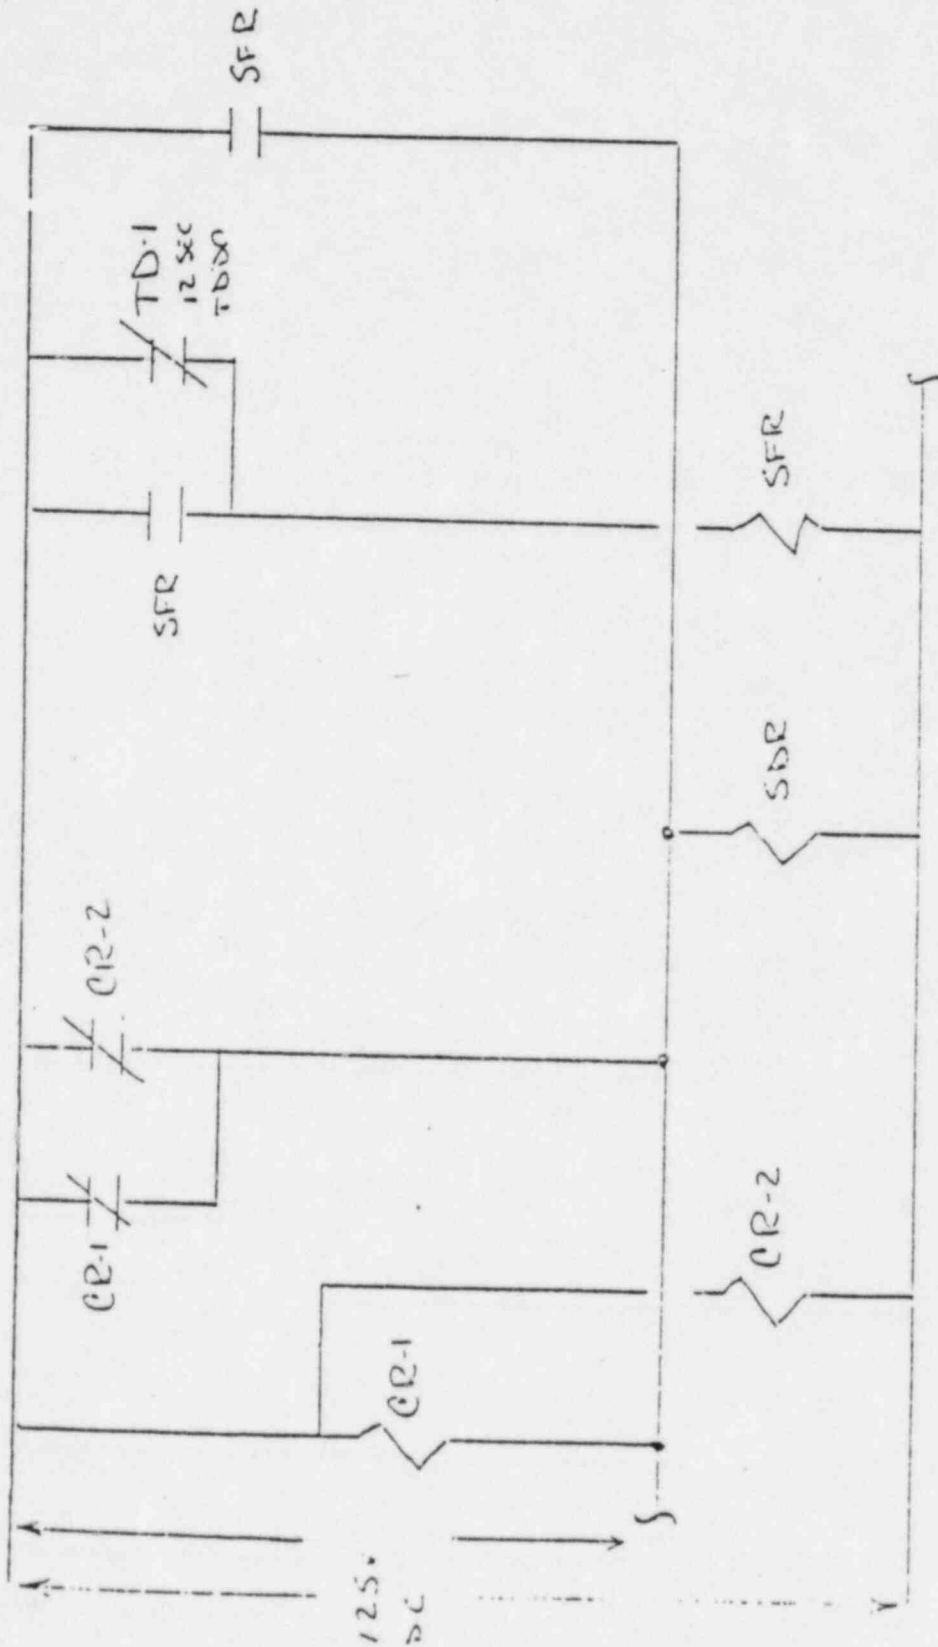
FIGURE - 4

"A" emergency diesel generator (EDG) failure-to-start relay (SFR) energized upon re-energization of the dc bus. This in turn energized the diesel shutdown relay (SDR) which stopped the engine (See Figure 4). On loss of dc control power and subsequent re-energization of the dc bus the SDR could be energized by operation of either the loss of dc power relays (CR-1 & CR-2) or the failure-to-start relay (SFR). Once tripped, local reset action would be required to restart the diesel engine.

- (a) Diesel Generator - The "A" diesel generator, that had "black started," was automatically tripped due to the actuation of the failure-to-start relay. To restart the diesel after this would require local reset action. The licensee considers the loss of a dc bus a single failure that would cause the loss of one train of redundant equipment; hence, re-energization of the dc bus and consequent events have no further safety consequence. When implemented, the licensee's revised procedures (to trip the DG and close the air valves) will assure that the DG is available again should dc power be restored. It is noted that even with dc power restored, the revised procedure does not assure the availability of the DG without additional operator action. We believe that the licensee's procedure should include a requirement to reset the diesel engine control when the dc bus is re-energized.

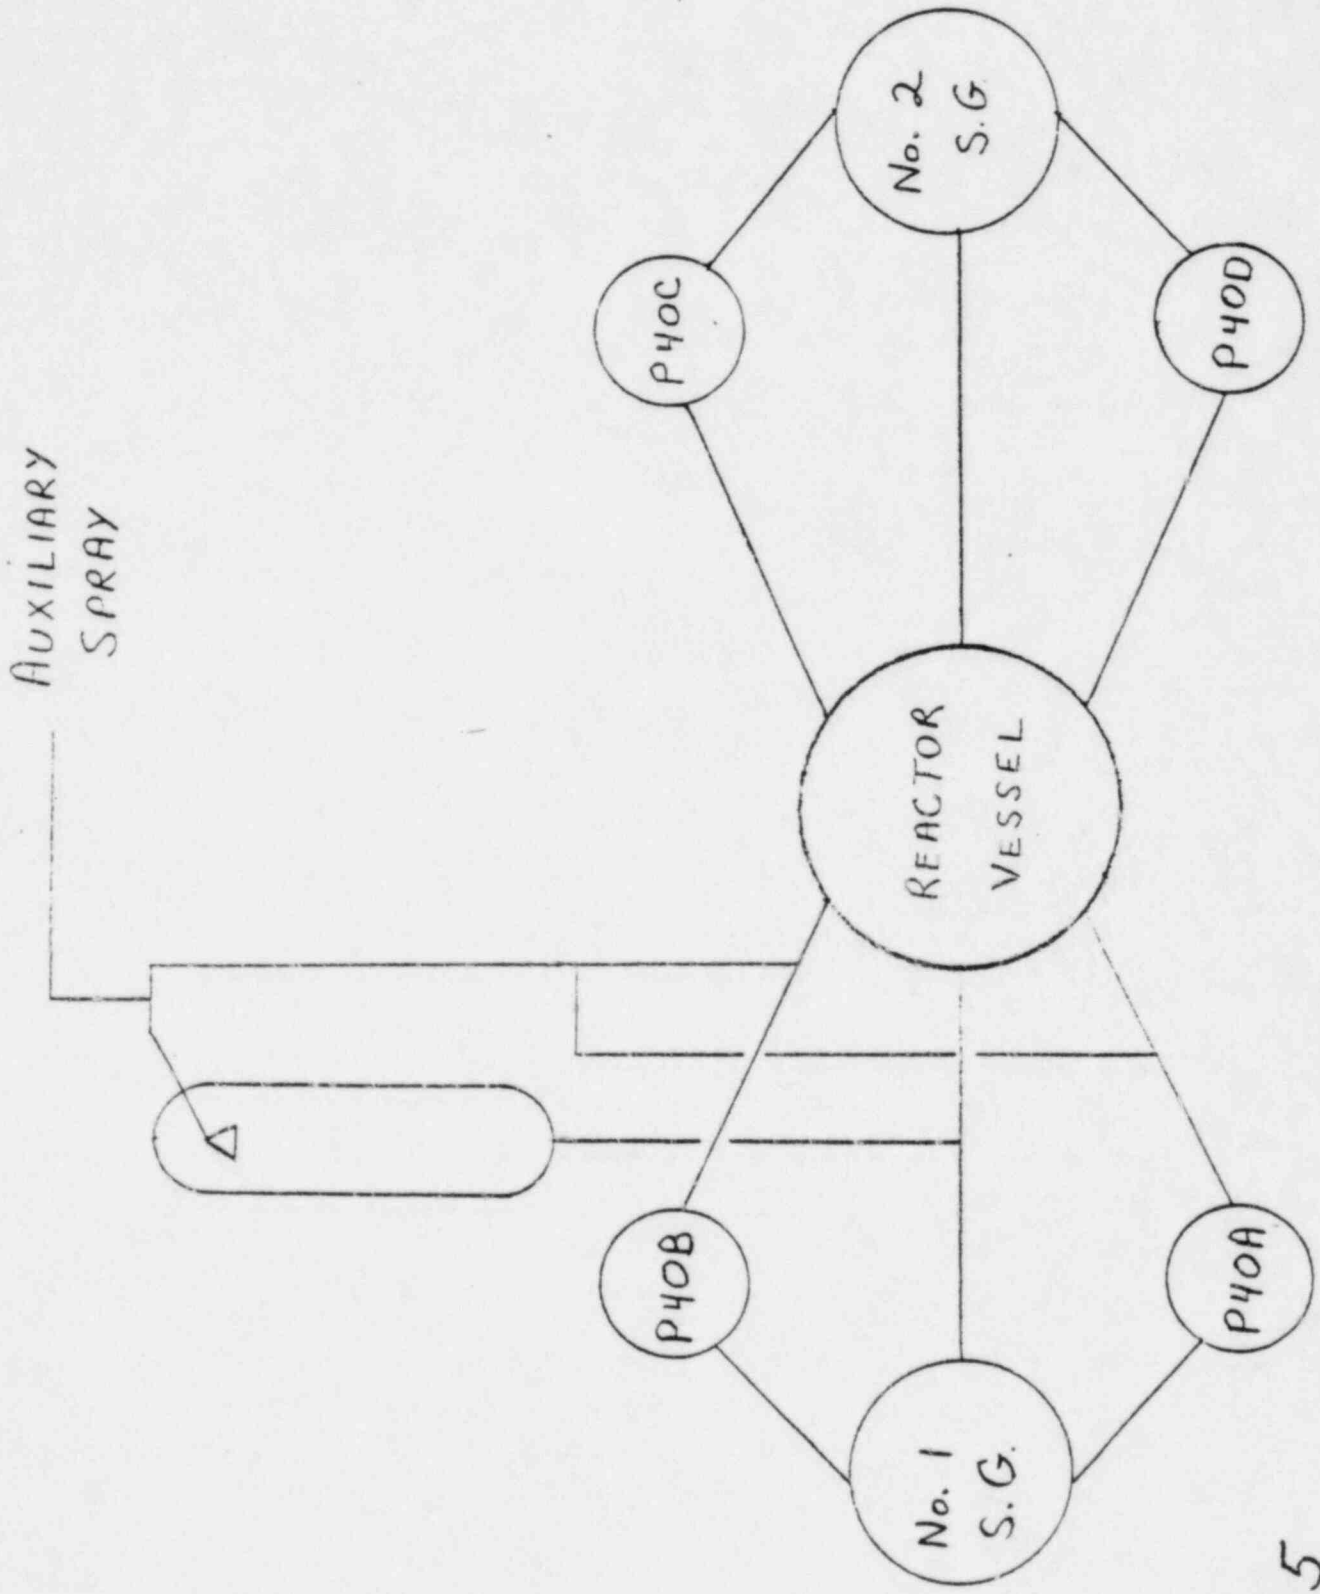
FIGURE 5

and the operator was trying to control pressurizer pressure by spraying with the normal spray system. However, only two reactor coolant pumps, P40A and P40C, were operating because the RSST supply breaker for the 6900 V bus 25B had tripped on overcurrent. The operators assumed this two-pump combination provided effective pressurizer spray since, as shown in Figure 5, one of the two lines to the common spray header comes from the cold leg at the P40A reactor coolant pump discharge. However, the operators were having difficulty controlling the pressure and therefore assumed non-condensibles were present in the pressurizer. Subsequent review of initial plant startup test data has shown that this two-pump combination results in no significant pressurizer spray flow.

As discussed previously, the 6900 V bus 25B supply breaker tripped on overcurrent when the "A" facility 125 V dc power was restored. Consequently, since reactor coolant pumps P40B and P40D are powered by the 25B bus, these pumps were stopped and forced circulation was being provided by pumps P40A and P40C. As can be seen from Figure 5, the pressurizer spray is taken from the discharge side of pumps P40A and P40B in the reactor coolant system loop with the surge line. Therefore, since spray lines are taken from only two cold legs the spray flow available with two pumps operating will vary depending on the two-pump combination running.

In this instance, the operators apparently failed to realize that with only P40A and P40C running the spray flow available was not sufficient to be effective in pressure control. The subsequent unexpected pressurizer behavior and the appearance of "hardness" caused by the superheating of the steam led the operators to believe non-condensibles were present in the pressurizer.

The licensee has revised the plant operating procedures to specify the pump combinations which should be used to achieve an effective pressurizer spray. A caution has been added to warn the operators that pump combinations other than those listed may lead to inadequate spray flow and the impression of system "hardness," i.e., non-condensibles present. The licensee is also conducting a generic review of all plant startup test data to determine other important operational data. In addition, the non-equilibrium pressurizer behavior and the core conditions necessary to produce large amounts of non-condensibles have been reviewed with the operators. We consider this action adequate.
