Duke Power Company
Oconee Nuclear Station
Unit 1

Report Number: RO-269/81-11, Supplement 1

Identification of Occurrence: Core Barrel Assembly Thermal Shield Bolts Broken

Subject: Broken Thermal Shield Bolts at Oconee Unit 1

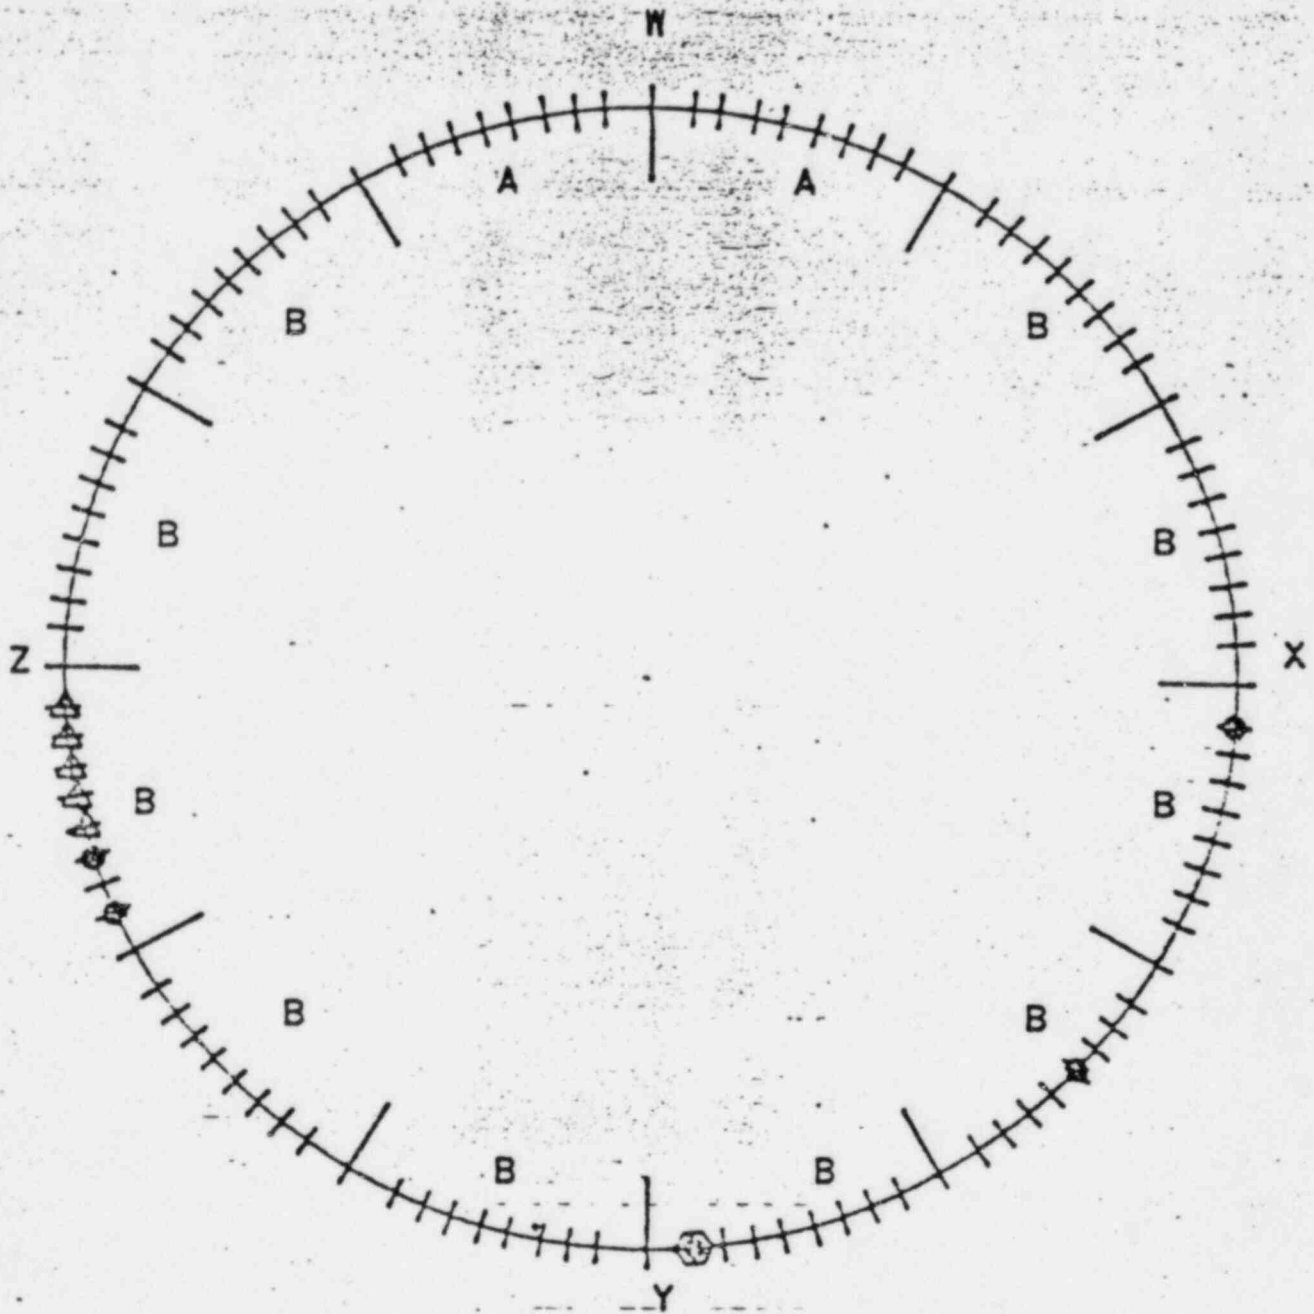
LOWER THERMAL SHIELD

1. Four of 96 bolts connecting the thermal shield to the lower grid flow distributor flange were missing.
2. Approximately 80 percent of the remaining thermal shield bolts were backed out from 0.1 to 0.5 inches.
3. Three bolt locking cups were missing.
4. One locking cup was partially attached.
5. One guide block on the Y-axis was missing.

BOLT MISSING
-

BOLT HEAD MISSING
- A ALL BOLTS FLUSH
- B ALL BOLT HEADS ~ 0.1" TO 0.2" OUT
-

BOLT HEADS 1/4" TO 1/2" OUT

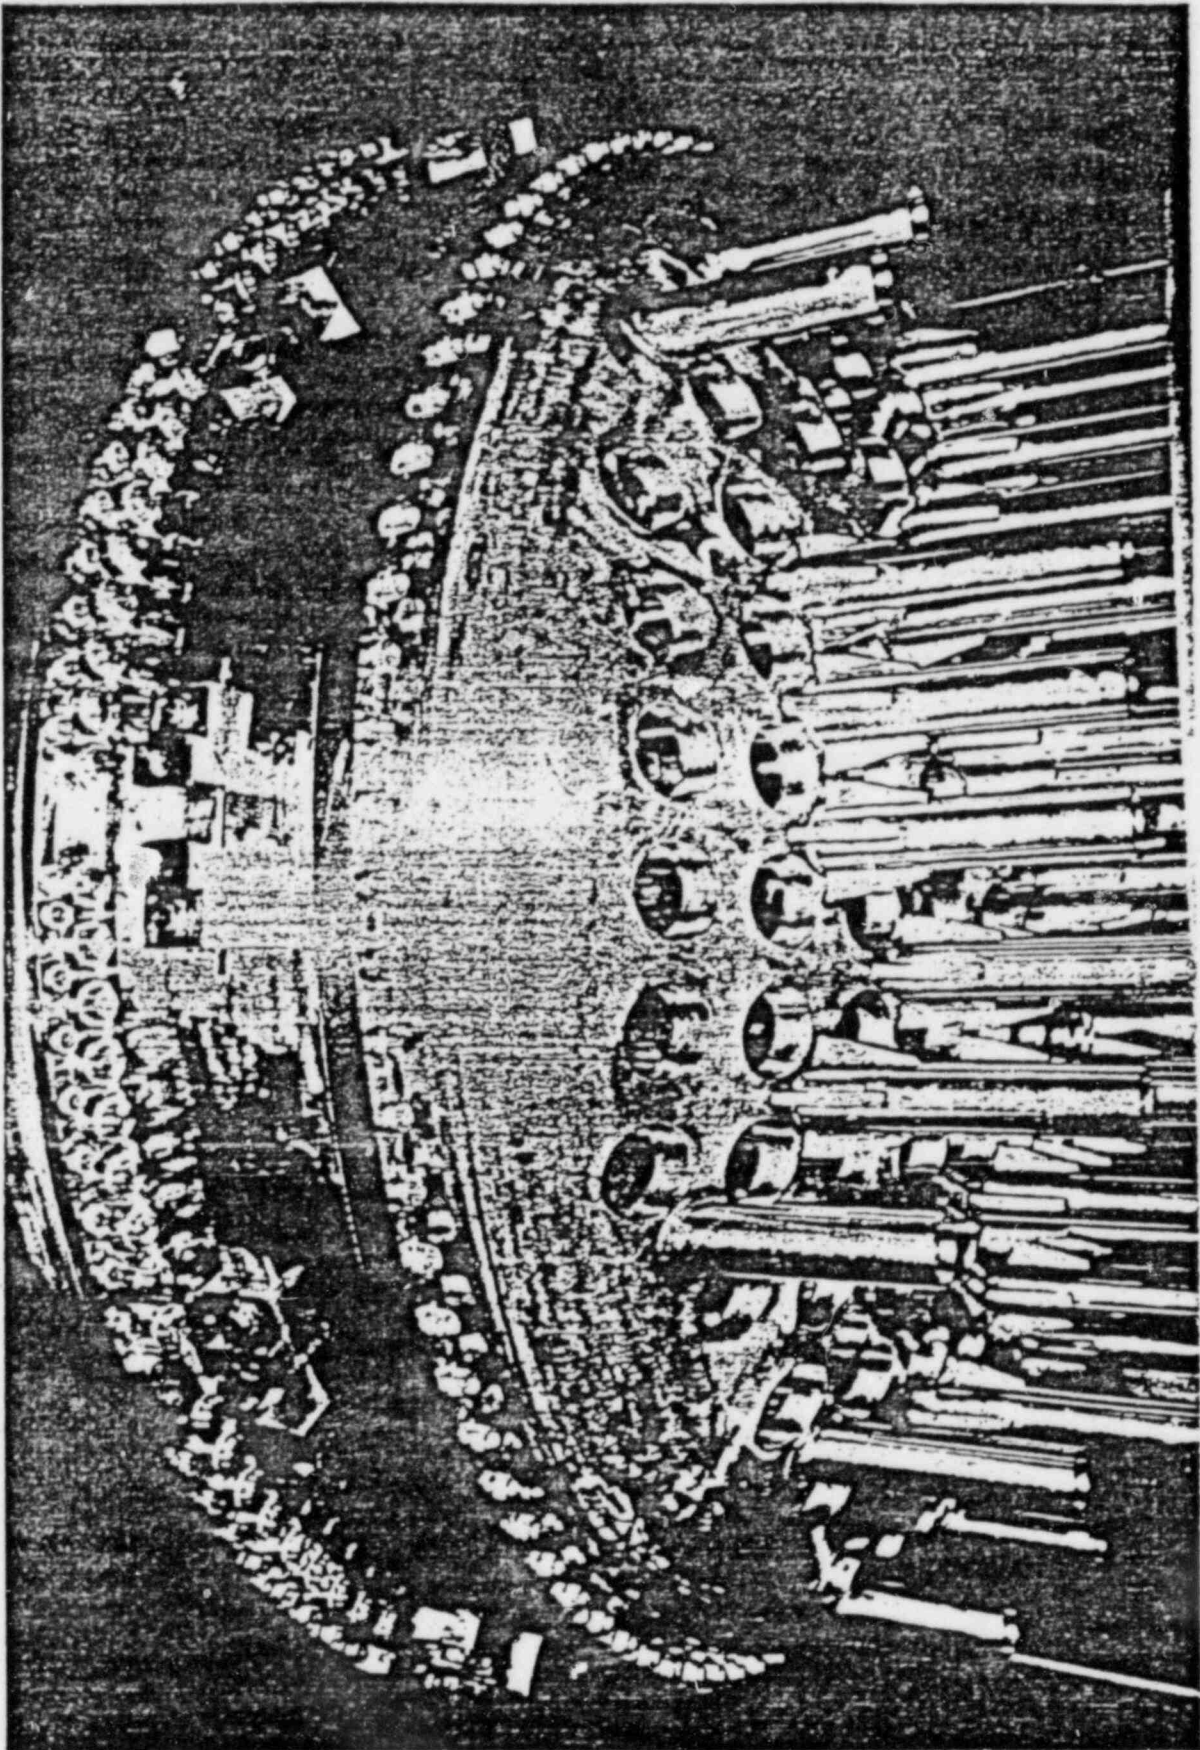
Attached to the exterior of the lower internals are 12 pairs of lateral restraint guide blocks. Each half of the blocks is about 3" x 6.5" x 5" and weighs about 18 lbs. Each pair of blocks straddles one of the 12 core support lugs. One of these 24 guide blocks was observed to be missing.

GUIDE BLOCK MISSING

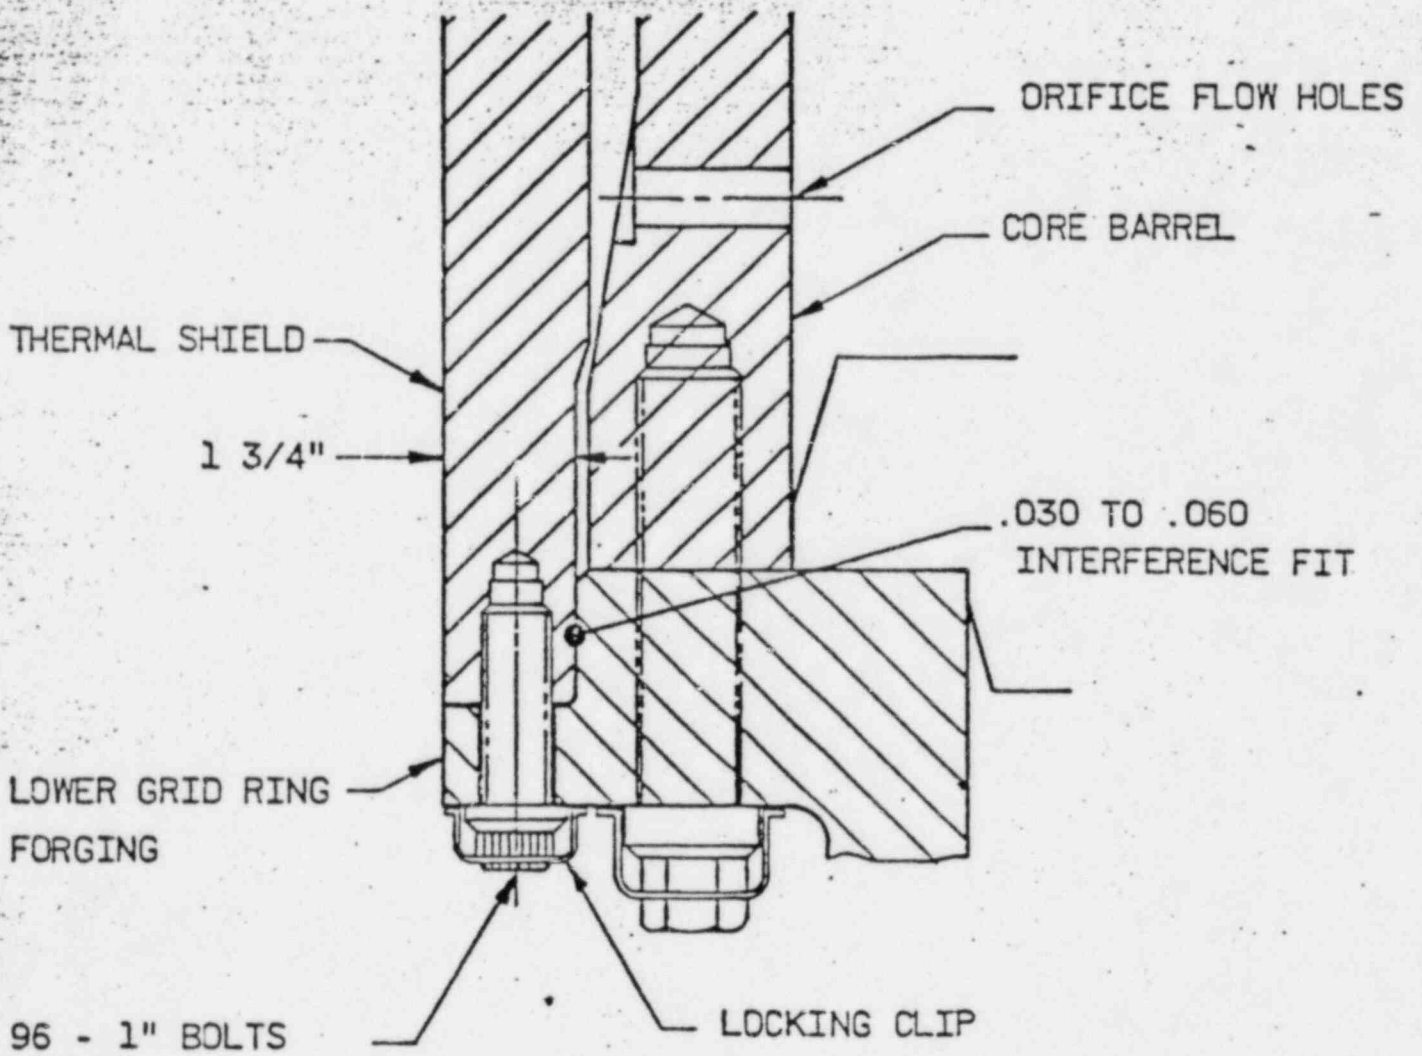
THERMAL SHIELD LOWER SUPPORT

The thermal shield is a 2-inch-thick cylinder surrounding the core barrel; it extends the length of the core region. Its function is to provide additional shielding against gamma and neutron flux effects on the reactor vessel wall in the core region to reduce gamma heating in the reactor vessel wall and radiation effects on the vessel materials. The bottom support is shown in Attachment 4. The ID of the thermal shield is machined to clear the bottom flange of the core barrel and to engage the lower grid with a diametral interference fit. Ninety-six 1-inch-diameter, high-strength bolts secure the bottom end of the thermal shield to the lower grid plate. (The four missing bolts were from this location.)

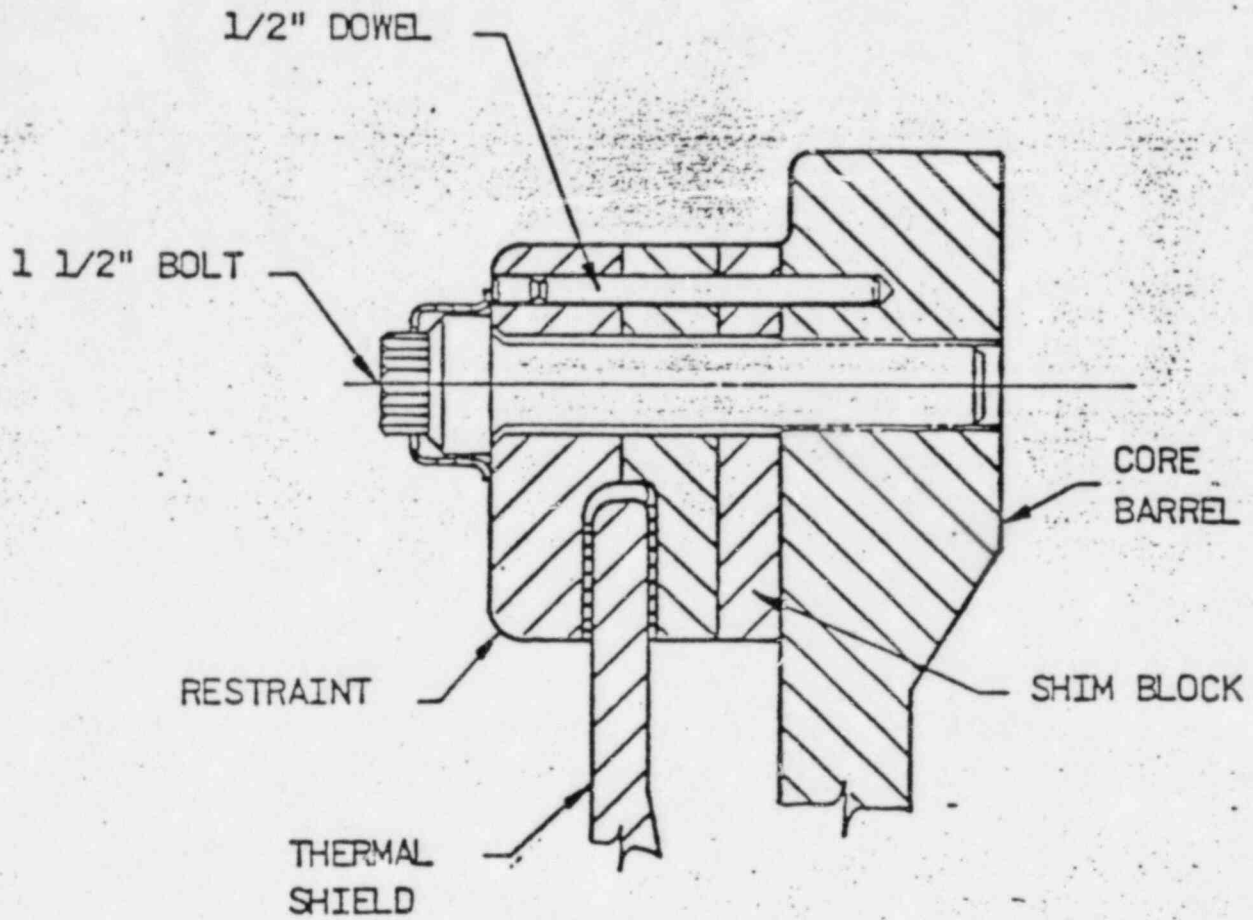
UPPER THERMAL SHIELD RESTRAINT

The thermal shield's upper support (shown in Attachment 5) consists of a Stellite clamp and shim pad that are contoured to the thermal shield and core barrel curvature. Twenty of these assemblies are placed at equal intervals around the top end of the thermal shield and secured to the core barrel by high-strength bolts (three in each assembly). The design restrains the thermal shield radially both inward and outward, and allows axial motion to accommodate longitudinal differential thermal growth between the core barrel and the thermal shield.

| Upper thermal shield restraint | Locking clips intact; no visual evidence of wear |
