MEMORANDUM FOR: J. F. Stolz, Chief, Operating Reactors Branch #4, DL  
FROM: P. C. Wagner, Project Manager, Operating Reactors Branch #4, DL  
SUBJECT: FORTHCOMING MEETING WITH DUKE POWER COMPANY (DPC)  
Time & Date: 9:00am-2:00pm, October 9, 1981  
Location: Phillips Building, Room P-422  
Bethesda, Maryland  
Purpose: To discuss the broken thermal shield bolts in Oconee Unit 1.

Re: Oconee Nuclear Station  
Docket No. 50-269  
RO-269/81-11, Supplement 2

Thermal Shield Bolt Failure Supplementary Information

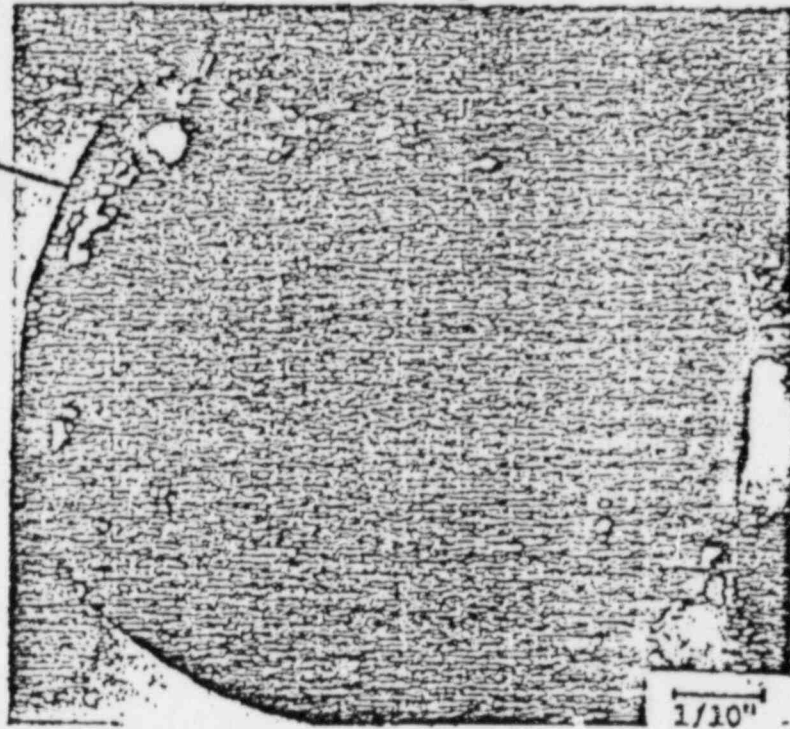
Figure 1. Macrograph of Fracture Surface on Bolt Shank 1

The broken samples consisted of three bolt shanks and two bolt heads. Of the five fracture surfaces, two were damaged from impact, and consequently clean fracture surfaces were not available for examination. The remaining three fracture surfaces (two bolt shanks and one bolt head) were examined and found to contain similar fracture features.

All of the broken bolts examined had fractured in or near the fillet between the head and shank. An island of transgranular fracture (as shown in Figure 1) with evidence of fatigue striations and/or crack arrest marks was surrounded by intergranular fracture, with evidence of grain boundary corrosion attack. No shear lips or other macroscopic indications of ductility were present on the fracture surfaces. The initiation and propagation of intergranular cracks with branch cracking in this material is consistent with a form of an environmentally assisted cracking process - stress corrosion and/or corrosion fatigue.

The factors which seem most likely at this time to have contributed to the lower thermal shield bolt failure are the rather pronounced microstructure transition at the head-to-shank fillet in the lower thermal shield bolts and the potential for this "metallurgical discontinuity" to increase the sensitivity to stress corrosion cracking and corrosion fatigue.

Intergranular  
Surface

Transgranular  
Island. Final  
Fracture Area
