SUBJECT: TMI-1 STEAM GENERATOR TUBE PROBLEM AND PROPOSED REPAIRS

Contact: **Doug Bedell, David Osterhout**For Release: **Immediately**Date: **April 7, 1982**
945-82**PLANS FOR REPAIRING STEAM GENERATOR TUBES AT TMI UNIT 1**

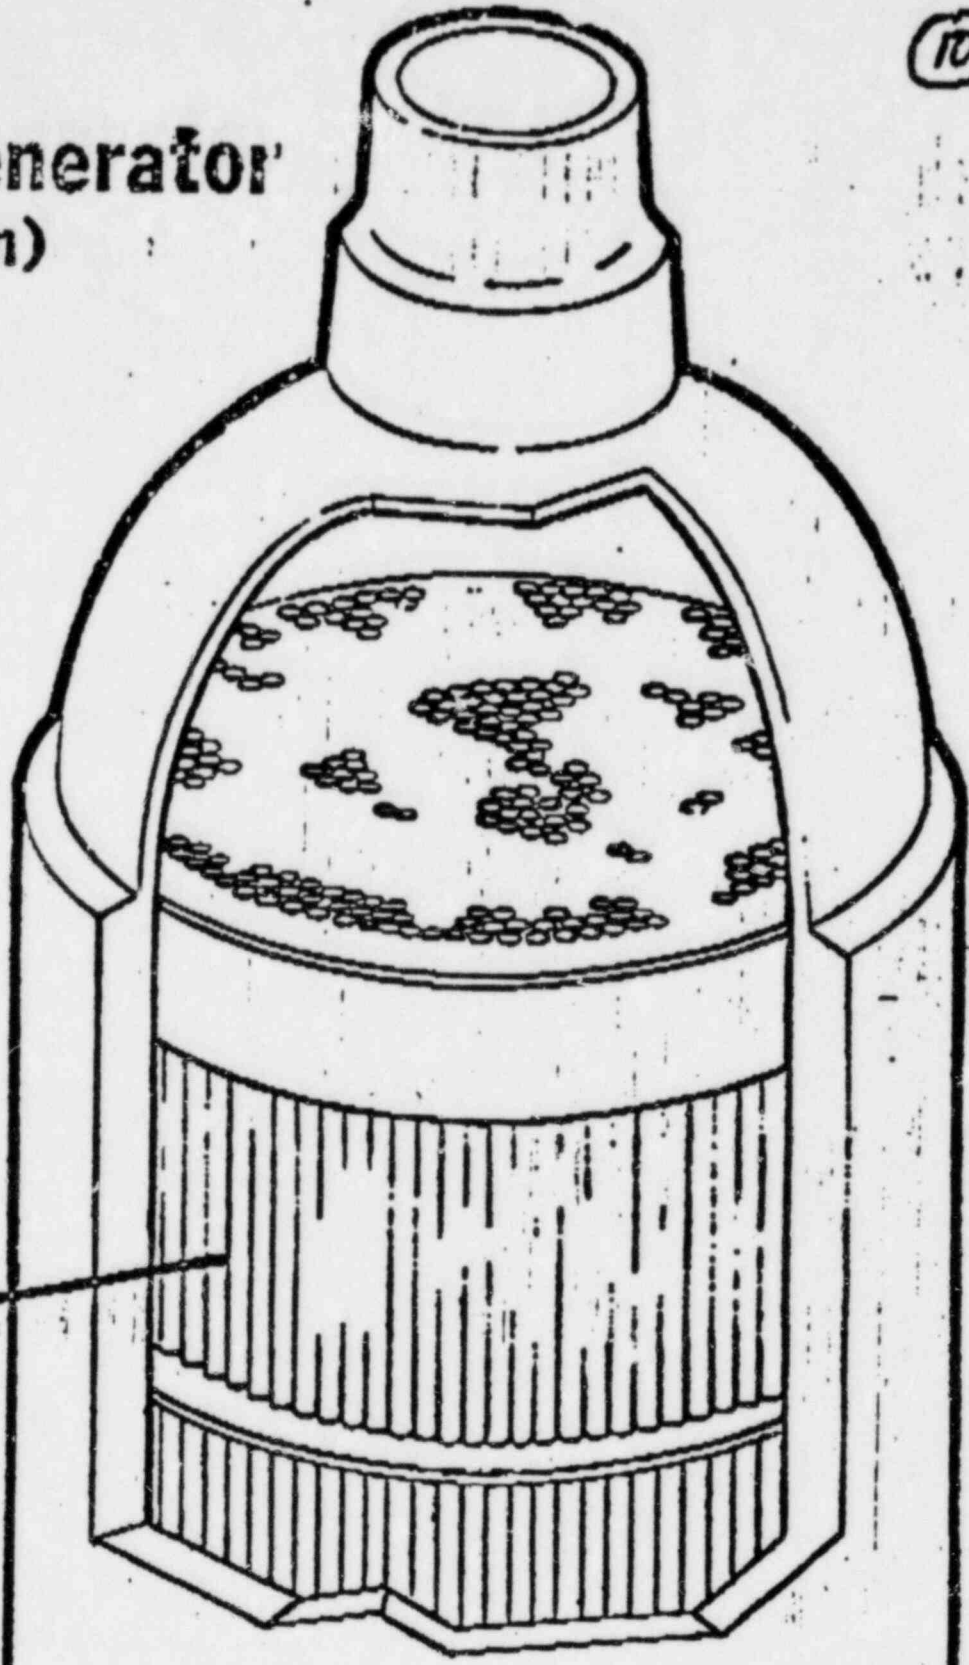
Steam Generator (Top Section)

"dry-out region" at the top of the generators and likely induced cracks in 8,000 to 10,000 tubes. The affected tubes are located predominately near the outer edge of the tube "bundles". About 140 tubes actually leaked during early low-pressure testing of the generators, and they are being plugged, along with 19 other tubes from which sections were removed for laboratory analysis. Cracking apparently stopped either because chemistry changes expected to take place at the lower temperature produced a less aggressive form of sulfur or because the environment in the "dry-out region" was improved when the water level was increased in the steam generators.

Using the tube expansion repair technique, the affected tubes will be expanded -- or "rolled" again -- below the area of corrosion so that a tight seal will be restored between the tube walls and the holes in the tube sheet. There will, however, be additional plugging of tubes where tests show leakage at higher test pressures or indications of corrosion below the upper tube sheets.

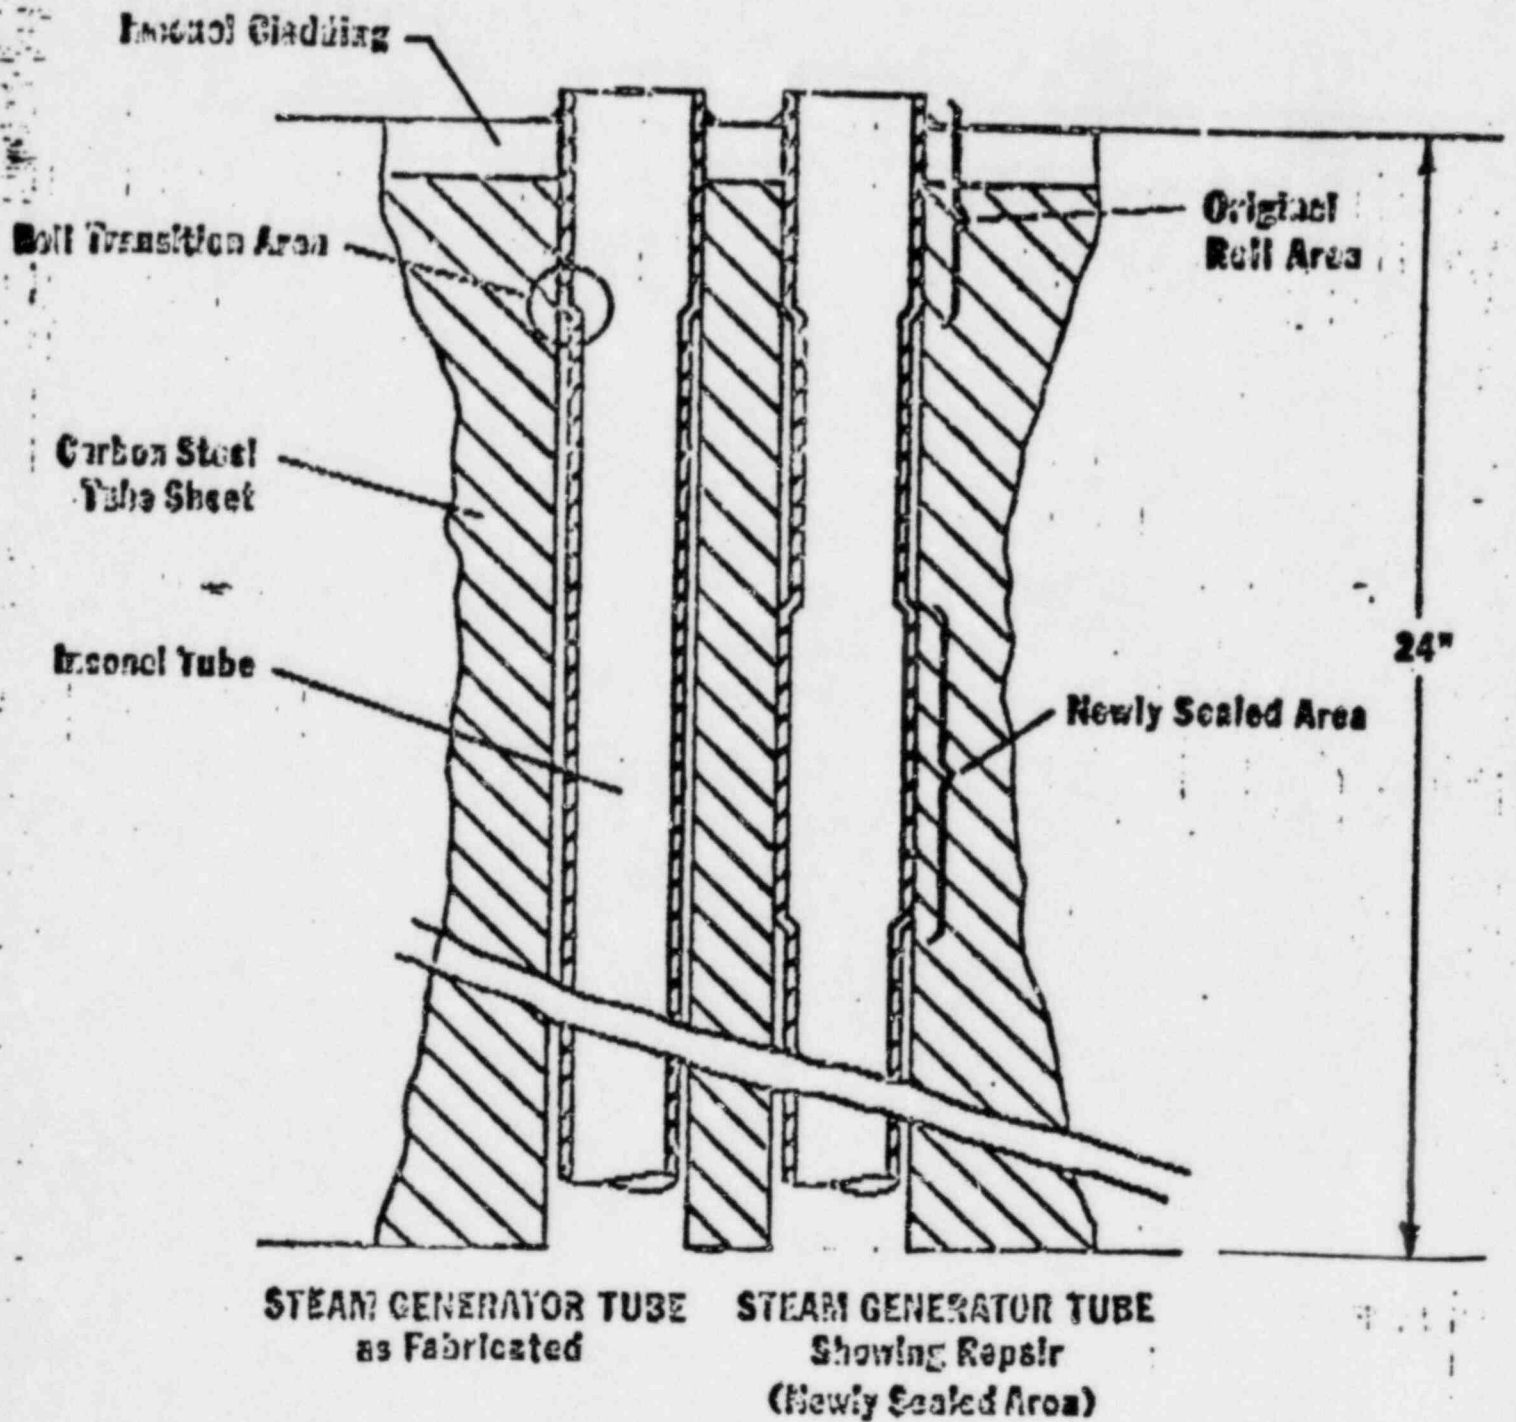
UNIT 2 STEAM GENERATOR TUBE SHEET AREA

generators, in the portion of the tubes where the upper one to one-and-a-half inch of the 56-foot long tubes was expanded -- or "rolled" -- to hold them tightly in place within the tube sheets. The tube sheets are two-foot thick blocks of steel containing holes for the 15,500 tubes in each of the steam generators.
