AEOD/E116

SUBJECT: TRIP REPORT TO NORTH ANNA-2 - FAILURE OF B PHASE
MAIN TRANSFORMER AND SUBSEQUENT FIRE IN THE TRANSFORMER
AREA

SUBJECT: UPDATE ON TRANSFORMER FIRE AT NORTH ANNA POWER STATION,
JULY 3, 1981

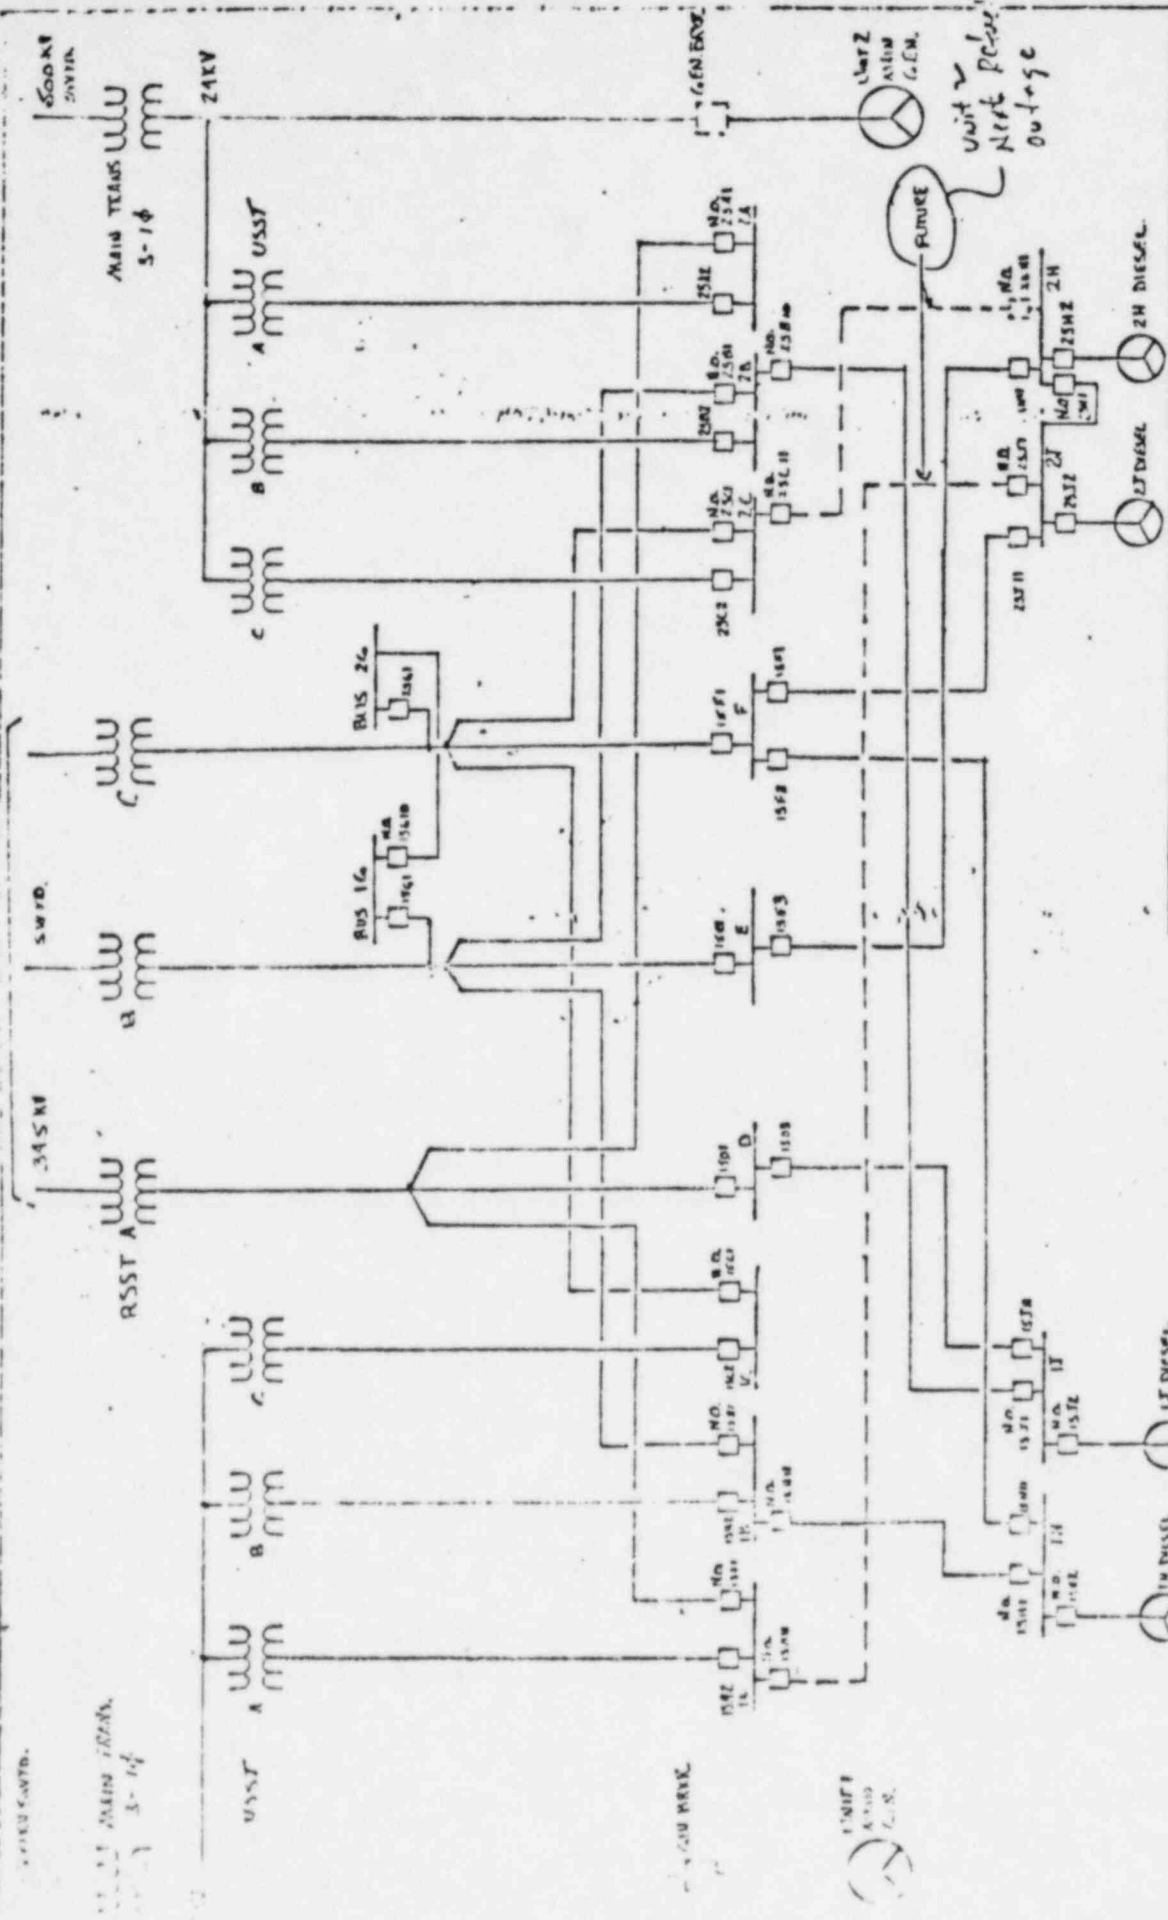
NORTH ANNA 1, 2 - SIMPLIFIER SINGLE LINE DIAGRAM

4. No damage was apparent in the A and C phase transformer sections (again apparently due to the sprinkler systems there).
5. Severe fire damage was seen in the spare transformer bay (which was empty at the time of the event). The spare transformer bay is not fitted with a fire protection system.
6. The fire in the spare bay caused severe damage to the turbine building wall and to overhead aluminium buses of the C Reserve Station Service Transformer (RSST-C). The cables associated with these buses, that were mounted on vertical cable trays on the turbine building wall, were also burnt. (RSST-C provides part of offsite power from the 34.5 KV switchyard to the onsite distribution system - see enclosed single line diagram).

At about 7:40 AM, the fire melted open bus bars that receive power from the reserve C transformer. These open bus bars were physically located over B transformer in their connection from C transformer to the turbine building. These bus bars supply emergency power to both Units and the melting of the bus bars caused reserve transformer C to relay out and the initiation of diesel generator power.
