U.S. NUCLEAR REGULATORY COMMISSION

Report No. 040-08724/90001

Facility: Bert Avenue Landfill
Cleveland, Ohio

Inspection: October 3, 1990, and follow-up on October 19, 1990

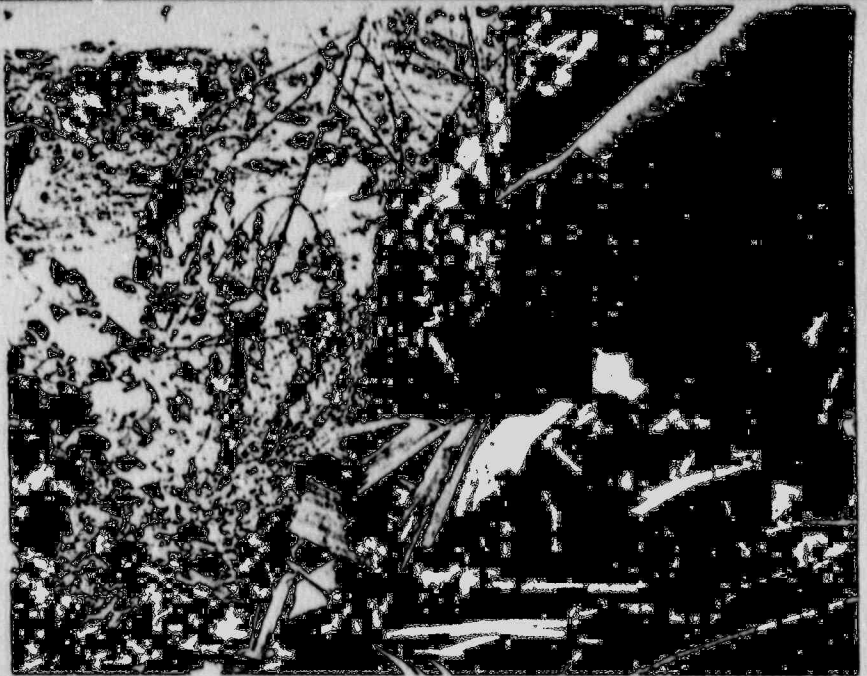
1

DEBRIS AGAINST FENCE

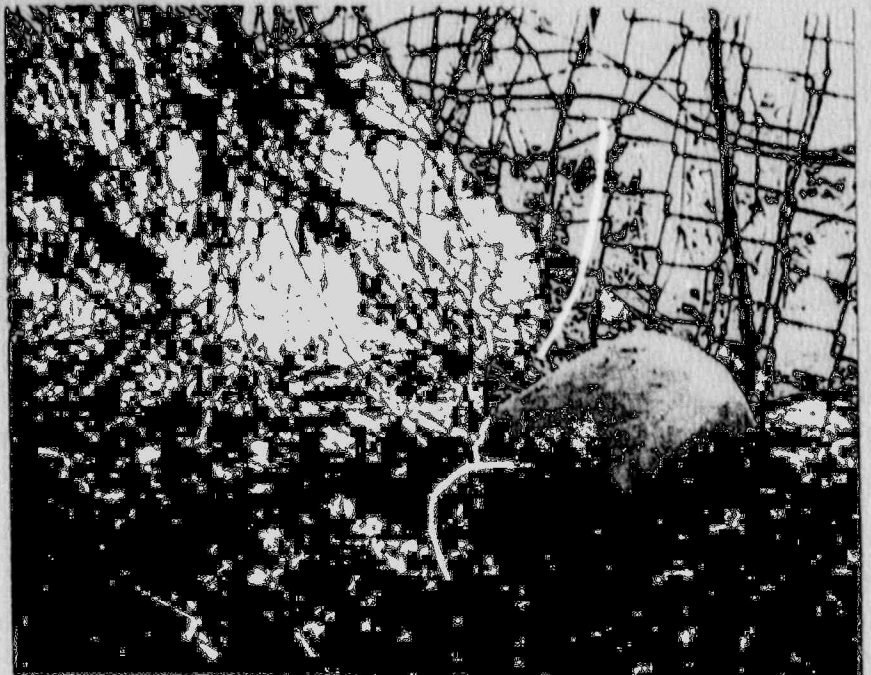
3

HOLE IN FENCE

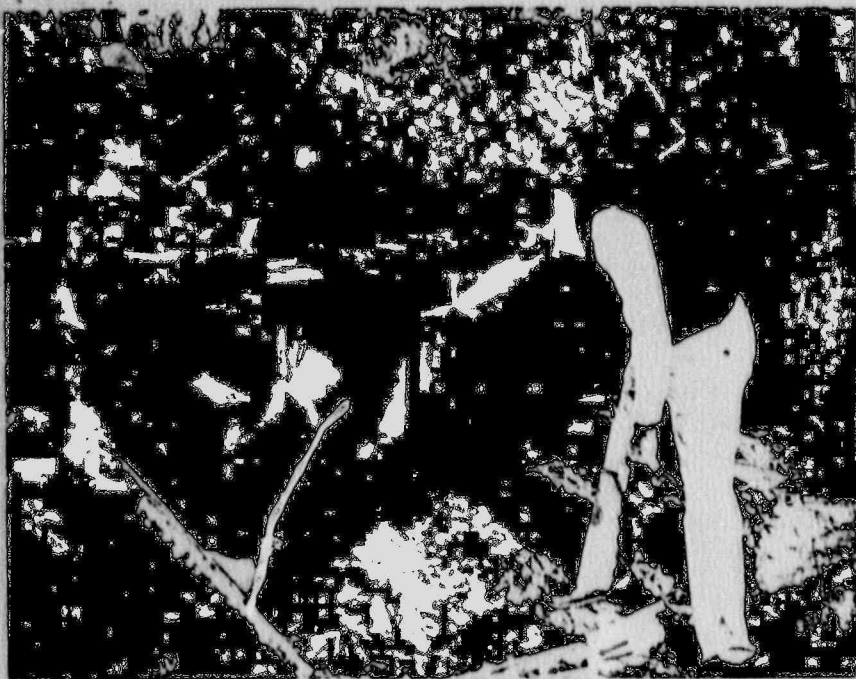
The inspectors walked around the outside of the fence surrounding the area that is contaminated with depleted uranium. Along the west boundary, there were at least two areas where the barbed wire and fencing had been bent over at the top, which would make it easier to climb over the fence. Behind a neighbor's garage there were metal folding steps and a two step wooden platform, which would also make it easier to climb over the fence. At the west boundary next to the playground, there were holes in the fence and debris piled against the fence which also reduced the effectiveness of the barrier (Photos 1, 2, and 3). There was also a shelter built from debris that looked like a playhouse. The playhouse was not in the restricted area but was near the fence (Photos 4 and 5).

← PLAYHOUSE

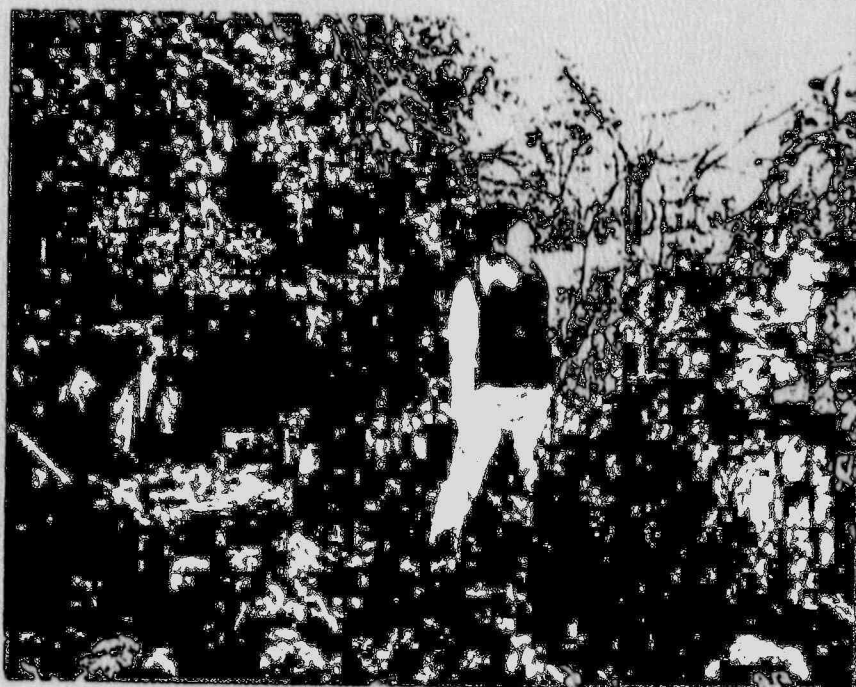
5

TOP OF FENCE BENT DOWN →

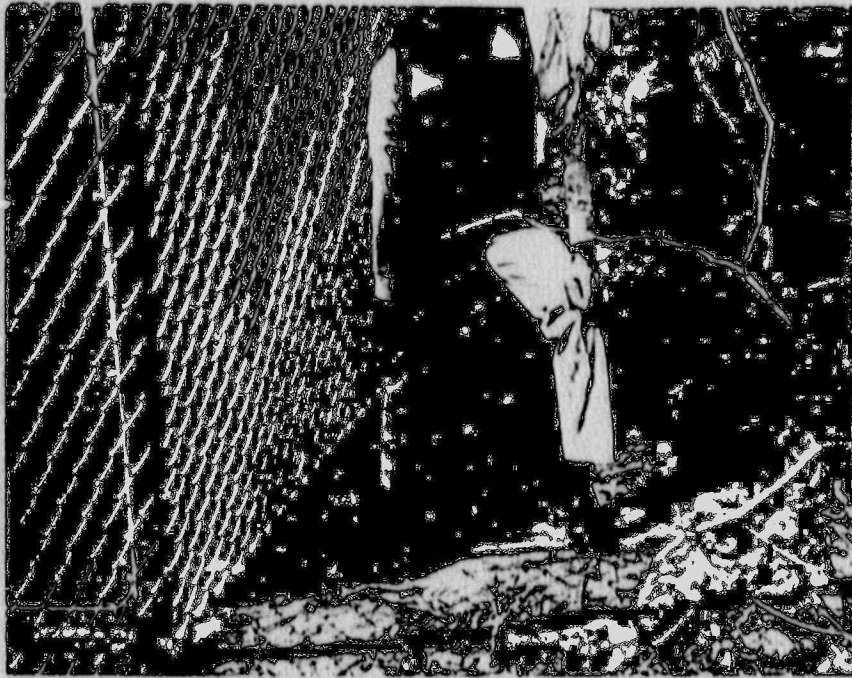
↑
6

A new 6-foot chain link fence had been erected at the top of a slope just to the north of the landfill. Along the north boundary there was an area where the soil had eroded, leaving a hole large enough so that a person could easily squeeze under the fence (Photo 6). The new chain link fence is connected to a 6-foot welded wire fence. There was a gap under the fence where the chain link and welded wire fence were joined (Photo 7).

HOLES UNDER FENCE

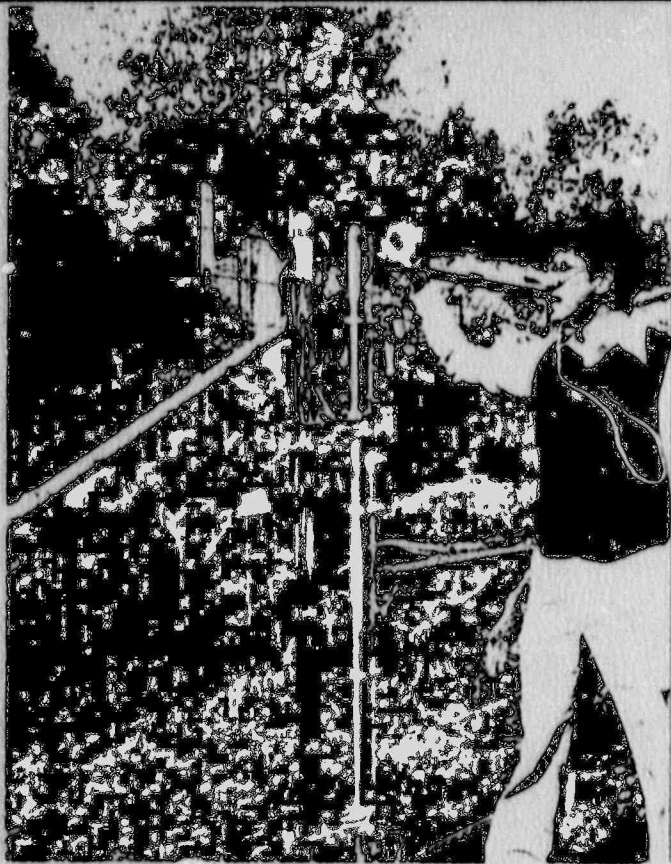
8

The east side of the site had a 6-foot welded wire fence. The fence was supported with metal posts that are sunk in the gravel. In certain locations this fence could be lifted up allowing access under it. There was also an area along the east boundary where the soil had eroded leaving a hole where a person could squeeze under the fence (see Photo 9). The top of the fencing was bent in on the gate along the east boundary (Photo 8).

← TOP OF FENCE BENT IN

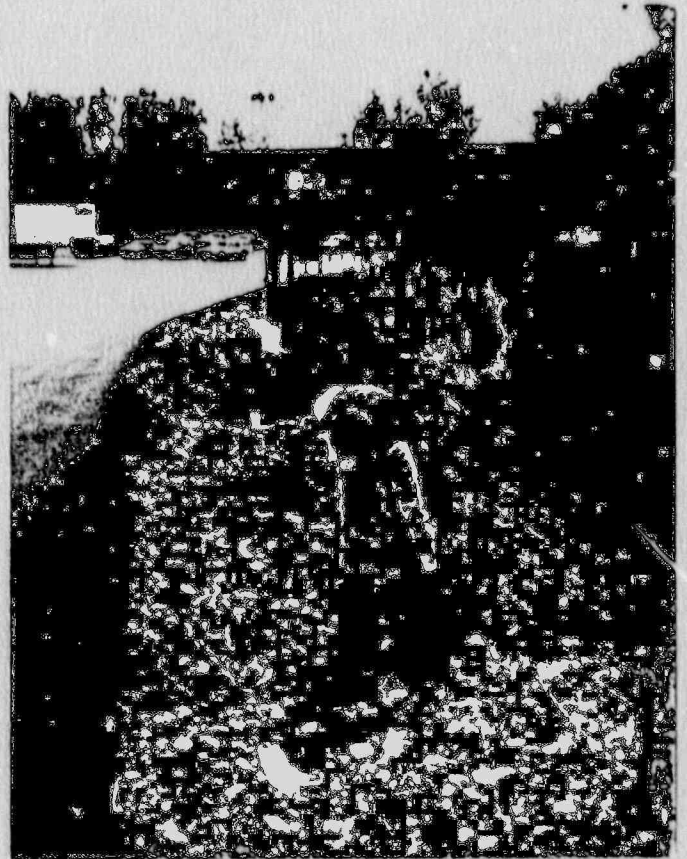
9

HOLE UNDER FENCE →

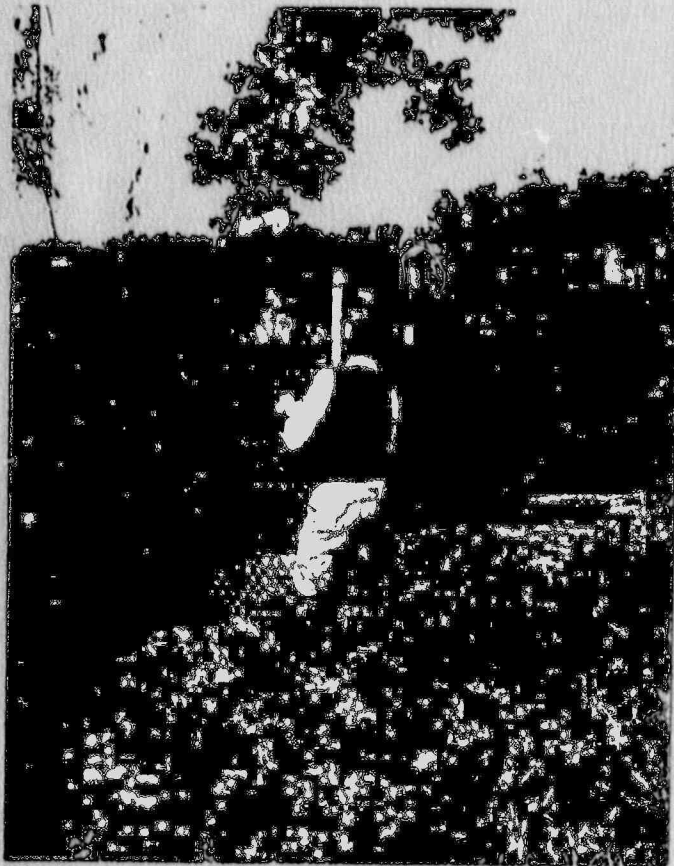
10

The welded wire fence met a new chain link fence at the southeast corner. At this corner there was a gap where a person could easily squeeze between the fence posts (Photo 10).

← GAP BETWEEN FENCE POSTS
