SUBJECT: COMANCHE PEAK STEAM ELECTRIC STATION (CPSES)
DOCKET NO. 50-448⁵
OPERATION PROHIBITED BY TECHNICAL SPECIFICATIONS
LICENSEE EVENT REPORT 90-036-00

Enclosed is Licensee Event Report 90-036-00 for Comanche Peak Steam Electric Station Unit 1, "Personnel Error Resulting in Failure to Comply With Technical Specification Action Requirements."

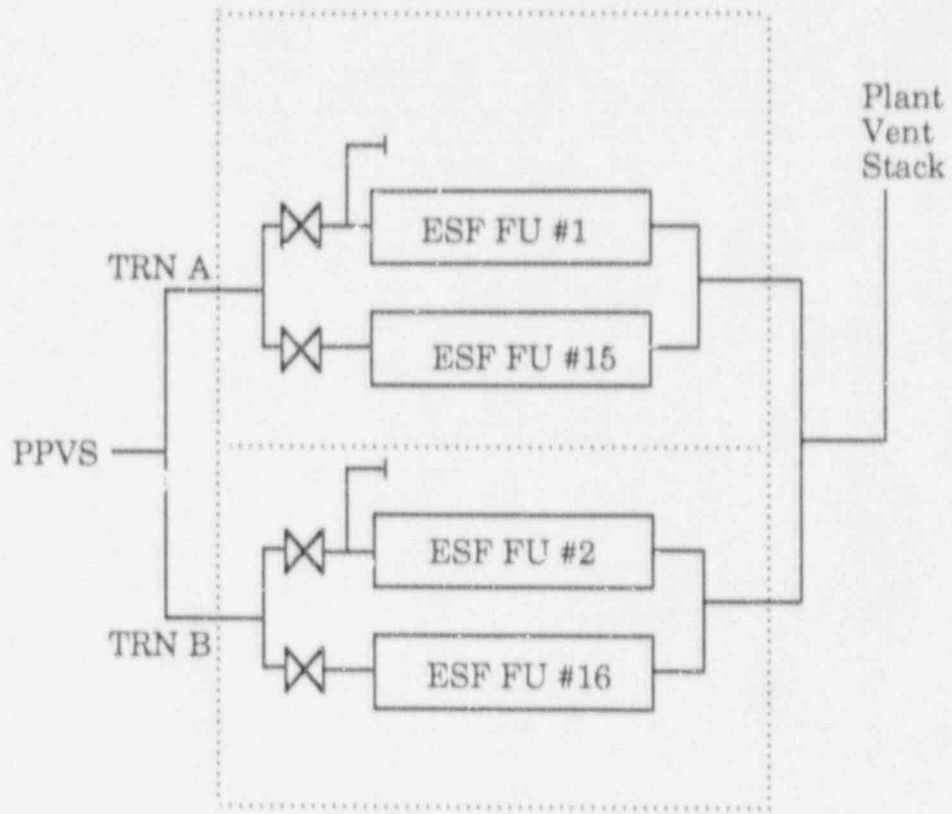
Figure 1

Filtration Units 01 and 02 were originally the only two filtration units designed as ESF units (refer to Figure 1). Filtration Units 15 and 16 were upgraded to ESF design criteria in 1988. These units are identical except for the following: filtration units 01 and 02 are provided with an exhaust register which removes air from its respective room. This register, added as part of the ESF upgrade of filtration units 15 and 16, functions to exhaust excess heat generated by the two fan motors and heaters in each ventilation equipment room while running both filtration units per train in post-accident configuration.
