AEOD/E211

FEB 24 1982

SUBJECT: REPETITIVE FAILURES OF EMERGENCY FEEDWATER FLOW VALVES AT
ARKANSAS UNIT 2 BECAUSE OF VALVE OPERATOR HYDRAULIC PROBLEMS

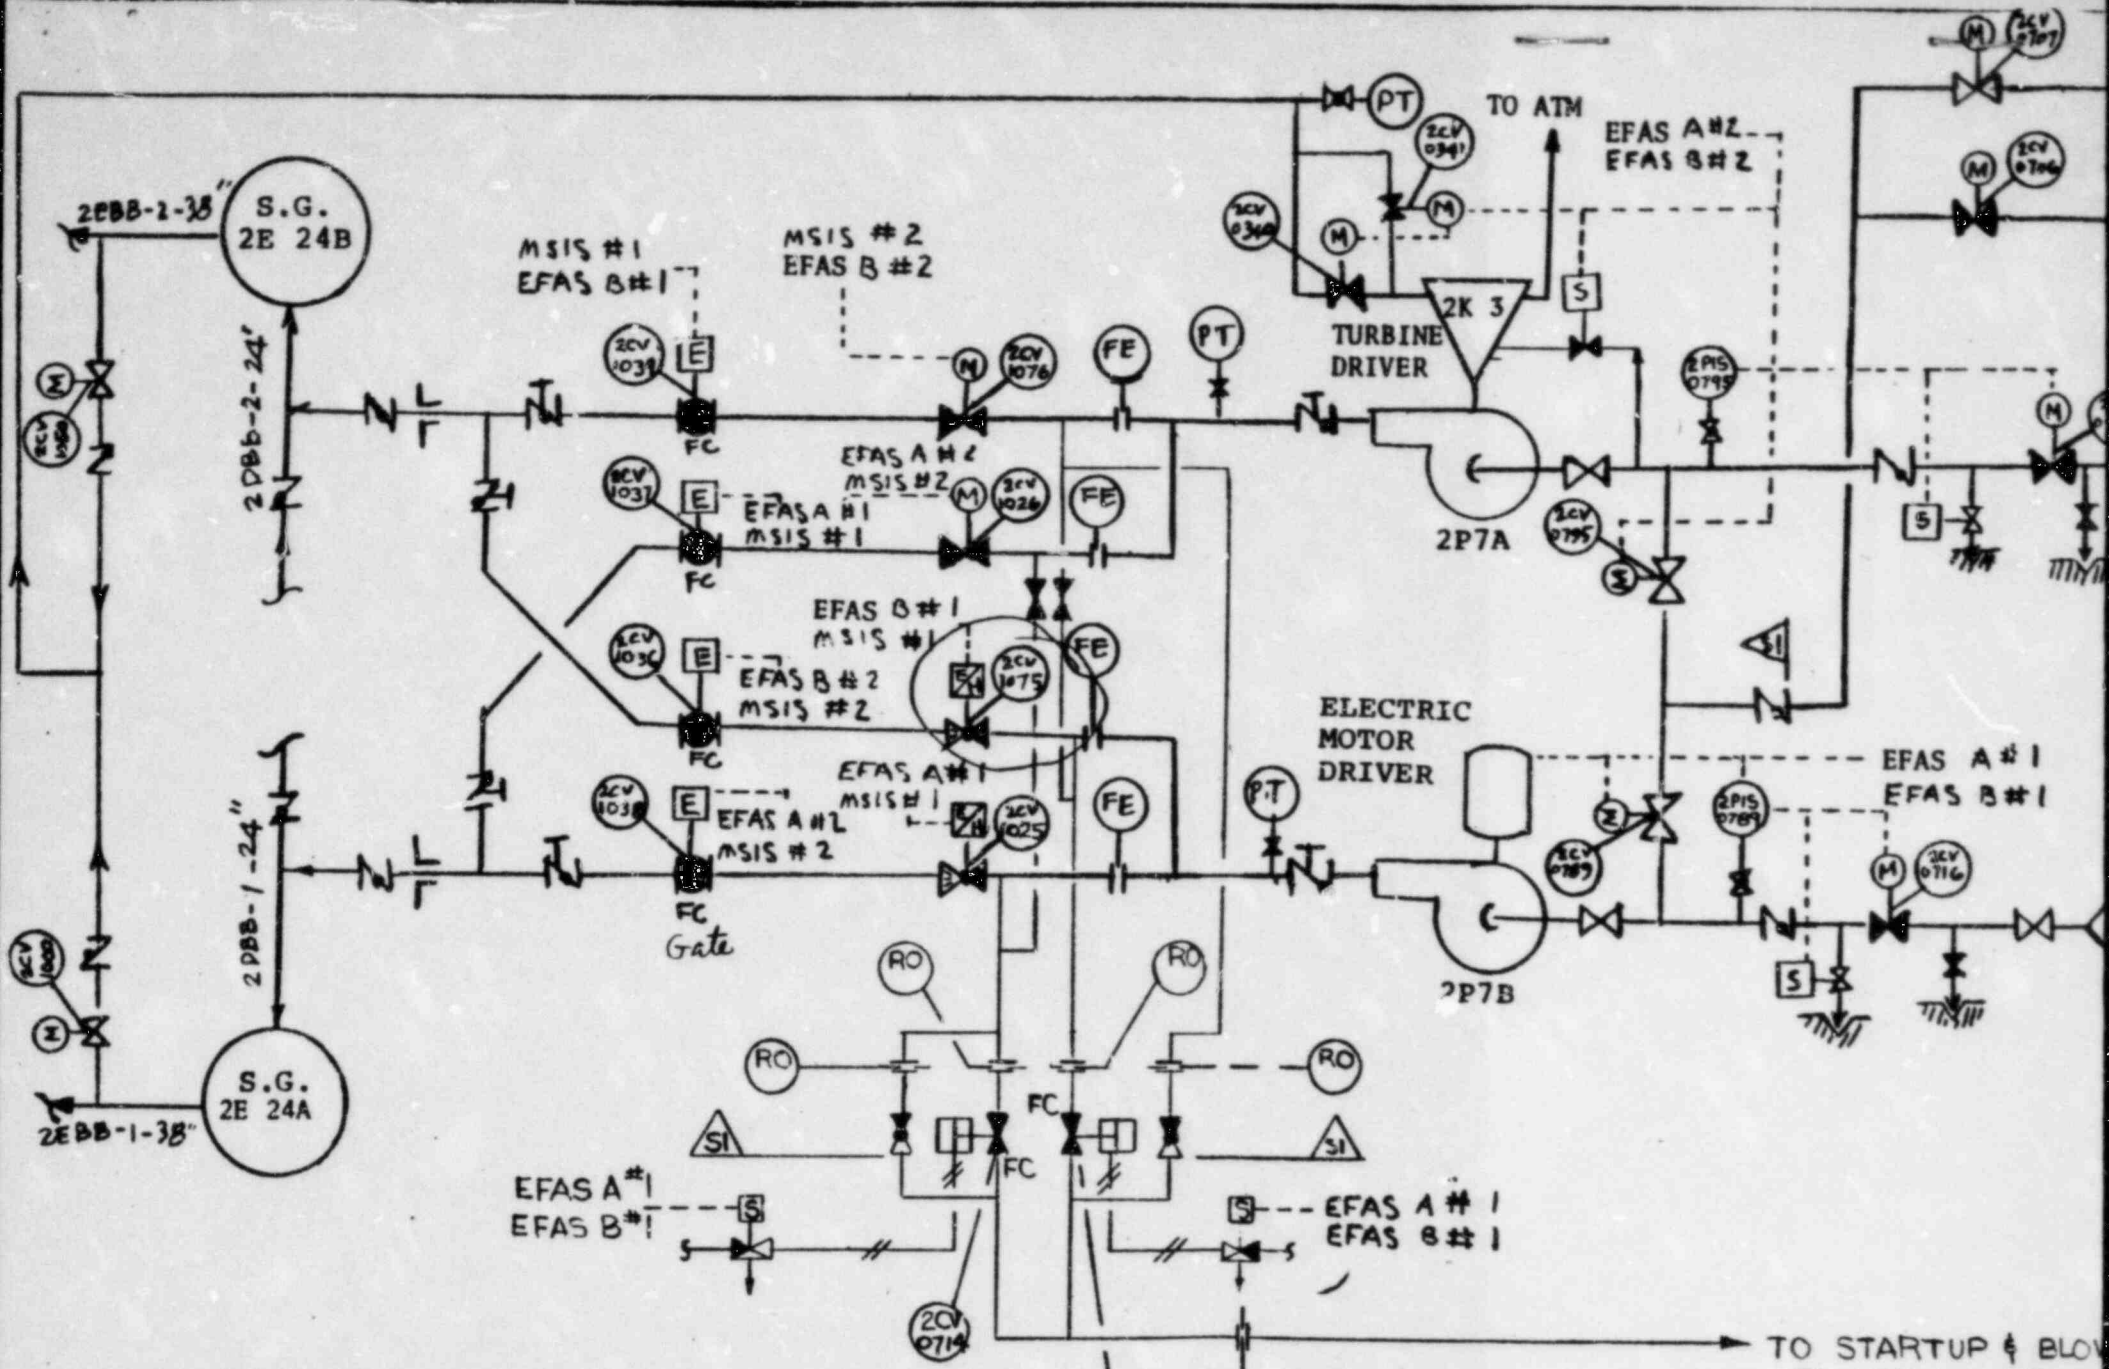
DIAGRAM
EMERGENCY FEEDWATER

When each of the referenced LERs was examined, it was apparent that the fuse failure was an isolated event, and that valve operator hydraulic problems were a repetitive mode of failure in the EFW system. (There are only two hydraulically operated valves in the EFW system, 2CV-1025 and 2CV-1075 - see attached flow diagram.) It was found that some of the referenced LERs were not for problems similar to the original LER; however, the LERs that did pertain to valve operator hydraulic problems referenced some additional LERs that were not referenced in the original LER. This sequence of acquiring LERs on Emergency Feedwater flow control valve failures due to failures of the hydraulic operator was pursued until all relevant LERs were acquired. A draft table of the reported failures and the relevant LERs are attached.
