CONNECTICUT YANKEE ATOMIC POWER COMPANY

HADDAM NECK PLANT

Reference: Facility Operating License No. DPR-61  
Docket No. 50-213  
Reportable Occurrence LER 50-213/90-024-00

TITLE (4)  
Containment Isolation Valve CC-TV-920 Declared Inoperable

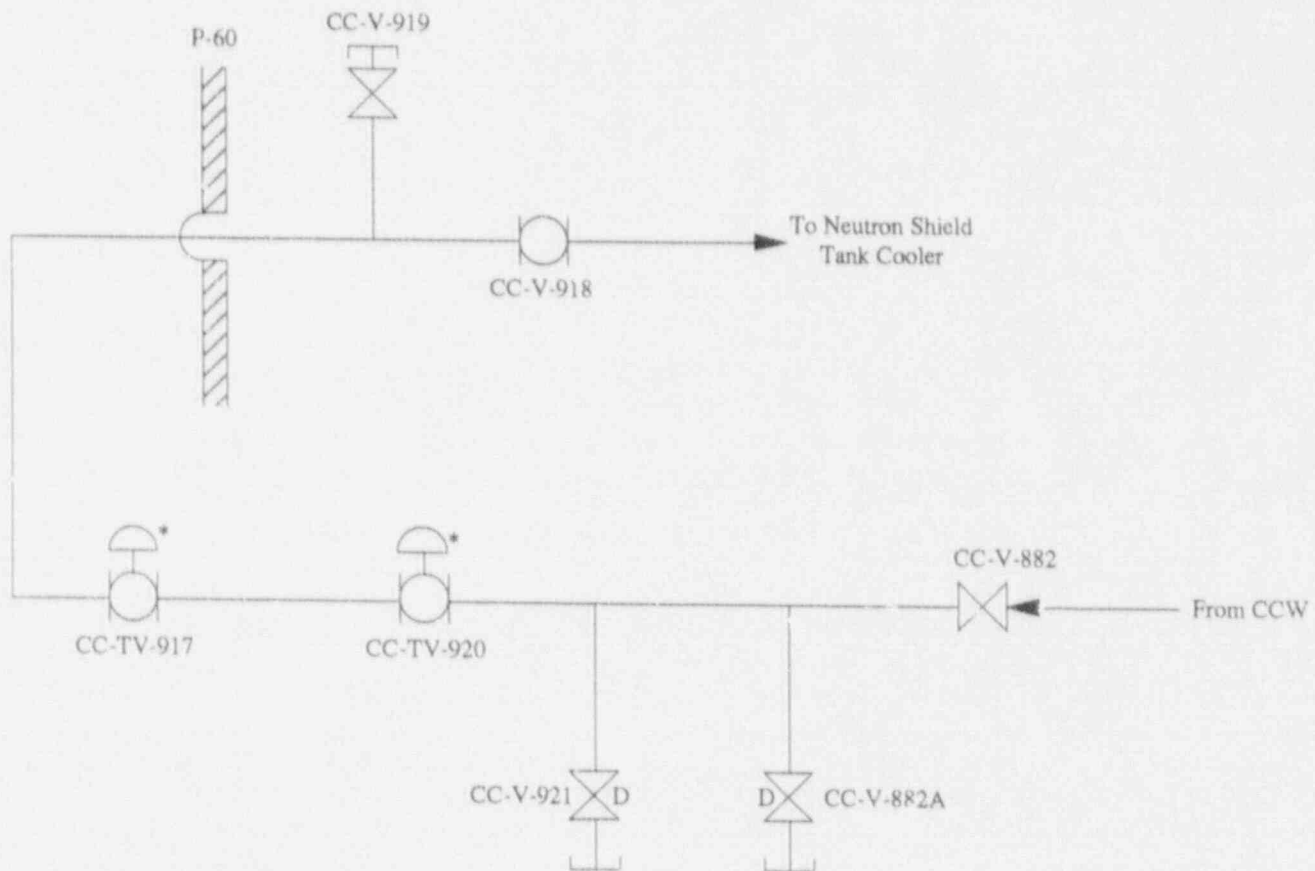
Figure 1  
Neutron Shield Tank Cooling Water Supply Penetration

The containment isolation valve CC-TV-920 (EIIS Code: ISV) forms part of the containment boundary associated with the component cooling water (EIIS Code: CC) supply to the neutron shield tank cooler (Figure 1). Valves CC-TV-917 and 920 close automatically on a high containment pressure actuation signal (EIIS Code: JM). The valves are inservice tested on a quarterly basis and were last tested on June 30, 1990, during the 1989/1990 refueling and maintenance outage.
