PHILADELPHIA ELECTRIC COMPANY

SUBJECT: Licensee Event Report
Limerick Generating Station - Units 1 and 2

Reference: Docket Nos. 50-352
50-353
Report Number: 2-90-019
Revision Number: 00
Event Date: November 1, 1990
Report Date: December 3, 1990
Facility: Limerick Generating Station
P.O. Box A, Sanatoga, PA 19464

TITLE (4) Half-scrum and various isolations resulting from a loss of power to a Reactor Protection System/Uninterruptible Power Supply panel due to inverter damage.

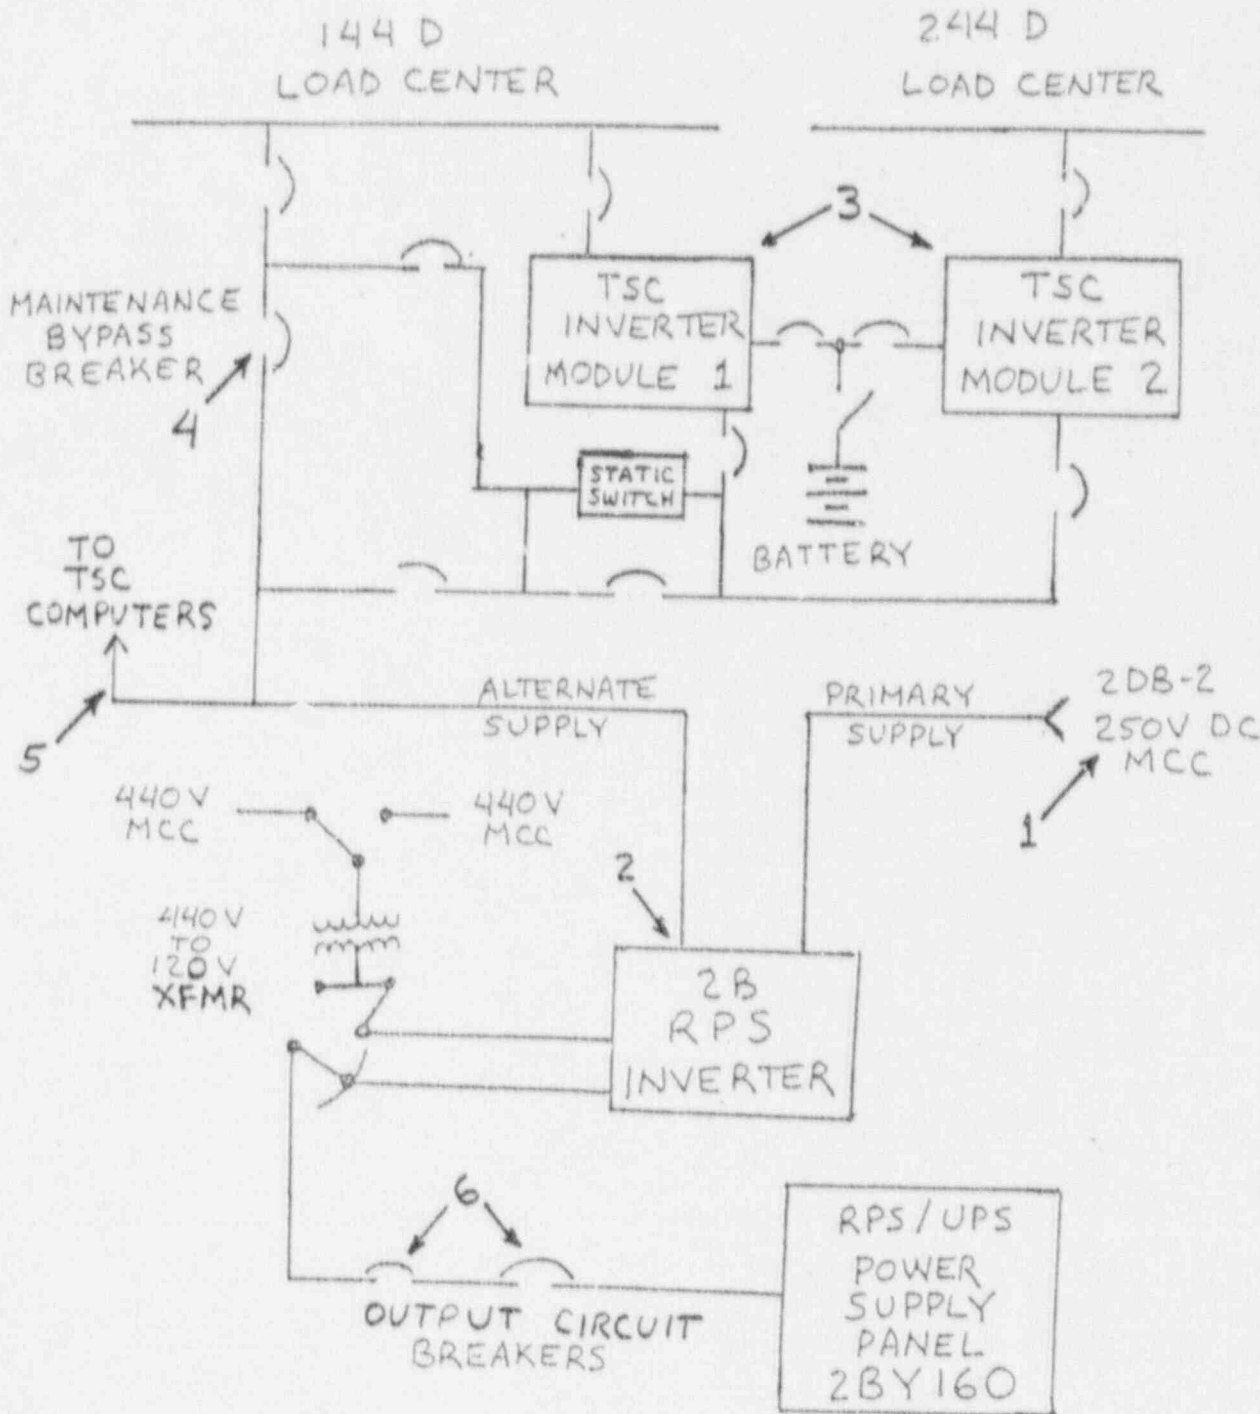
DIAGRAM 1

During normal operation, the static inverters are supplied by a primary (DC) supply (Diagram 1, item 1) and are aligned to an alternate (AC) supply (item 2) as a backup to the primary supply. The static inverters automatically synchronize their output to match the frequency of the alternate (AC) supply. This synchronization precludes voltage transients when switching from the primary to alternate supply. The '2B' RPS static inverter "OUT OF SYNC" light was illuminated indicative of a problem in the phase synchronization circuitry. The synchronization circuit problem had been identified by Operations personnel and an Equipment Trouble Tag (ETT) had been attached to the static inverter. Corrective Maintenance on the static inverter had not yet been performed when this event occurred due to a delay in processing of the ETT. The synchronization problem was caused by a damaged (crimped) connector in the static inverter circuitry.

On November 1, 1990, preparations were being made to perform maintenance on the TSC static inverters (item 3), which act as the alternate supply through the RPS inverter. The Maintenance Bypass Breaker (MBB) (item 4) was closed by Operations personnel to provide the alternate (AC) power to loads normally supplied by the TSC static inverters, including the alternate supply to the RPS static inverters. When the primary supply was removed from the TSC static inverters, the TSC computers (item 5), supplied by the TSC inverters, lost power. It was determined that the MBB was open although it was indicating closed. Per Shift Supervision direction, the MBB was cycled open and closed. This restored the AC power to the loads.

When the alternate supply was restored, the '2B' RPS static inverter automatically attempted to synchronize its output with the alternate supply frequency. Due to the damaged connector in the RPS static inverter circuitry, the output sensed was a square wave-form. The RPS static inverter could not synchronize the square wave output with the sinusoidal wave of the alternate supply. This inability to synchronize resulted in an output condition that tripped the '2B' RPS undervoltage breaker (item 6) and caused the loss of power to the RPS/UPS power distribution panel, 2BY160.

All static inverters were inspected for damaged connectors and no other problems were identified. Preventive and Corrective Maintenance work including repair of the damaged connector was completed on the TSC and RPS static inverters and the alternate power source was restored on November 21, 1990. The routine Preventive Maintenance (PM) work for each static inverter currently inspects for damaged and degraded equipment within the static inverter, including cabling and connectors. This PM work is scheduled for the upcoming first Unit 2 Refueling Outage, currently scheduled to begin in March, 1991. The reason for the MBB indicating closed when it was actually open could not be determined. Subsequent testing demonstrated that the MBB was functioning properly.
