HADDAM NECK PLANT

LICENSEE EVENT REPORT (LER)

TITLE (4)
Feedwater Regulator Bypass Check Valves Failed Leakage Test

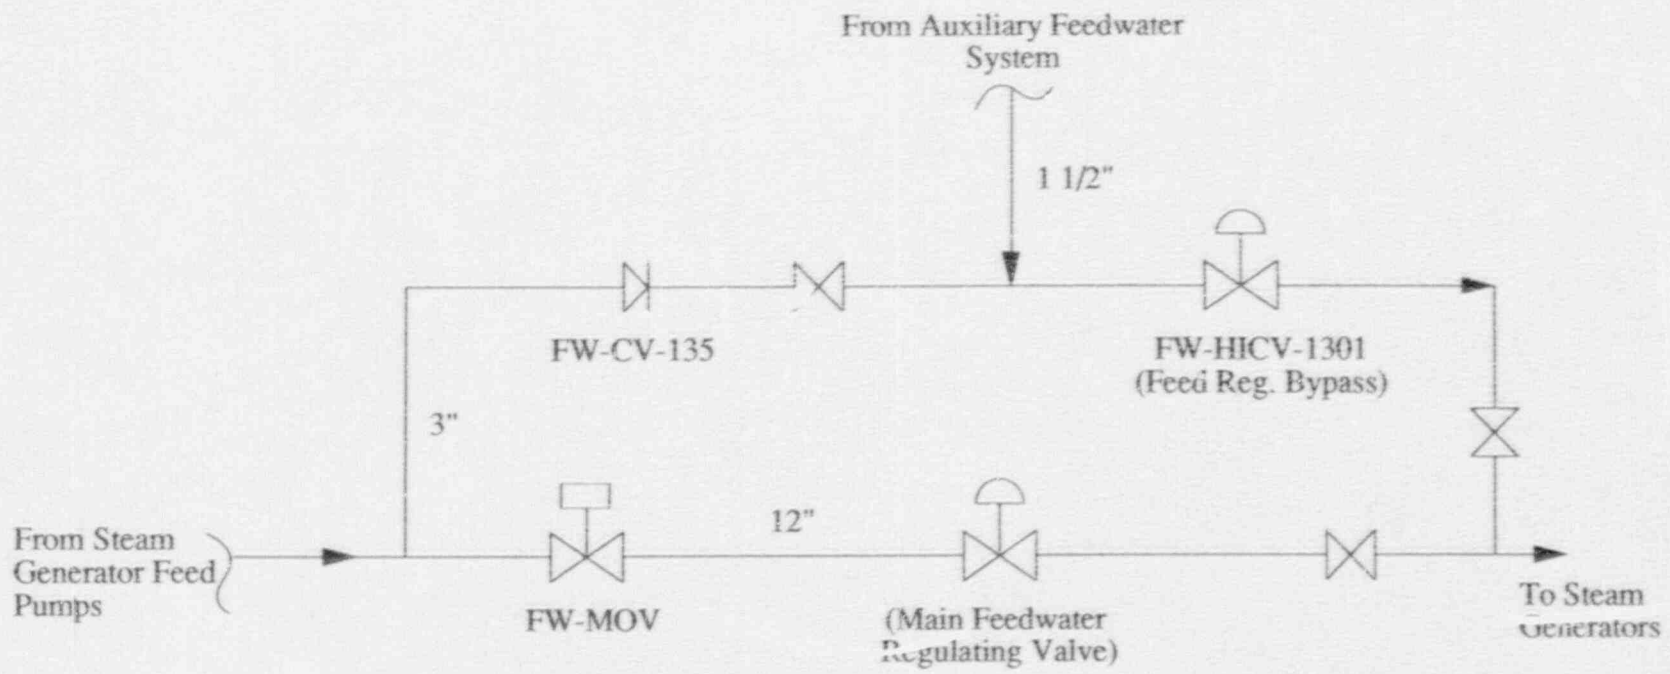
Figure 1
Feedwater System (Typical)

The feedwater regulator bypass check valves (EIIS Code: V) FW-CV-135-1, 2, 3, 4 are 3 inch Powell 900 lb. "Y" check valves. The major function of these valves is to insure that, in the event of an Auxiliary Feed System (EIIS Code: BA) actuation, flow is directed to the steam generators and not diverted to the main feed system (EIIS Code: SJ) via backflow through the feedwater regulator bypass line (see Figure 1). The FW-CV-135 valves are inservice leak tested at a minimum frequency of once per refueling outage.

The root cause is attributed to valve chatter which accelerated the wear of the valve disc and seat. It is believed that the valve chatter was due to the valves being located in a turbulent flow region (less than one pipe diameter (3") from the 18 inch main feedwater header).

Short term corrective action consisted of repairing the check valves and relocating the valves further downstream of the main feedwater header. Long term action consists of performing a seat leakage test during the next cold shutdown.
