UNITED STATES  
NUCLEAR REGULATORY COMMISSION  
WASHINGTON, D. C. 20555

SUBJECT: TIE BREAKER BETWEEN REDUNDANT CLASS 1E BUSES -  
POINT BEACH NUCLEAR PLANT, UNITS 1 AND 2

DOCKET NO. 50-301  
POINT BEACH NUCLEAR PLANT UNIT 2  
LICENSEE EVENT REPORT NO. 80-005/03L-0

SIMPLIFIED ELECTRICAL ONE LINE DIAGRAM...  
 POINT BEACH NUCLEAR PLANT  
 UNITS 1 & 2

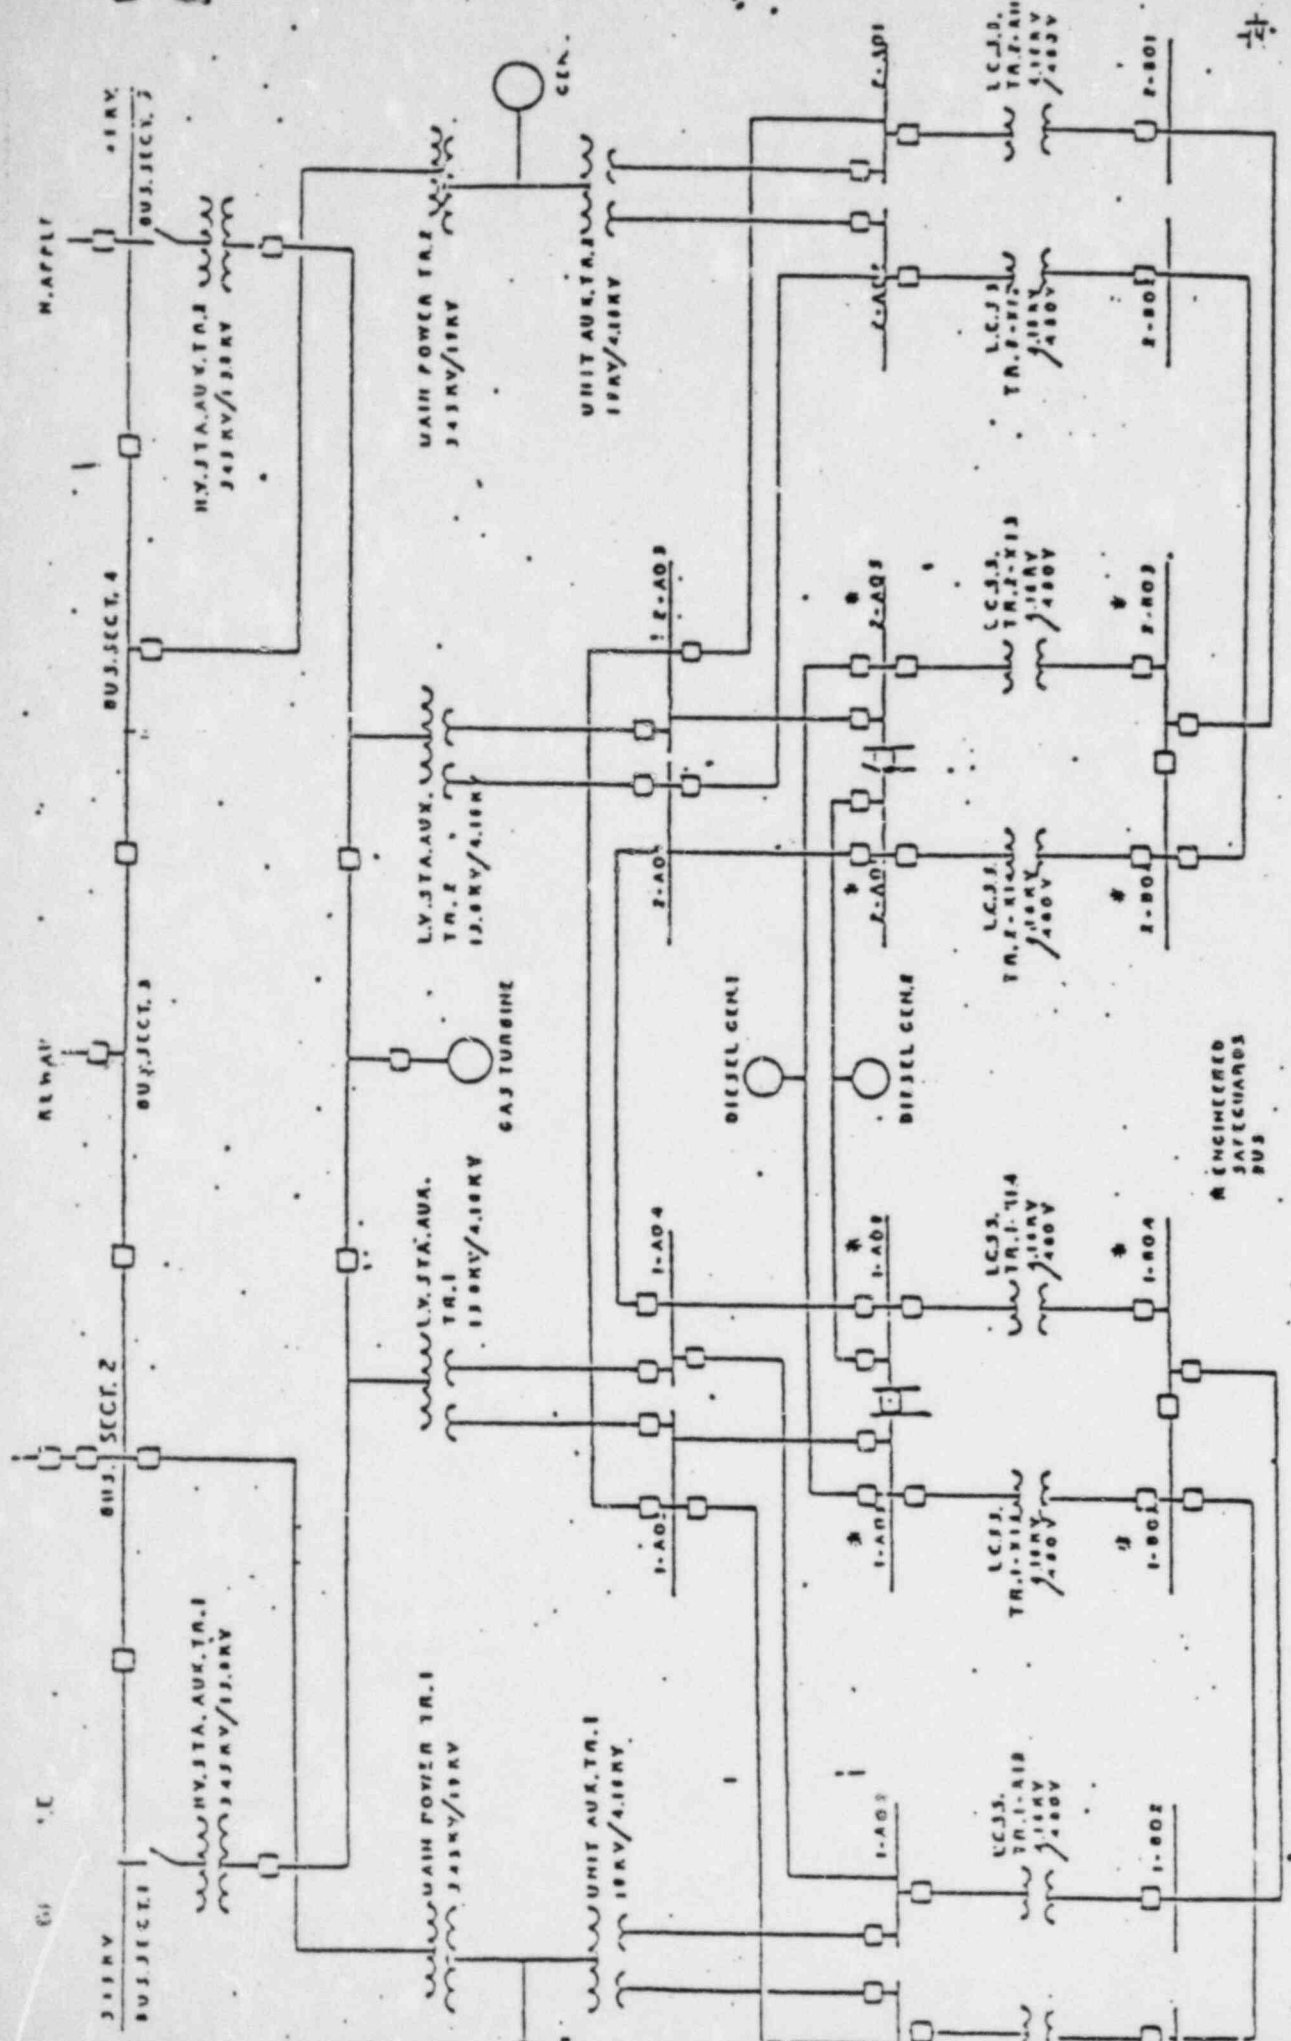
Each unit of Point Beach Nuclear Plant has tie breakers that interconnect redundant Class 1E buses; one between 4160V Class 1E buses and another between 480V Class 1E buses (see enclosed one line diagram). The tie breakers had been provided for flexibility in operation of the distribution system. They are designed to automatically open (when closed) upon loss of normal ac power supply to the buses. The control scheme of a tie breaker is such that it cannot be closed when both the normal feeder breakers to the buses are closed. Interlocks are provided that will prevent closure of a normal feeder breaker if the tie breaker is closed. Interlocks are also provided between the emergency diesel generator output breakers and the 4160V tie breaker that will prevent closure of the diesel generator breaker if the tie breaker is closed. All these design features insure that redundant power sources are not operated in parallel when redundant load groups are interconnected. However, the plant design does not prevent the closure of the 4160V tie breaker when the 4160V Class 1E buses are supplied power by the emergency diesel generators. This is contrary to the requirements of Position 4(d) of

Regulatory Guide 1.6,\* which states that if manual connection of redundant load groups is possible, then at least one interlock should be provided to prevent parallel operation of standby power sources.

At 1415 hours on 06-09-80, during a training walkdown of the safeguards electrical supply cabinets, it was noted that the tie breaker between the A05 and A06 safeguards buses was shut. This is an improper electrical lineup. In the event that the single breaker tying buses A05 and A06 together fails to open on a loss of AC, closure of both emergency Diesel generator output breakers would be prevented. This event is reportable per Technical Specification 15.6.9.2.B.3

With the unit at 100% steady state power, it was noted at 1415 hours on June 9, 1980 that the safeguards buses were improperly energized. Instead of the A05 bus being independently supplied by the A03 bus, it was supplied by the A06 bus via the bus tie breaker. A05 and A06 are the two high voltage safeguards buses for the unit. The discovery of the improper electrical lineup was made during a training walk-down, and proper lineup was promptly restored following discovery of the improper lineup.

Shutting the tie breaker between the A05 and A06 buses threatened to cause a reduction in the degree of redundancy provided by engineered safety feature systems.

We believe that the design of the interconnection between redundant safety-related electrical load groups at Point Beach Nuclear Power Plant, Units 1 and 2, should be reviewed and modified, as required, to assure that it fully complies with the requirements of Regulatory Guide 1.6.

To prevent future recurrence of this event, the electrical layout board will be modified to provide unique identification of the A05 and A06 buses' tie breaker. This modification will also include like tie breakers between other safeguards buses. Also, procedures will be changed to include an electrical lineup check after performance of the loss of AC test and prior to return to power.
