December 5, 1990
5000-90-1995
C320-90-302

Subject: Oyster Creek Nuclear Generating Station (OCNGS)
Locket No. 50-219
License No. DPR-16
Oyster Creek Drywell Containment

GPUN Detailed Summary Addressing Water Intrusion
and Leakage Effects Related to the Oyster Creek Drywell

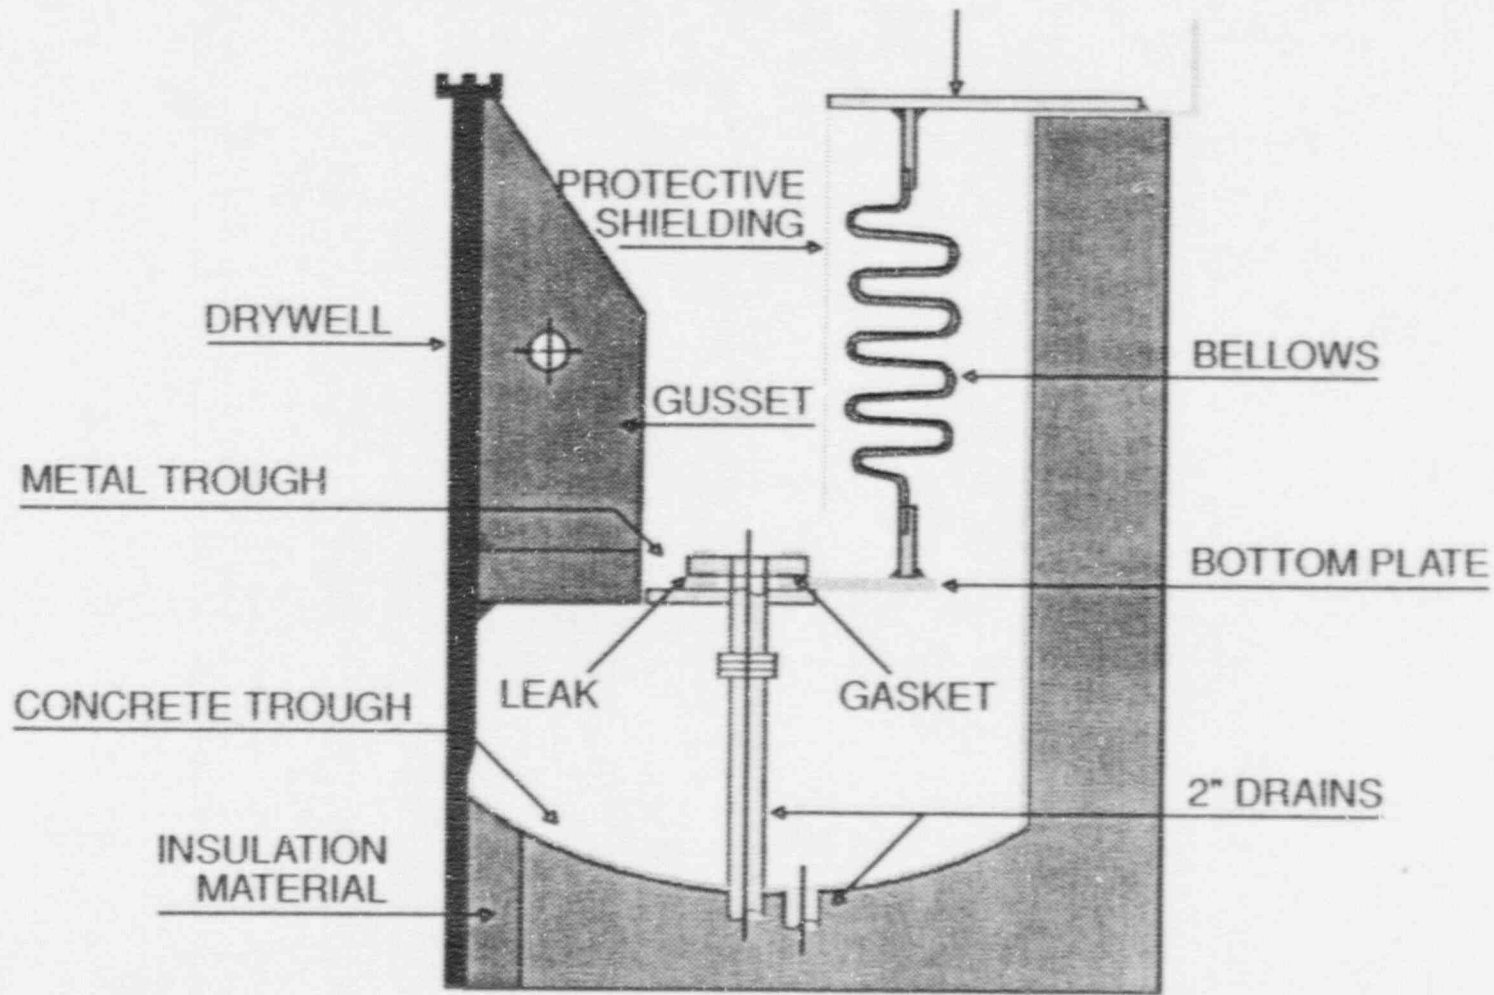
DRYWELL TO CAVITY SEAL

The bellows allow for expansion between the drywell and the refueling cavity and are made of stainless steel. They were repeatedly tested using helium (external) and air (internal) without any indication of leakage. Any leaks from the refueling bellows would wind up in the concrete trough, which has a leakage detection/collection system. No leakage has been observed for the last two refuelings.
