SUBJECT: Calvert Cliffs Nuclear Power Plant
Unit No. 1; Docket No. 50-317; License No. DPR 53
Licensee Event Report 94-003
Pressurizer Heater Sleeve Cracking

LICENSEE EVENT REPORT (LER)

TITLE (4)
Pressurizer Heater Sleeve Cracking

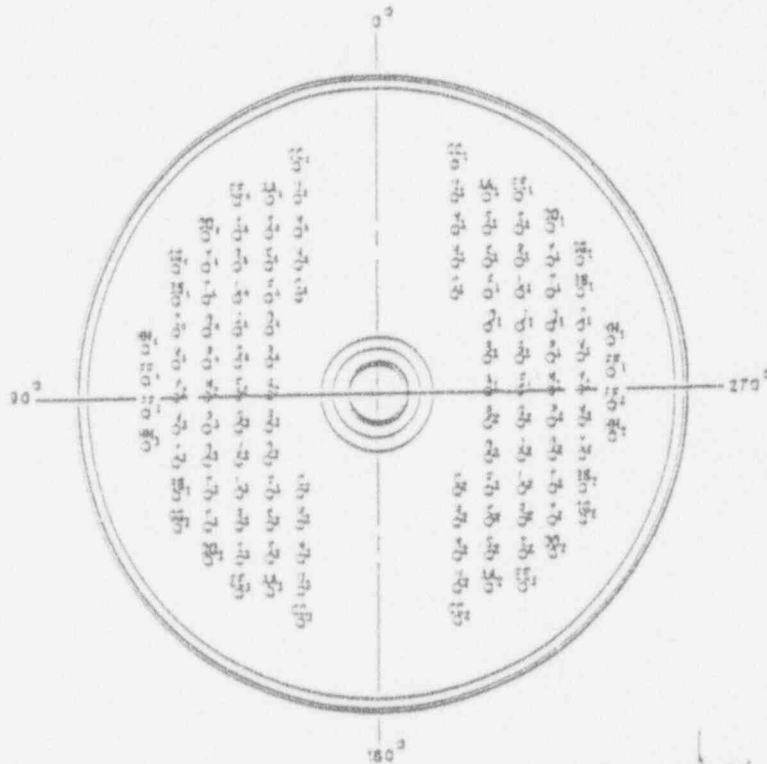
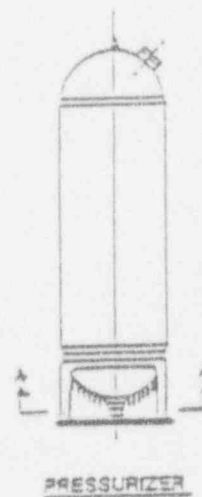
FIGURE 2

The heater sleeves (see Figure 2) extend through 1.156 inch diameter hillside penetrations in the lower head of the PZR. The lower head is a 48-7/16 inch inside radius hemispherical head fabricated from A-533, Grade B, Class 1 steel. The lower head is 3-7/8 inch thick. An Inconel weld overlay, approximately 3/8 inch thick, was applied to the inside surface of the lower head prior to stress relief of the vessel. The heater sleeves are Inconel 600 (SB-167-64) tubing (Figure 3). The initial dimensions of the tubing were 1.25 inch outer diameter (OD) and 0.905 inch inner diameter (ID). The outside diameter of the length of the tubing which inserts in the vessel was machined down to 1.156 inch. After stress relief of the vessel, the heater sleeves were inserted into the lower head and an Inconel "J" shaped partial penetration weld (J-weld) was made between the vessel Inconel weld overlay and the Inconel sleeve.

In the fabrication of the Unit 1 heater penetrations, the ID of the Inconel sleeve was specified to be reamed after welding to accept a 0.895 inch rod and to remove any distortion or melt-through in the tube caused by welding. The reaming was less than the nominal heater sleeve ID of 0.905 inch.

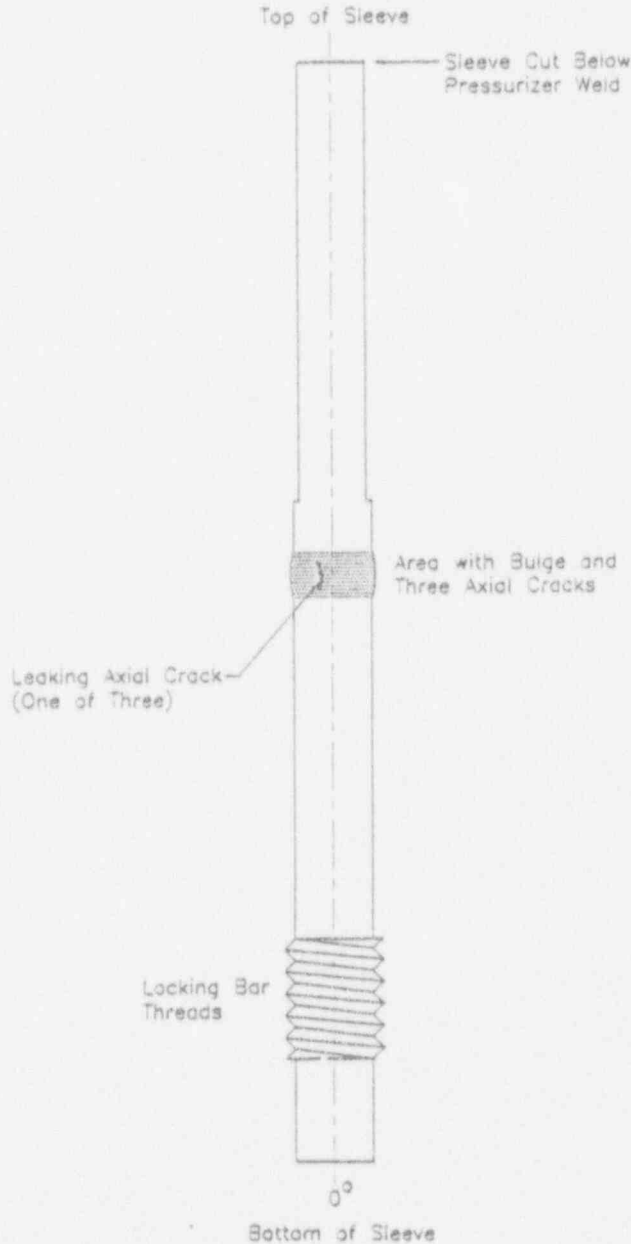
FIGURE 4

Eddy current testing of heater sleeve FF-1 identified no defects near the PZR weld, but did identify axial indications approximately one inch below the outside surface of the pressurizer. In addition, some volumetric or lift-off indications in the vicinity of the axial indications was detected. Circumferential and volumetric or lift-off indications were observed all the way down to the locking bar area (Figure 4).

Heater sleeve FF-1 was cut just below the weld and examined in the laboratory. A visual examination of the as-received sleeve revealed a circumferential bulge approximately 0.5 inches long and 0.019 inches high (diametrical) in the area of the boric acid leaks. Liquid penetrant testing identified three axial indications in the bulge region of the sleeve, each about 0.25 inches long (Figure 4).

After sectioning the sleeve, liquid penetrant testing was performed on the inside diameter surface in the region of the bulge and in the axially scored area. The testing revealed the three axial indications in the bulge area and a large number of circumferential crack-like indications in the areas with axial scoring (Figure 5). Circumferential cracks were evenly spaced, and were oriented on two sides of the sleeve only, 180 degrees apart in the area of the scoring. Dimensioning of the sleeve indicated that it was approximately 0.014 inches out-of-round just below the bulge, and 0.005 inches out-of-round near the locking bar.

Metallographic examination of the indications was performed and revealed intergranular cracks in all cases. The axial flaws were through-wall and many of the circumferential cracks extended approximately 70 percent through the wall. Most cracks had very little branching and were heavily oxidized, which indicates they had been in service for some time. Microchemistry (XPS and Auger) results from the crack surfaces showed levels of contaminants and corrosion film composition which indicate some sulfur compounds on the surfaces, with the highest concentrations at the crack tips. Some caustics were also observed. However, it is not clear if contaminants played a role in the

cracking. The most probable cracking mechanism is Primary Water Stress Corrosion Cracking (PWSCC).

The cracks and resulting leaks in FF-1 were caused by PWSCC. The source of stress for the cracking was the bulging and axial scratches associated with the removal of the stuck reamer. The microstructure of FF-1 is rated as susceptible to PWSCC, and the sleeve heat is the same as that which cracked previously in Calvert Cliffs Unit 2 (LER 50-318/89-007, Revision 2). Sufficient temperature exists to allow the observed cracking, since the thermal insulation on this unit extends below the locking collar. While chemical contaminants (sulfur) could have contributed to the cracking, they were not observed in sufficient quantities to be a major contributor.

HEATER SLEEVE FF-1

- A. As described above heater sleeve FF-1 was removed and examined in a laboratory. Sleeve locations B-3 and FF-1 have been plugged with an Alloy 690 plug welded to the outer diameter of the PZR lower head.

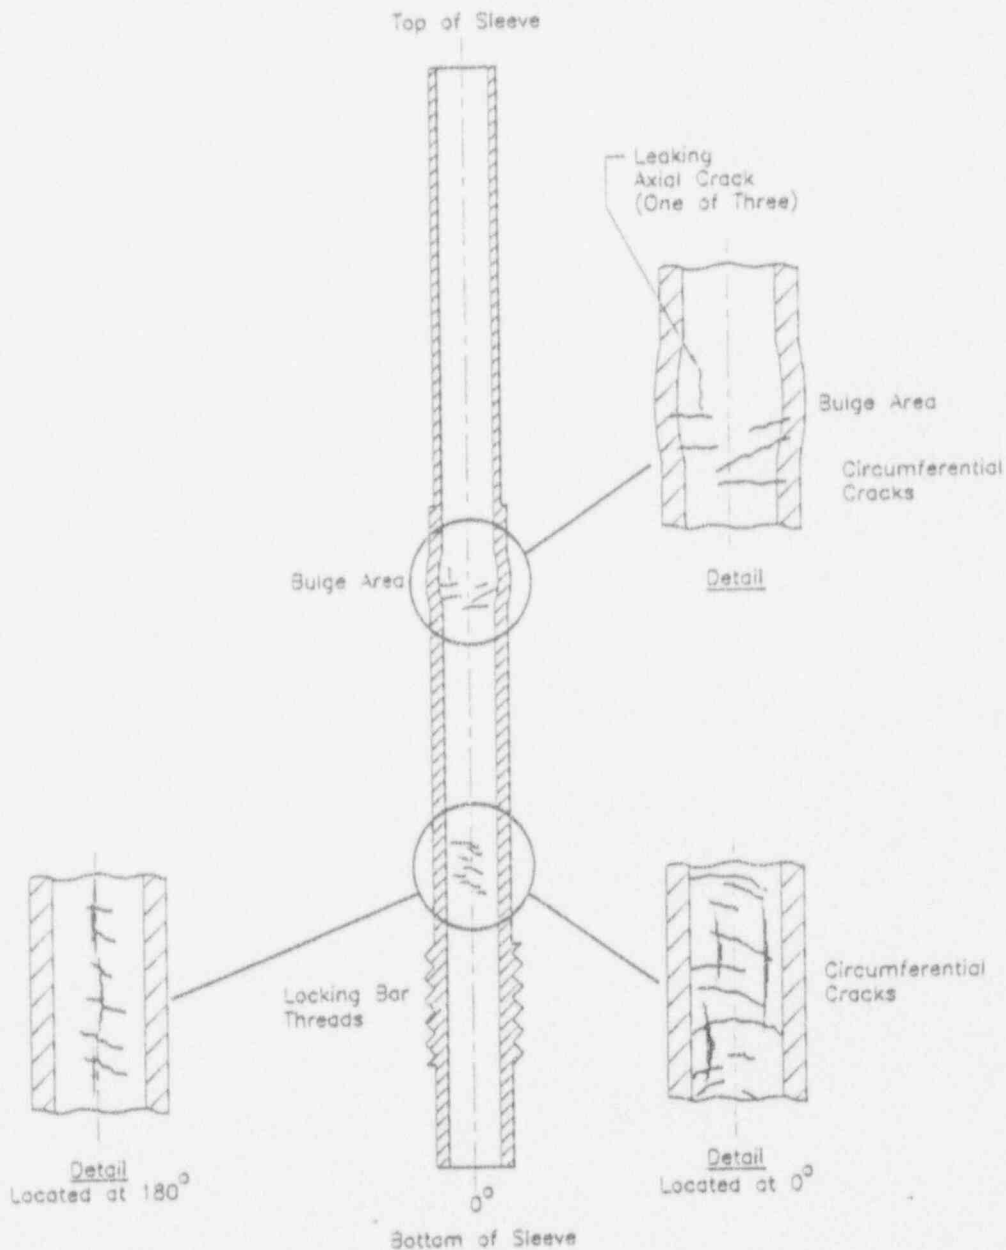
FIGURE 5

CROSS-SECTION OF SLEEVE FF-1 SHOWING CRACKS
