Subject: McGuire Nuclear Station Unit 1 and 2  
Docket No. 50-369  
Licensee Event Report 369/90-28

LICENSEE EVENT REPORT (LER)

TITLE (4) Ice Basket U-Bolts Were Found Damaged Or Missing Because Of A Material Deficiency

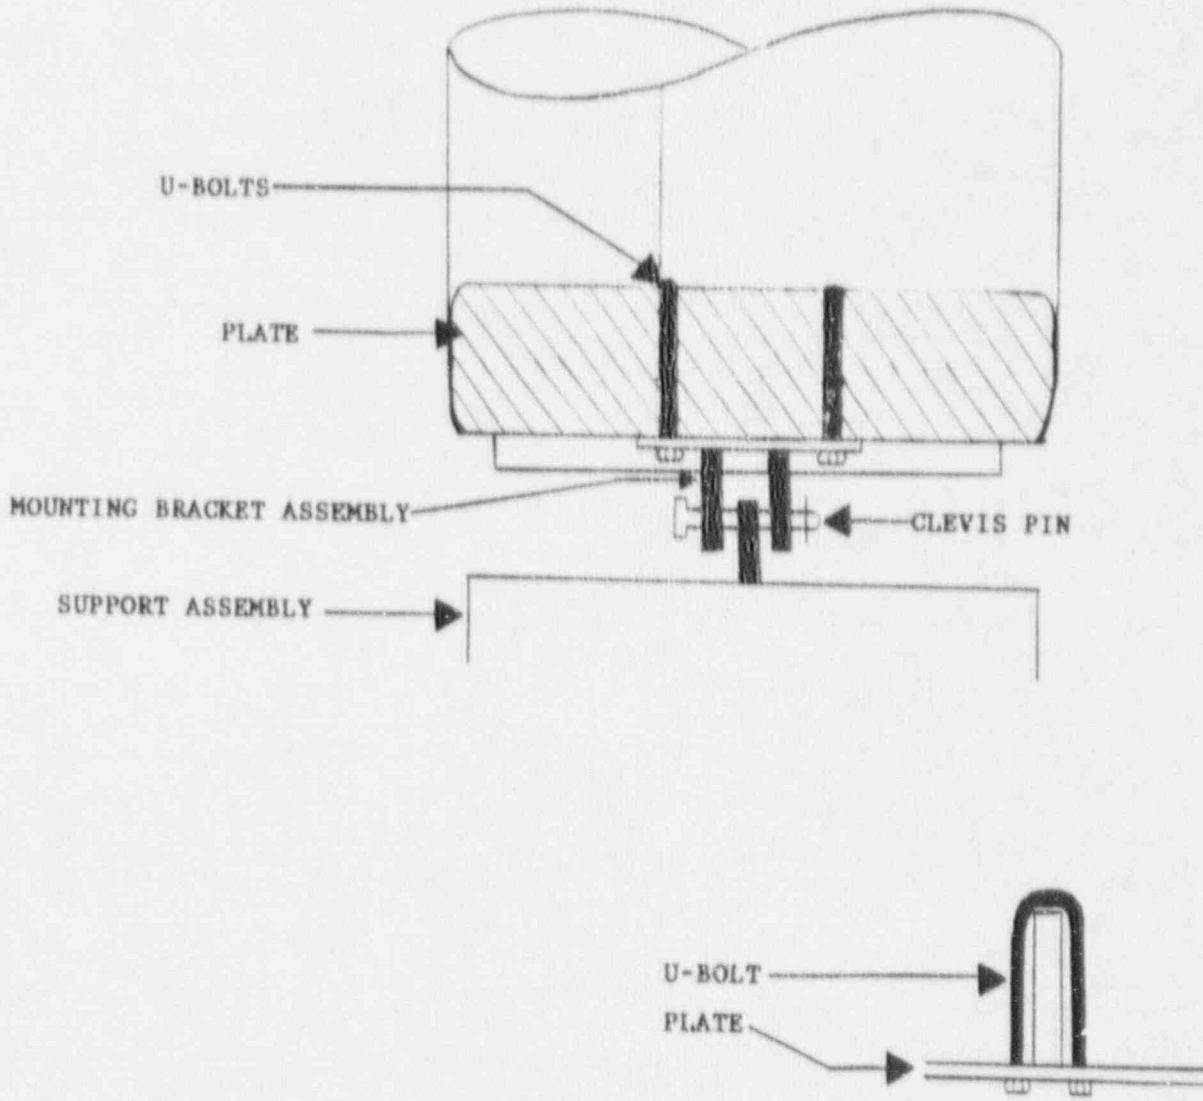
## BOTTOM ICE BASKET ASSEMBLY

Two U-bolt assemblies, located at the bottom of each ice basket column, affix the basket, by means of a clevis, to its lower support structure. These assemblies serve to provide assurance that the ice basket does not lift-off under the loading condition represented by a Design Basis Accident (DBA) Large Break (LB) LOCA in combination with a Safe Shutdown Earthquake (SSE). The U-bolts are Cadmium plated, 3/8 of an inch in diameter, SAE J 429 Grade 8 material. (Reference page 8 of 8.)
