Hope Creek Generating Station

HOPE CREEK GENERATING STATION  
DOCKET NO. 50-354  
UNIT NO. 1  
LICENSEE EVENT REPORT 90-024-00

LICENSEE EVENT REPORT																										
FACILITY NAME (1)										DOCKET NUMBER (2)				PAGE (3)												
HOPE CREEK GENERATING STATION										0	5	0	0	0	3	5	4	1	OF	8						
TITLE (4): REACTOR SCRAM ON HIGH AVERAGE POWER RANGE MONITOR FLUX LEVELS DUE TO BROKEN PRIMARY CONTAINMENT INSTRUMENT GAS LINE																										
EVENT DATE (5)			LER NUMBER (6)				REPORT DATE (7)			OTHER FACILITIES INVOLVED (8)																
MONTH	DAY	YEAR	YEAR	**	NUMBER	**	REV	MONTH	DAY	YEAR	FACILITY NAME(S)		DOCKET NUMBER (5)													
1	1	04	9	0	0	2	4	0	0	1	1	2	0	3	9	0										
OPERATING MODE (9)		1	THIS REPORT IS SUBMITTED PURSUANT TO THE REQUIREMENTS OF 10CFR: (CHECK ONE OR MORE BELOW) (11)																							
POWER LEVEL		1	0	0	20.402(b)	20.405(a)(1)(i)	20.405(a)(1)(ii)	20.405(a)(1)(iii)	20.405(a)(1)(iv)	20.405(a)(1)(v)	20.405(c)	50.36(c)(1)	50.36(c)(2)	50.73(a)(2)(i)	50.73(a)(2)(ii)	50.73(a)(2)(iii)	50.73(a)(2)(iv)	50.73(a)(2)(v)	50.73(a)(2)(vii)	50.73(a)(2)(viii)(A)	50.73(a)(2)(viii)(B)	50.73(a)(2)(x)	73.71(b)	73.71(c)	OTHER (Specify in Abstract bel

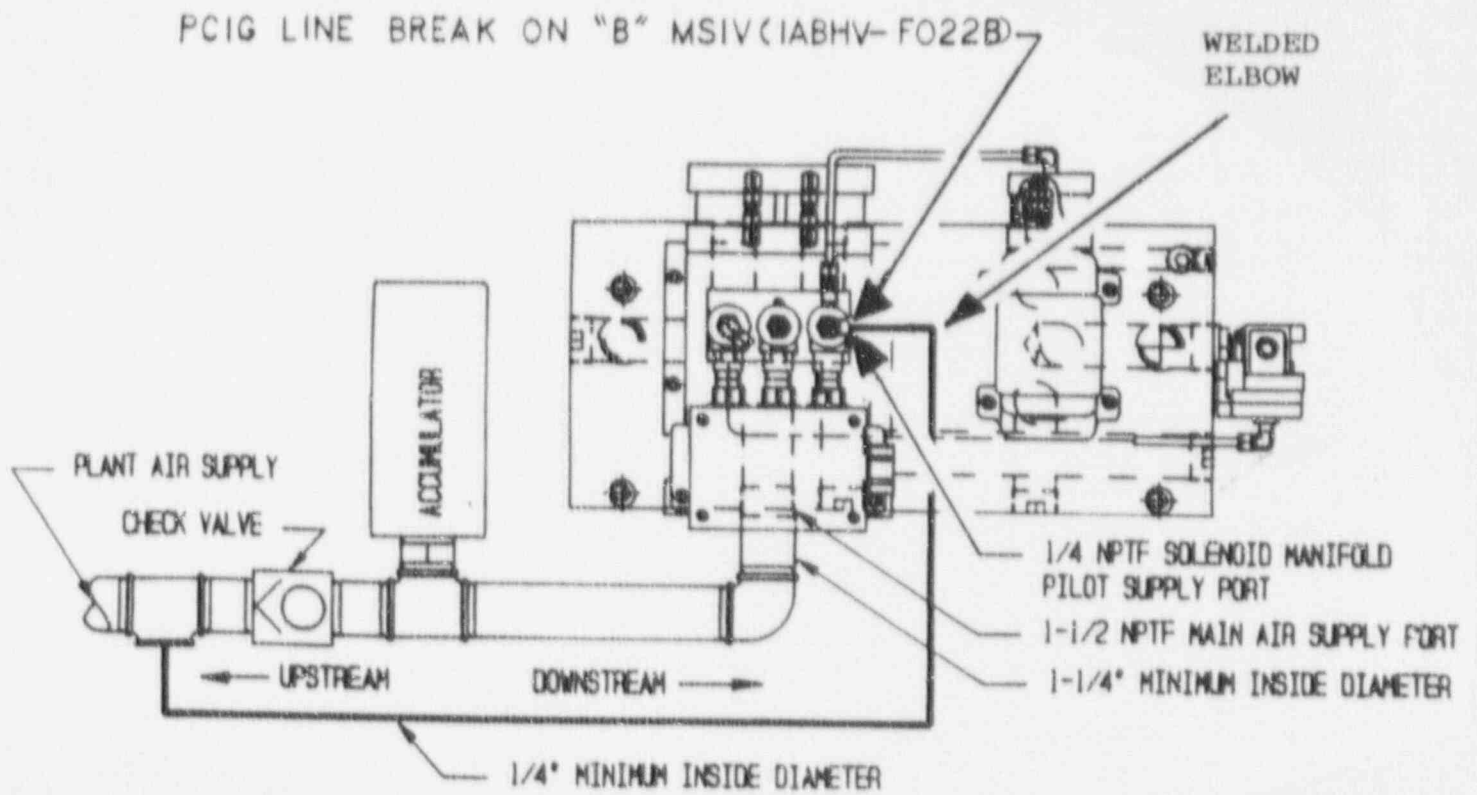
MSIV Pilot Actuator PCIG Supply Schematic

A threaded fitting on the PCIG Supply Line to the B Inboard MSIV Pilot Actuator failed, causing the MSIV to close. The closure of the B MSIV caused an increase in Reactor Pressure and a reduction in voids resulting in a Reactor Scram on High Neutron Flux. Refer to Attachment 1 for a depiction of the PCIG line and associated fitting.

The PCIG fitting that failed is a pipe nipple that threads into the solenoid manifold block, and is then welded to a PCIG line elbow. The nipple failed at the threaded connection. Subsequent to the scram, the nipple was sent to Lehigh Testing for analysis. This analysis indicated that the pipe nipple was not adequately threaded into the solenoid manifold block during installation. Two other factors contributed to the failure of the nipple: 1) vibration during normal plant operation and 2) tensile residual stresses induced on the threaded connection when welding the opposite end of the nipple to its connecting PCIG line elbow during installation.

1. A design change was implemented on all inboard MSIV PCIG supply lines. This design change encompassed installation of new unions, elimination of flanges and replacement with unions/couplings, and replacing the PCIG pipe nipples with schedule 80 -vs- schedule 40 nipples. The outboard MSIVs utilize flexible hoses for PCIG supply, and therefore, were determined to be satisfactory as installed.

6. This report will be forwarded to the Nuclear Training Department for inclusion in the licensed operator requalification programs.
7. The maintenance procedure used to remove and install MSIV Operators will be revised to add a technique that will allow indication of adequate thread engagement of the pipe nipple into the solenoid manifold block.
