SUBJECT: Licensee Event Report
Peach Bottom Atomic Power Station - Unit 2

Reference: Docket No. 50-277
Report Number: 2-90-032
Revision Number: 00
Event Date: 11/06/90
Report Date: 12/06/90
Facility: Peach Bottom Atomic Power Station
RD 1, Box 208, Delta, PA 17314

TITLE (4) Potential Loss of Primary Containment Due to a Leak in the Backup Nitrogen Supply to a Containment Purge Isolation Valve Boot Seal

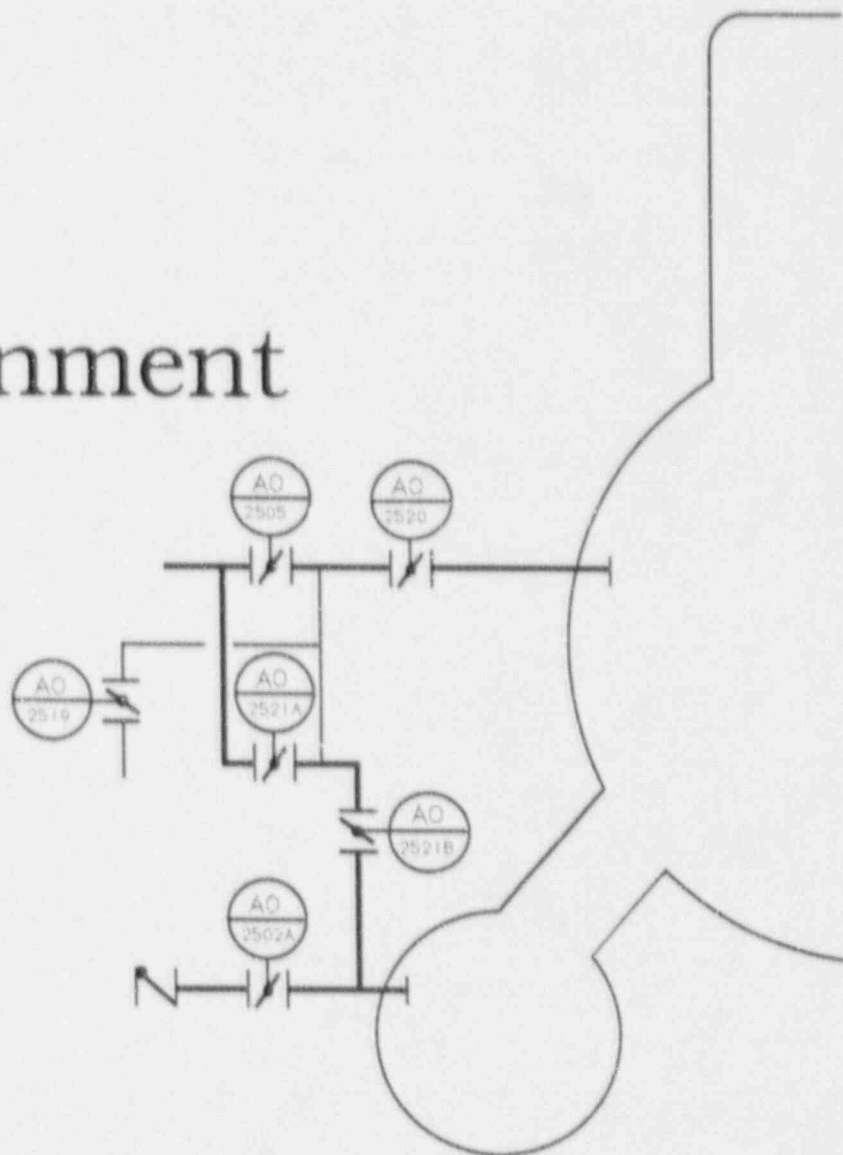
Figure 1

Unit 2 was in the RUN mode at 98% rated thermal reactor power. Air Operated (AO)-2521A "Torus Air Purge Outboard Isolation Valve" (EIIIS:ISV), and its associated pneumatic supply was blocked closed with its boot seal deflated for maintenance. The AO-2520 "Drywell Air and N2 Purge Inboard Isolation Valve" and AO-2521B "Torus Air Purge Inboard Isolation Valve" were blocked closed in support of AO-2521A maintenance (See figure 1 for valve layout).
