SHIELDALLOY METALLURGICAL CORPORATION

RE: Reply to Notice of Violation:
License No. SMB-1507
Docket No. 040-08948

SUBJECT: NRC INSPECTION REPORT 040-08948/93001(DRSS) DEPT. ENV. SERV.

Report No. 040-08948/93001(DRSS)

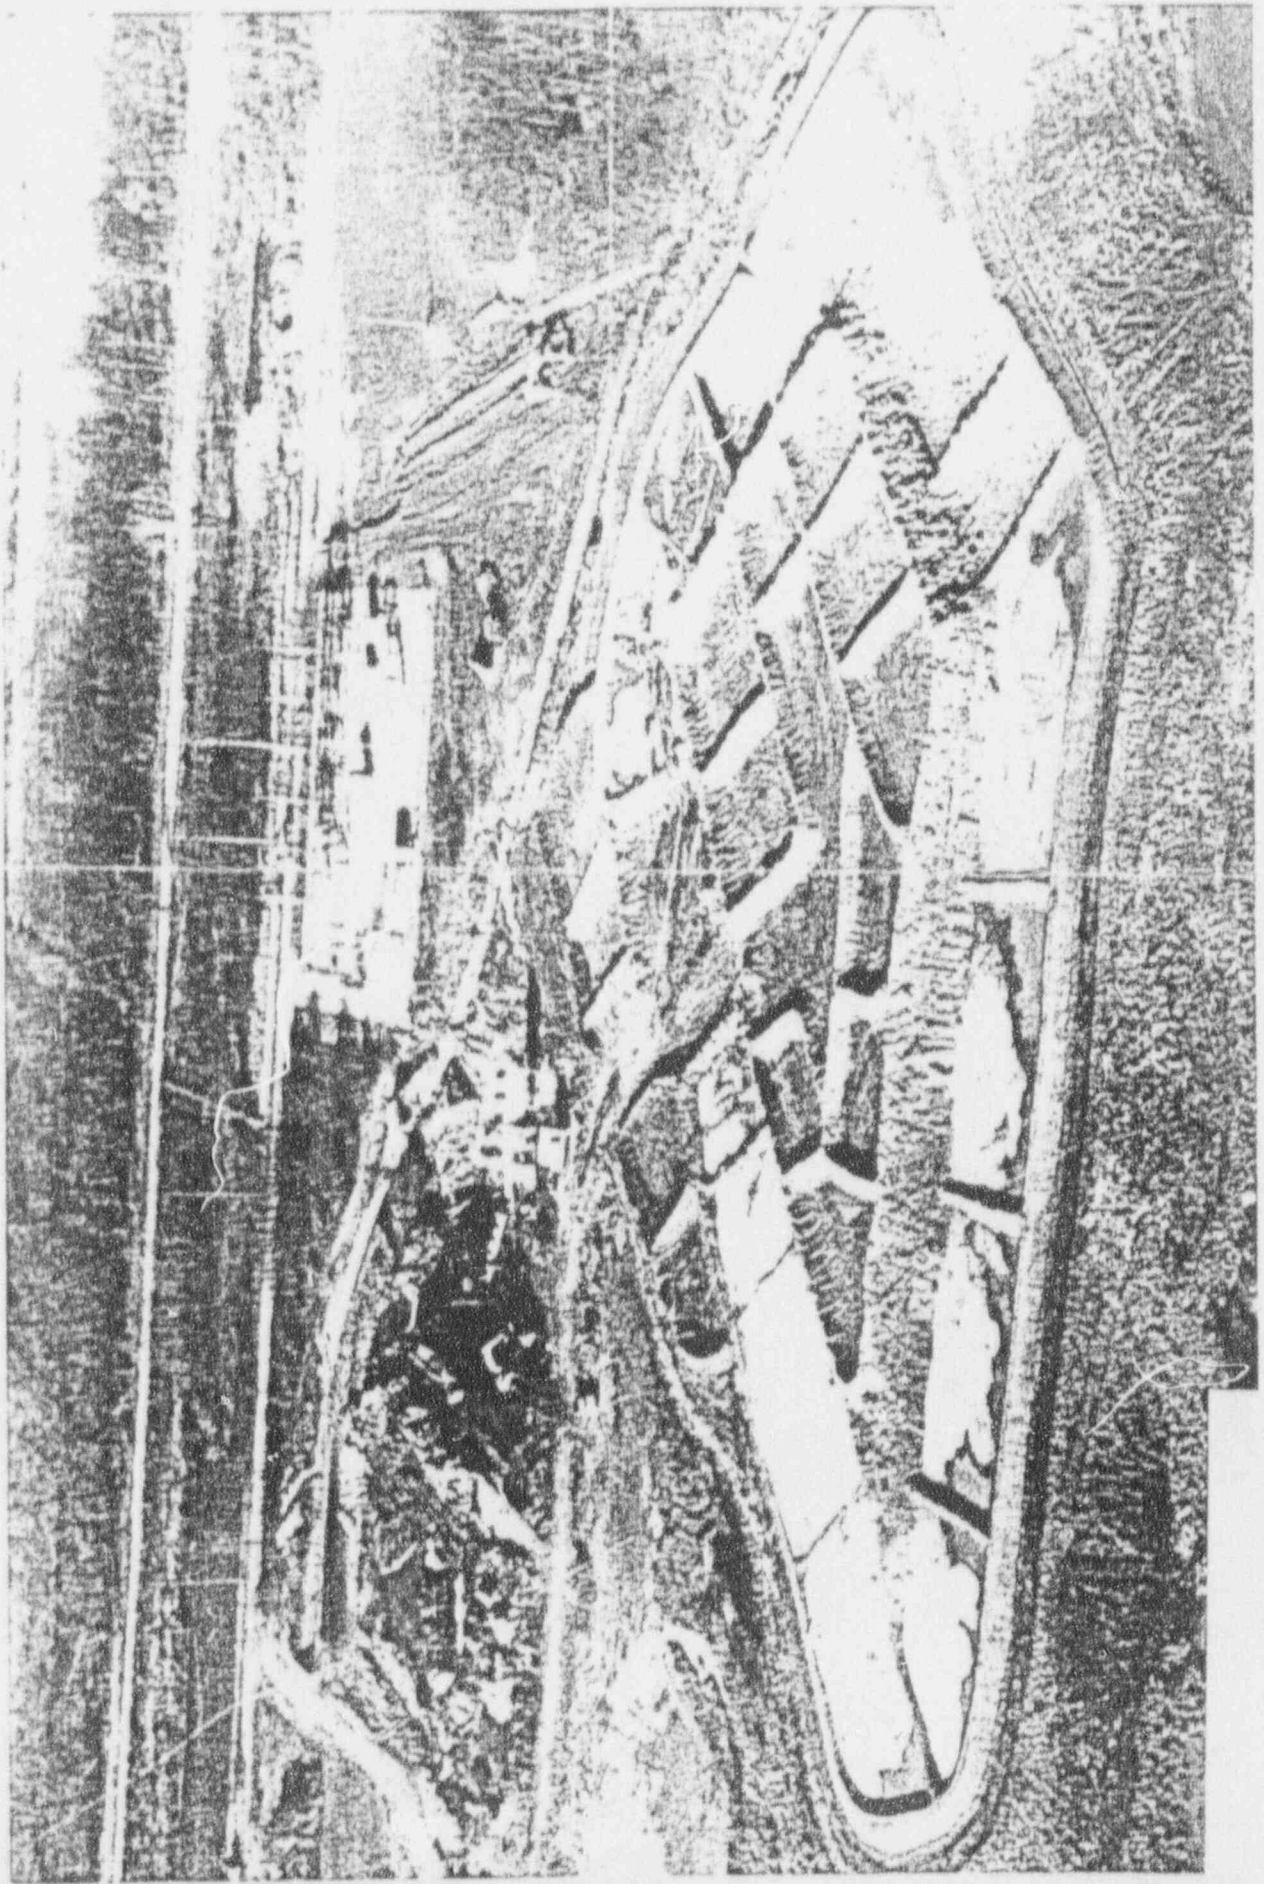
ATTACHMENT B

This pile originally consisted of approximately 3.0×10^5 tons (3.0×10^{06} kgs) of slag and soil covering 7.6 acres with an average concentration of thorium-232 (Th-232), uranium-238 (U-238) and radium-226 (Ra-226) of 1.4 picocuries per gram (pCi/g) {52.0 millibecquerels per gram (mBq/g)}, 3 pCi/g {111 mBq/g}, and 2.4 pCi/g {89.0 mBq/g}, respectively. Following decontamination of the manufacturing facilities and adjoining areas, an additional 1.4×10^5 tons (1.4×10^{06} kgs) of higher concentration slag was added to the West Pile. The additional material had an average concentration of Th-232, U-238, and Ra-226 of 42 pCi/g { 1.6×10^3 mBq/g}, 54 pCi/g { 2.0×10^3 mBq/g}, and 42 pCi/g { 1.6×10^3 mBq/g}, respectively. The top of the pile, according to SMC employees, is composed of at least 6-8 feet of cover material consisting of Chemfix (a clay-like material), a geotextile cover material, and approximately 6-8 inches of sand. This covers the top of the slag pile only. The shoulders of the piles are not covered and the slag is exposed. The licensee indicated during the December 13, 1993 exit meeting that it had planned to put a similar cover over the shoulder and then cover the entire pile with another 2 feet of soil and seeding. However, the licensee delayed this phase in 1991 when it failed to obtain final NRC approval for the containment request. Attachment B is a picture of the construction of the Chemfix cover.

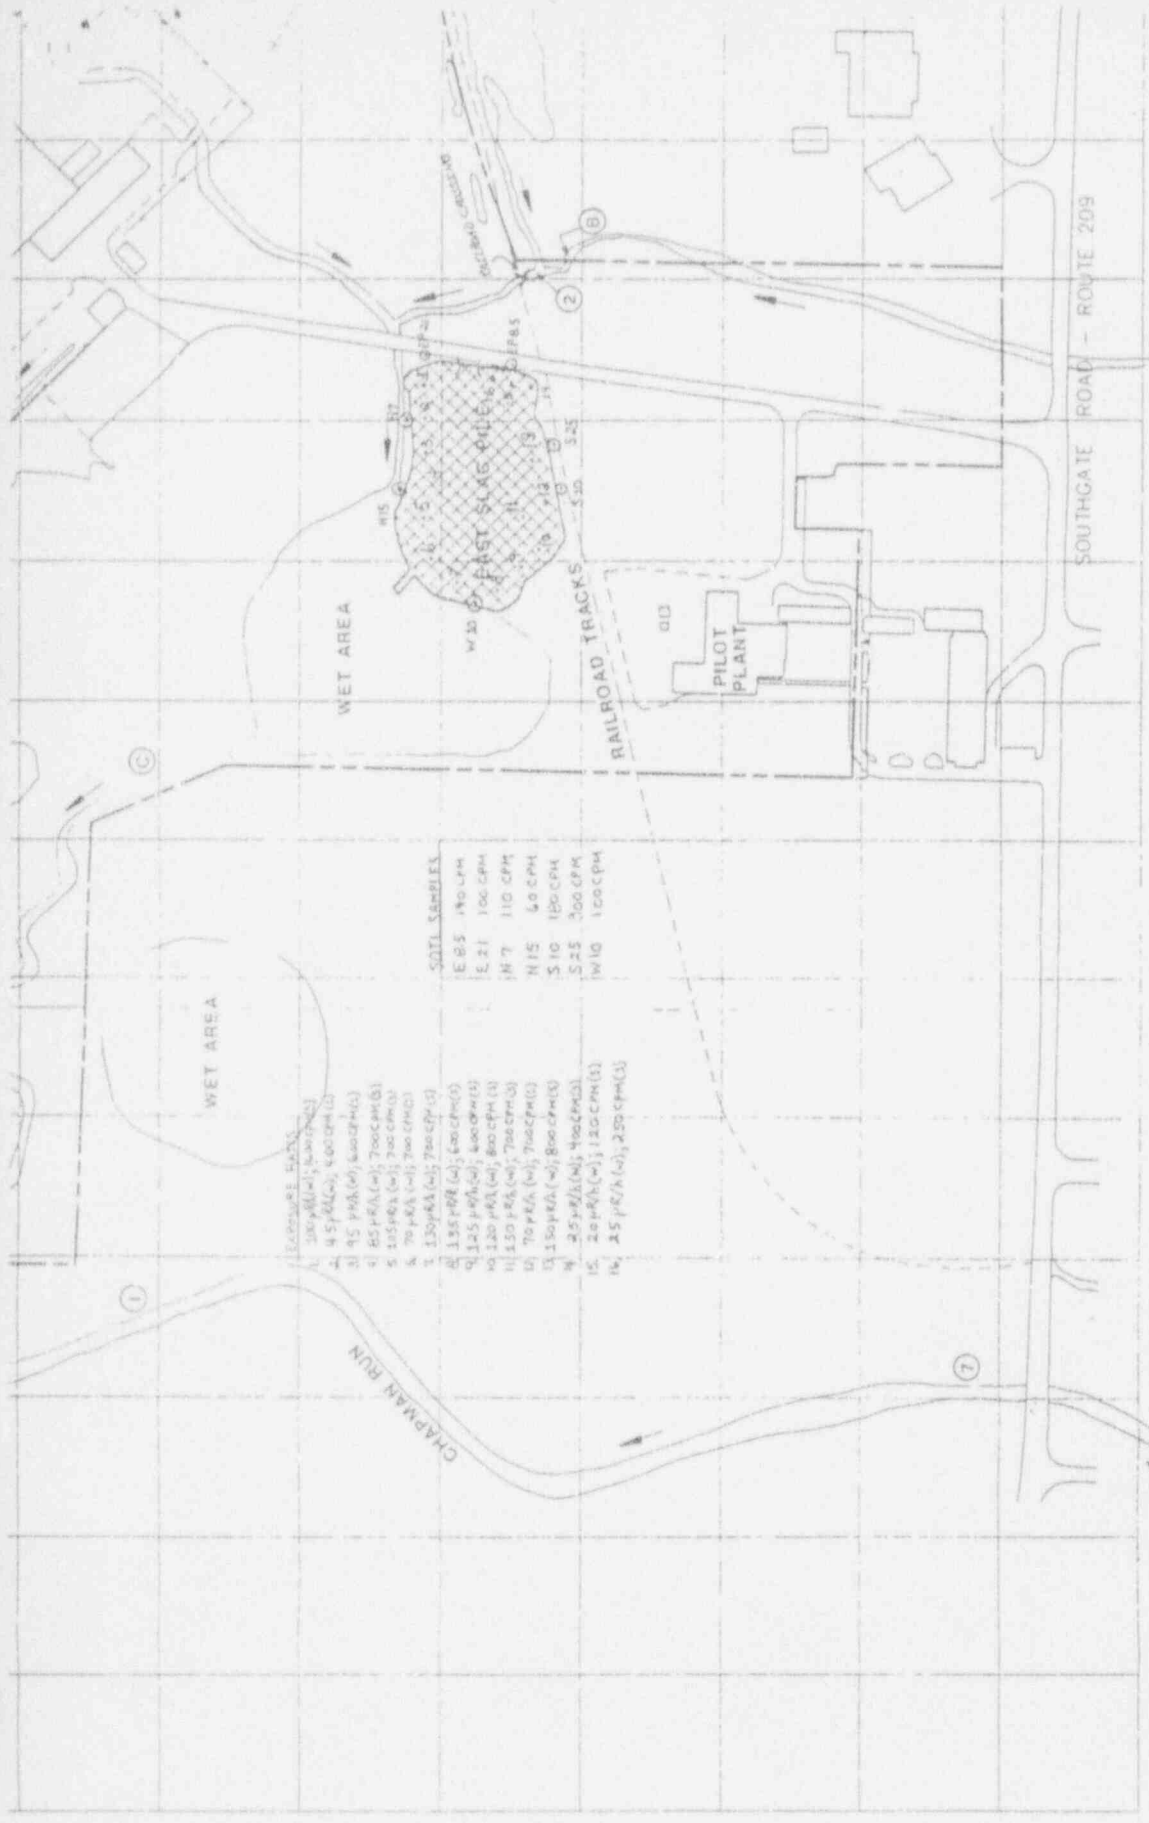
- (1) A number of surface count rate and 1 meter exposure rate measurements were taken. The measurements ranged from approximately 120 counts per minute (cpm) to 800 cpm and 20 microreontgens per hour (1R/h) [5.16 nanocoulomb per kilogram per hour [nC/kg/h]] to 150 1R/h [38.7 nC/kg/h]. The average gamma radiation level was 10 1R/h (2.58 nC/kg/h). The survey results are documented in Attachment F and the locations of the measurements are indicated on the Attachment G. Natural background radiation levels for the site were approximately 75 cpm and 10 1R/h (2.58 nC/kg/h).
- (2) A number of soil samples were collected from around the perimeter of this pile. The locations of these samples are indicated on Attachment G. The railroad and entrance road to the plant form an embankment on the south and east side of the East Slag Pile. The direct exposure rate

- 1. 100 pPR (w); 400 cPM (S)
- 2. 45 pPR (w); 400 cPM (S)
- 3. 45 pPR (w); 400 cPM (S)
- 4. 85 pPR (w); 700 cPM (S)
- 5. 115 pPR (w); 700 cPM (S)
- 6. 70 pPR (w); 700 cPM (S)
- 7. 130 pPR (w); 700 cPM (S)
- 8. 135 pPR (w); 600 cPM (S)
- 9. 135 pPR (w); 600 cPM (S)
- 10. 130 pPR (w); 800 cPM (S)
- 11. 130 pPR (w); 700 cPM (S)
- 12. 70 pPR (w); 700 cPM (S)
- 13. 130 pPR (w); 800 cPM (S)
- 14. 25 pPR (w); 400 cPM (S)
- 15. 20 pPR (w); 130 cPM (S)
- 16. 15 pPR (w); 250 cPM (S)
