U.S. NUCLEAR REGULATORY COMMISSION

Report Nos. 50-456/94008(DRP); 50-457/94008(DRP)

Facility Name: Braidwood Station, Units 1 and 2

Areas Inspected: Special, reactive safety inspection to review the circumstances surrounding the inoperability of both trains of Control Room Ventilation.

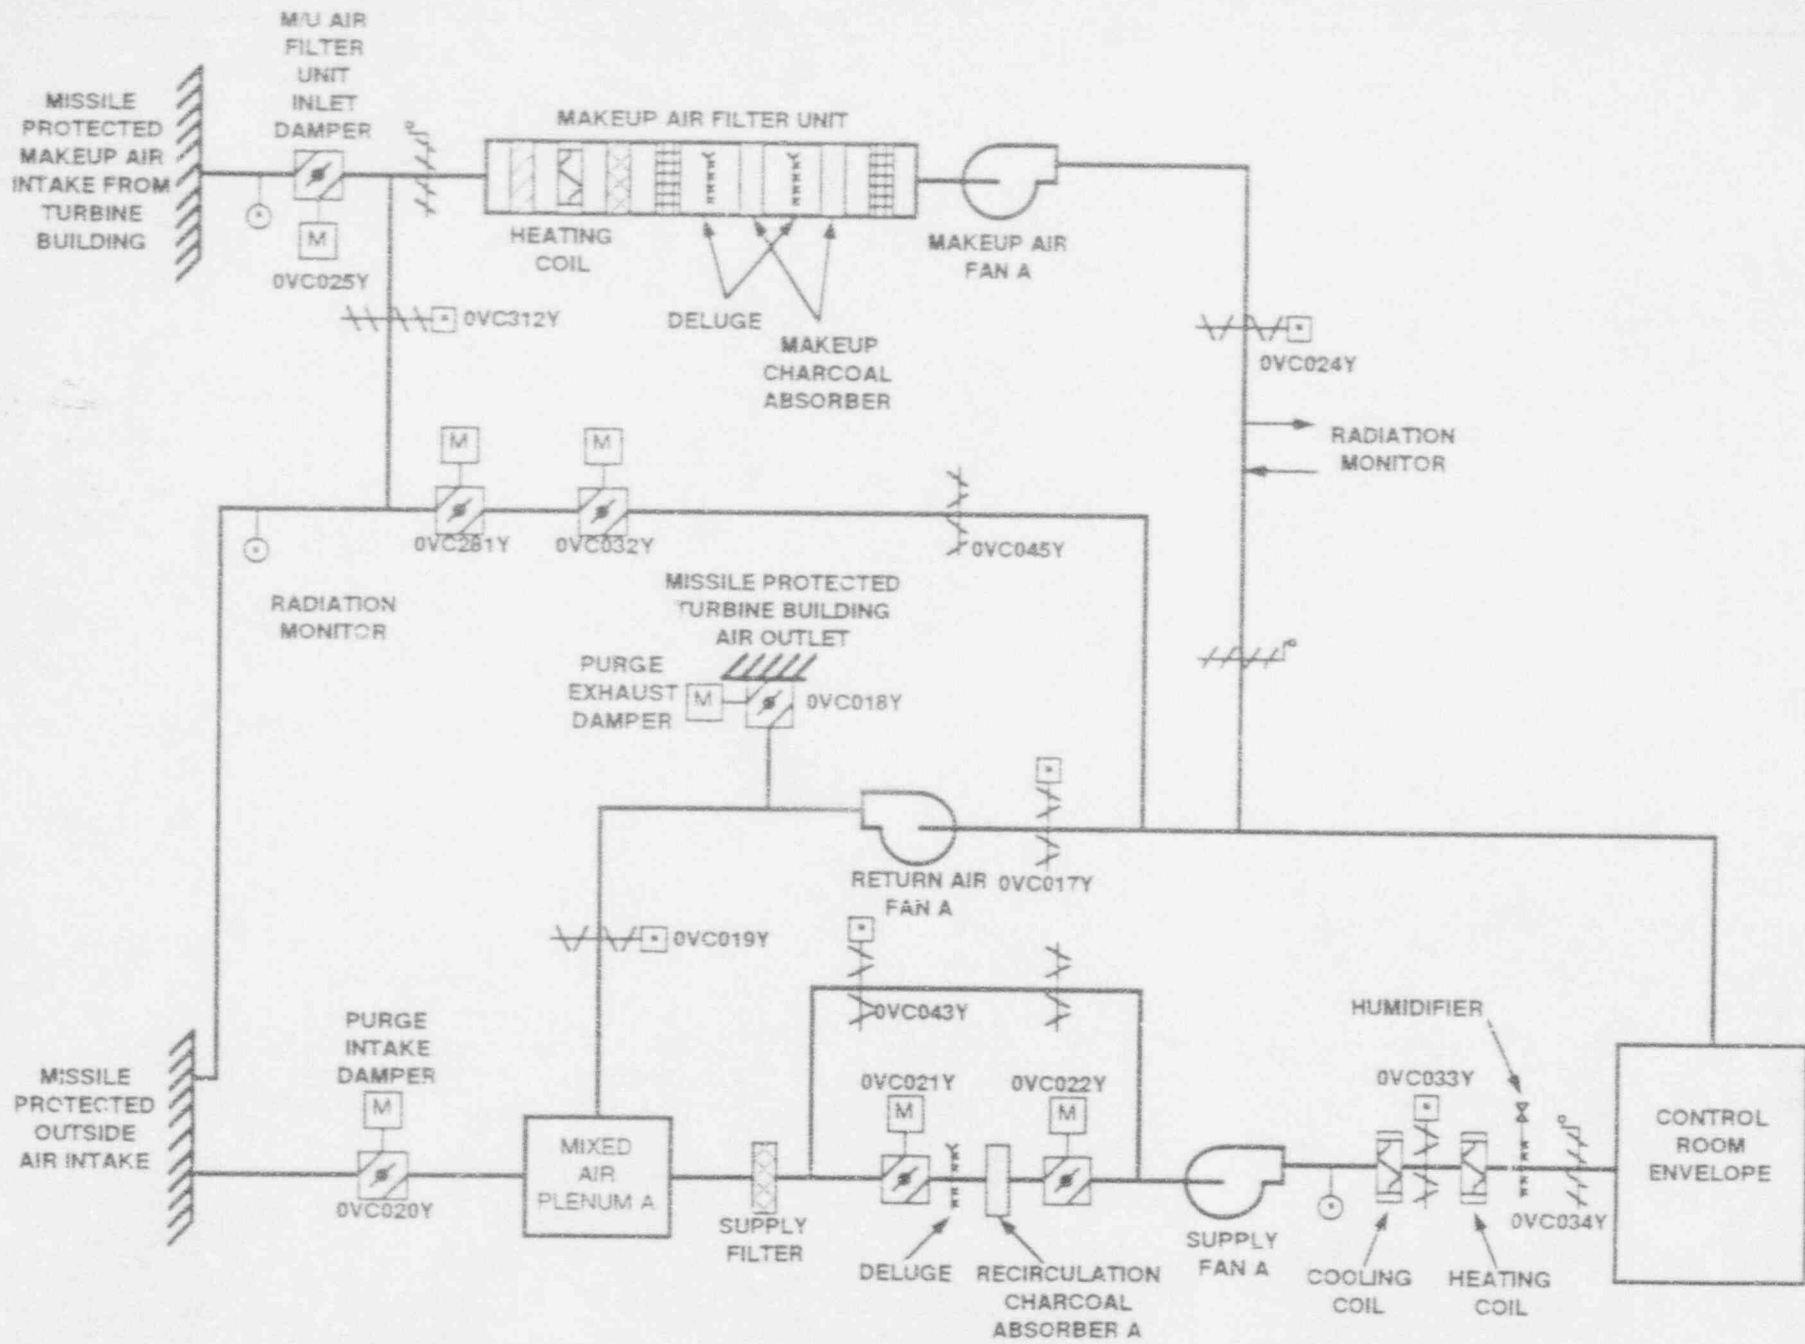
FIGURE 1 CONTROL ROOM HVAC SUPPLY TRAIN A

Damper OVC018Y (Attachment 1) failed to open. EMD found motor grounded and dead battery pack. Both the motor and battery pack, as well as other failed components were replaced and operationally checked by cycling the damper and the damper was returned to service.

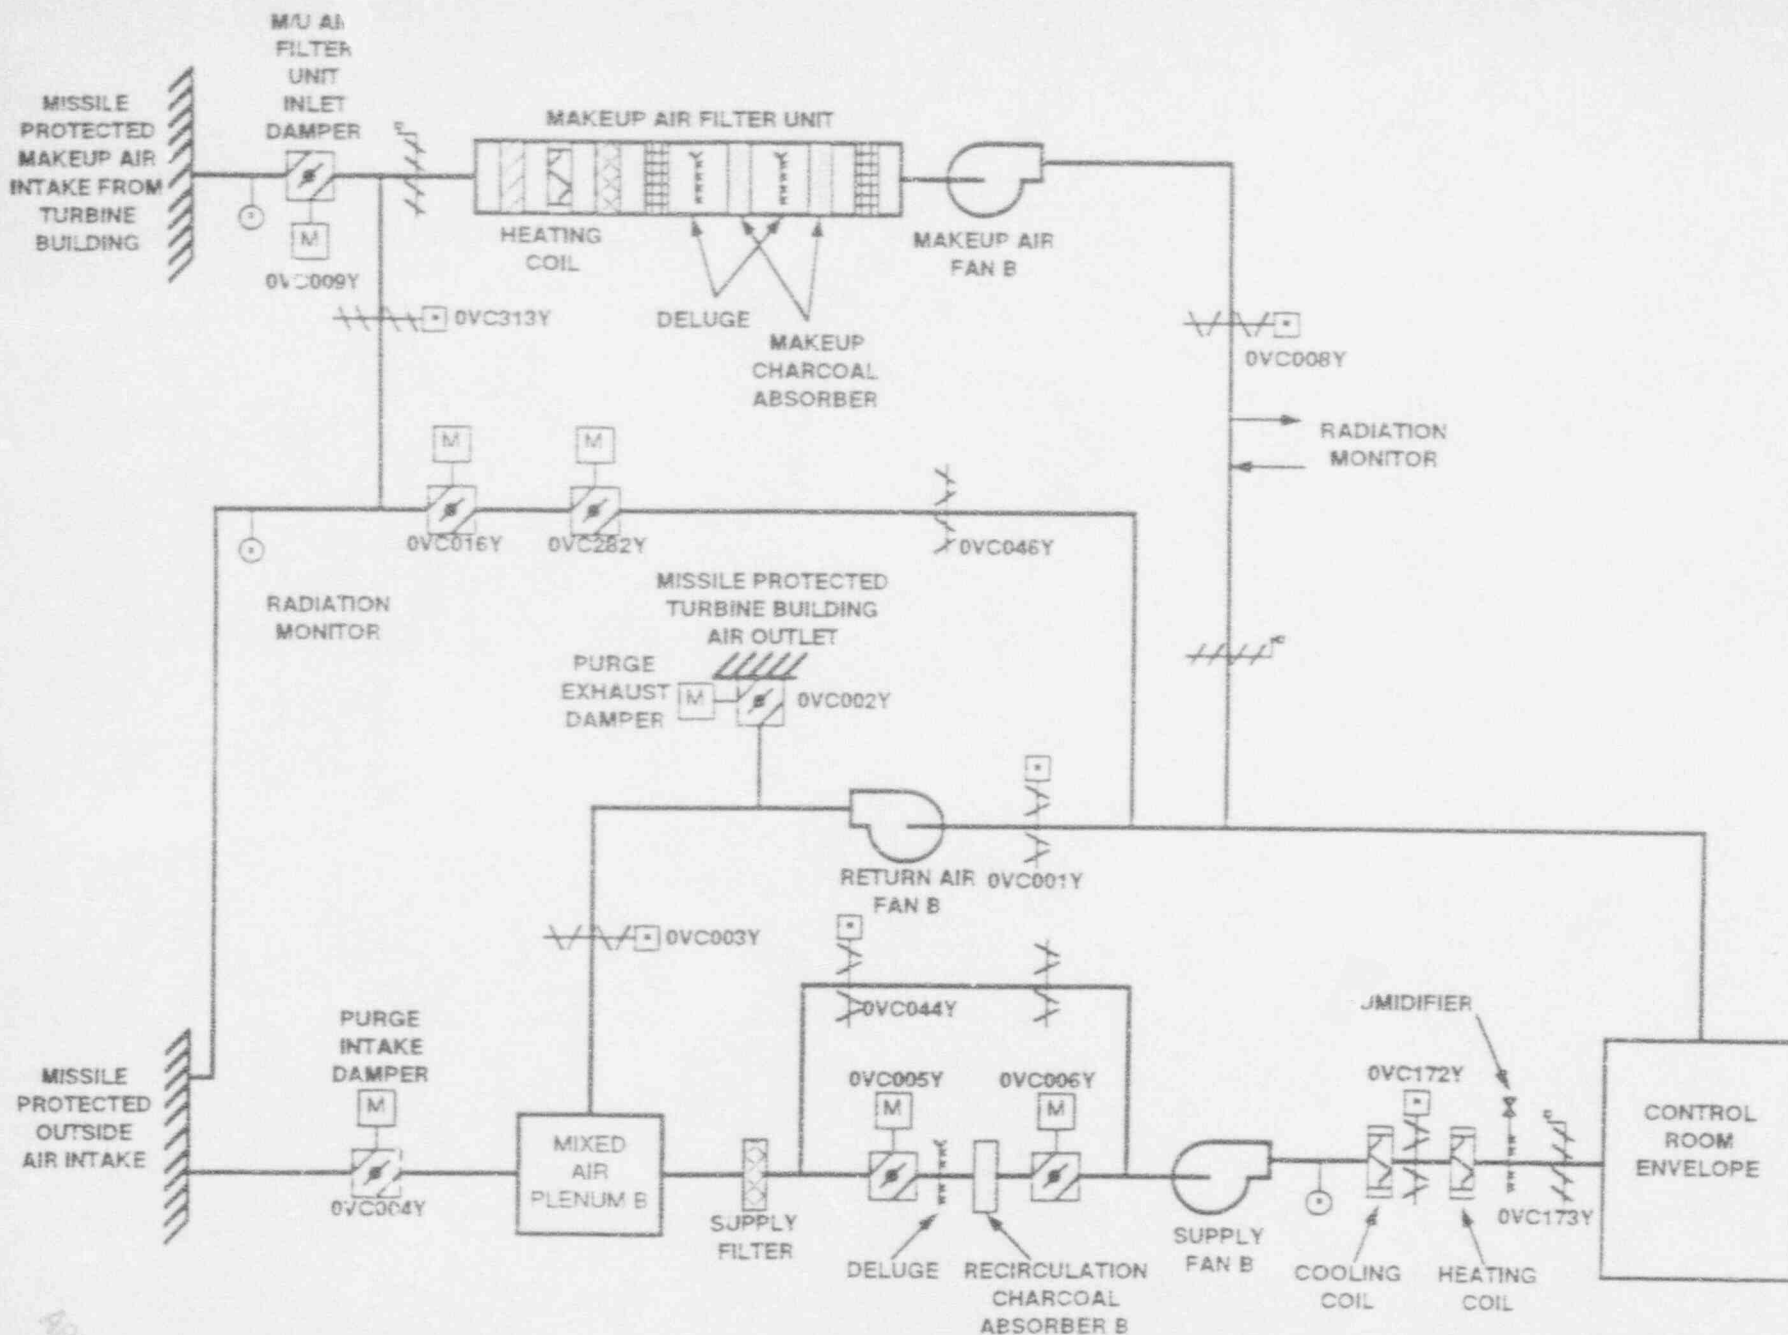
FIGURE 2 CONTROL ROOM HVAC SUPPLY TRAIN B

Damper OVC313Y (Attachment 2) did not close on loss of normal power supply during initial installation testing. The Operational Analysis Department (OAD) replaced the battery associated with damper OVC313Y and completed a satisfactory retest prior to turning the system over to System Engineering for pre-operational testing.

Damper OVC04Y (Attachment 2) would not open. EMD found motor grounded and dead battery pack. Both the motor and battery pack, as well as other failed components, were replaced and operationally checked by cycling the damper and the damper was returned to service.

Damper OVC16Y (Attachment 2) did not open when the VC supply fan was started. EMD found the motor grounded and the backup battery bad. Both the motor and battery pack, as well as other failed components, were replaced and the damper was returned to service.

Damper OVC02Y (Attachment 2) did not actuate when a purge signal was manually generated. EMD replaced both actuators (which included the motor and battery pack) and observed the damper stroke with proper indication prior to returning the damper to service.

Preoperational testing of the VC system verified the support functions of the backup batteries. Additionally, during testing, a failure of the battery for damper OVC313Y (Attachment 2) occurred on January 6, 1987. Documentation verified that the battery was replaced and returned to operable. The vendor manual contained information for installing the batteries. These instructions were followed.
