Vice President  
Operations  
Grand Gulf Nuclear Station

**SUBJECT: Grand Gulf Nuclear Station  
Unit 1  
Docket No. 50-416  
License No. NPF-29  
Response to RAI Regarding Settlement  
of Category I Structures  
AECM-90/0209**

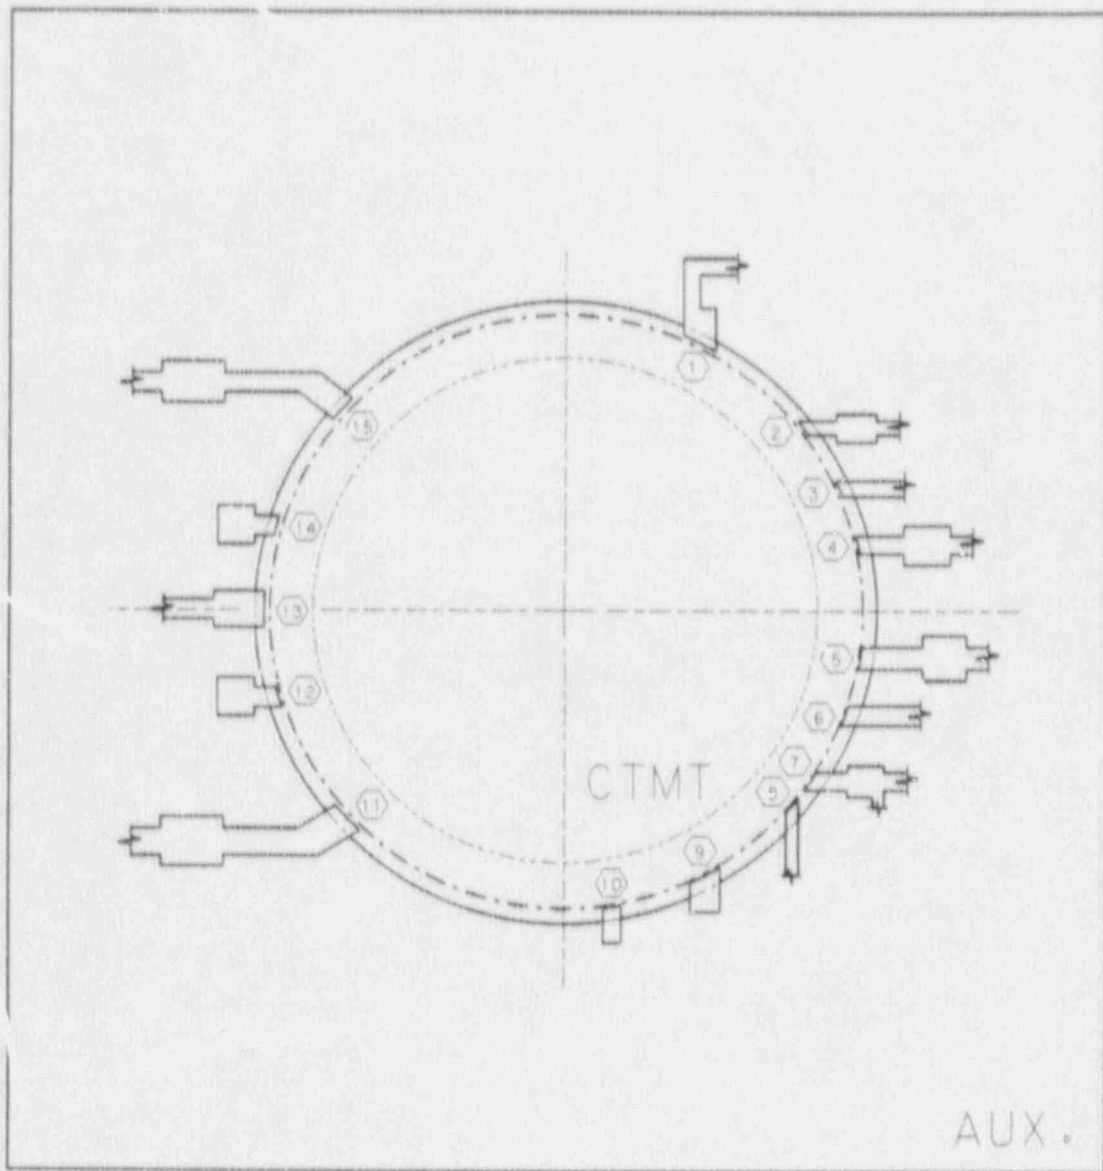
FIGURE 1

In the April 17, 1990, NRC General Site Tour, it was noted that the gap beneath an Auxiliary Building wall and the Containment base mat appeared to be missing. A subsequent investigation by Entergy confirmed that the gap was not provided in nine (9) locations (see attached Figure 1) and failed to locate existing documentation which accepted this condition. A material nonconformance report (MNCR 0048-90) was written to document and address this condition. Based on this discovery, the information provided to the NRC on April 16, 1990 which showed that the Auxiliary and Containment buildings have moved towards one another, was re-evaluated. Further investigation revealed that the buildings are actually tilting in the same direction and, since the buildings are in contact in the vertical direction, there is no differential settlement between Auxiliary and Containment Buildings. The initial error in determining the measured differential settlement was due to the method used in combining the data for Containment points 11 and 13 with the relocated Containment points 11A and 13A.

Allowable differential settlements for the Auxiliary and Containment Buildings are 1.15 inches and 0.6 inches, respectively. These values are based on maintaining a minimum clearance between buildings to preclude building contact during an OBE occurrence considering the worst case scenario of the two structures tilting toward one another along the same axis. The measured differential settlements of 0.89' and 0.33" on the Auxiliary Building and Containment, respectively, are of no safety significance since both these values are less than the UFSAR allowables and the structures are tilting in the same direction. Furthermore, field inspections of the seismic gap between the Auxiliary and Containment Buildings reveal that actual closure of the gap is not evident.

NOTE: VERTICAL SEISMIC GAP IS ABSENT AT LOCATIONS 1, 2, 4, 5, 7, 11, 13, 14 AND 15.

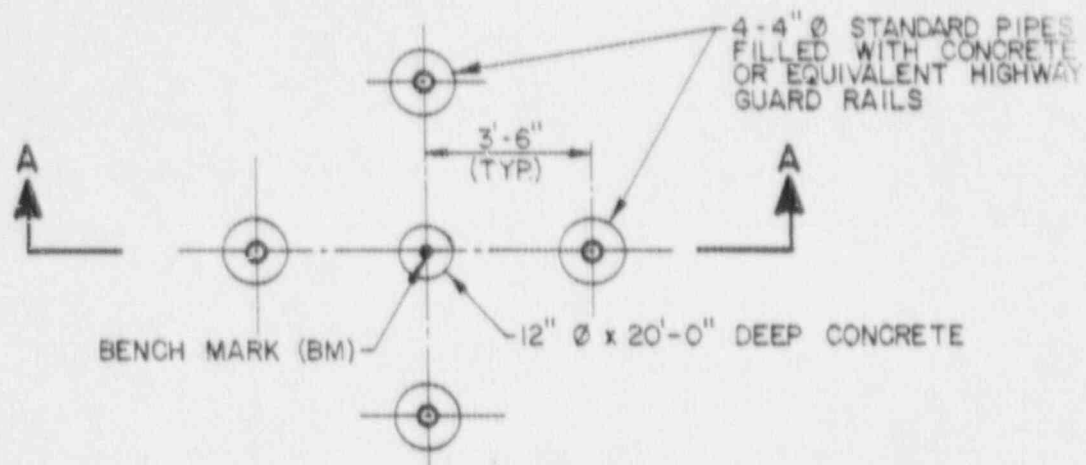
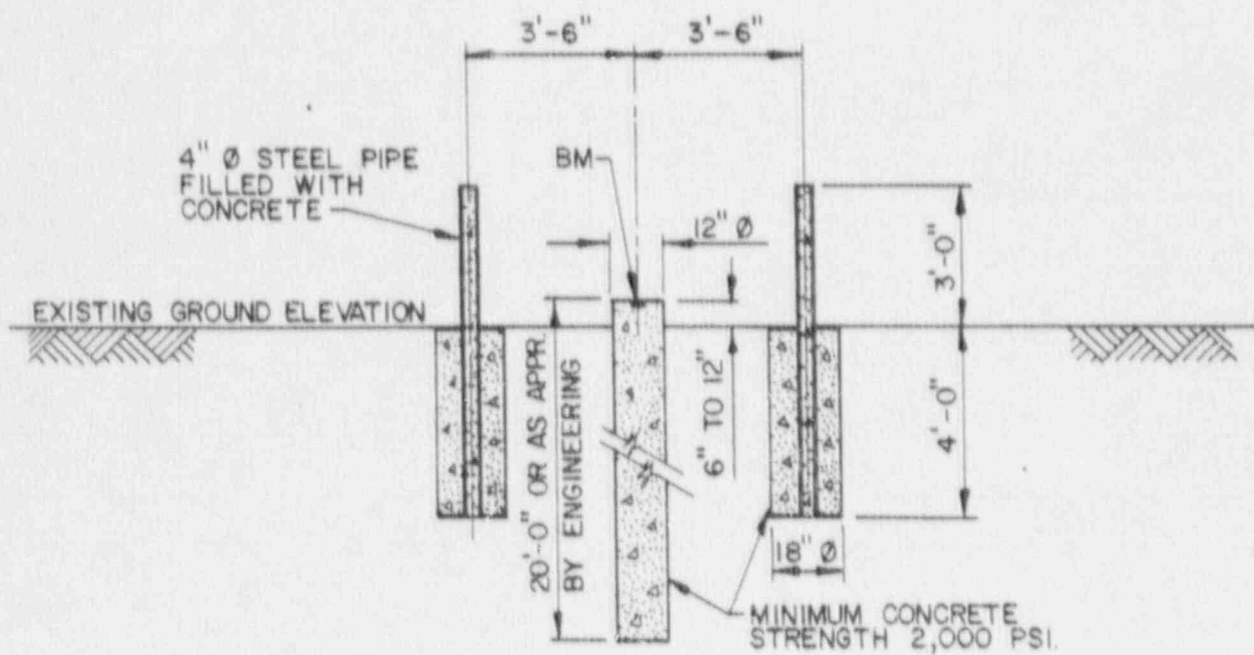
FIGURE 2

The two permanent bench marks are located within the Owner Controlled Area of the plant site. These markers are located away from any major structure to prevent disturbance to the bench marks. Permanent bench mark no. 1 is located between the security boundary fences south of the Unit 1 warehouse and requires a security guard to unlock a security gate for admittance. Permanent bench mark no. 2 is located approximately 300 feet northwest of the Unit 2 Turbine Building and is protected by 4 steel posts (see attached Figure 2).

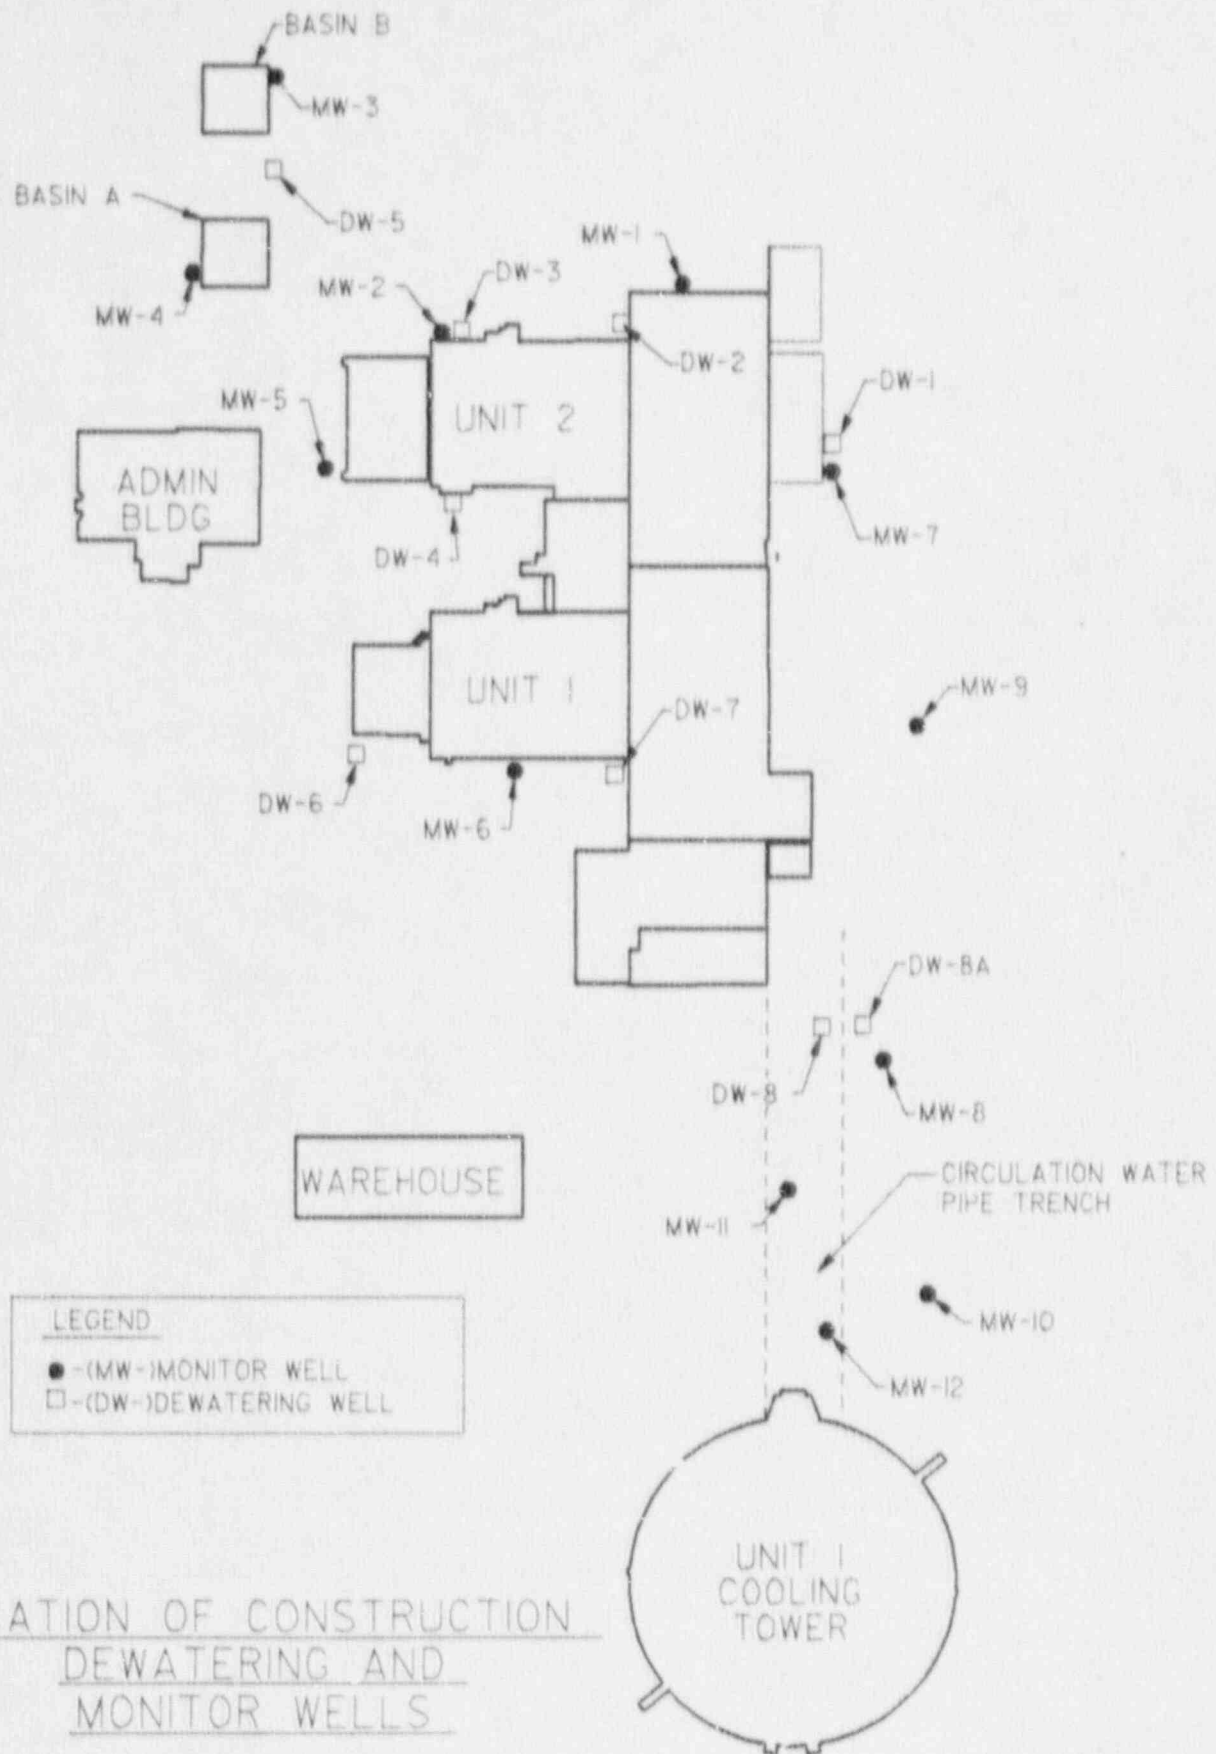
FIGURE 3

From January through July, 1983, Well DW-8 (see Figure 3) exceeded the design maximum groundwater elevation of 109.00 ft. MSL. The highest water level recorded during this period was 110.21 ft. MSL in February, 1983. The high groundwater elevation was reported to NRC via AECM-84/0020 in March, 1984. Since this initial exceedance, there have been additional groundwater level exceedance events. These were reported in March, 1985 (AECM-85/0088), February, 1986 (AECM-86/002), March, 1986 (AECM-86/0202), March, 1990 (AECM-90/0062), April, 1990 (AECM-90/0083) and September, 1990 (AECM-90/0183).

Water levels above 109 ft. MSL have been exceeded only around DW-8 by less than three feet. Other areas around the plant have generally been within the expected range. It is therefore concluded that the minor fluctuations have had a negligible effect upon plant settlement. As noted above, a more thorough report addressing groundwater monitoring at GGNS will be completed by the end of December, 1990.

Presently, data is still being obtained to help further clarify flow patterns and sources of recharge. Additional monitoring wells are being installed along with a visual examination of the cooling tower basin and circulating water pipes during RFO4. In response to a separate NRC request a more thorough report addressing groundwater monitoring at GGNS will be completed and submitted to the NRC by the end of December, 1990.
