Houston Lighting & Power

South Texas Project Electric Generating Station
Unit 2
Docket No. STN 50-499
Licensee Event Report 90-018 Regarding
Unplanned Engineered Safety Features (ESF)
Actuations During the Performance of a Surveillance Test

TITLE (4)
**Unplanned Engineered Safety Features Actuations
During the Performance of a Surveillance Test**

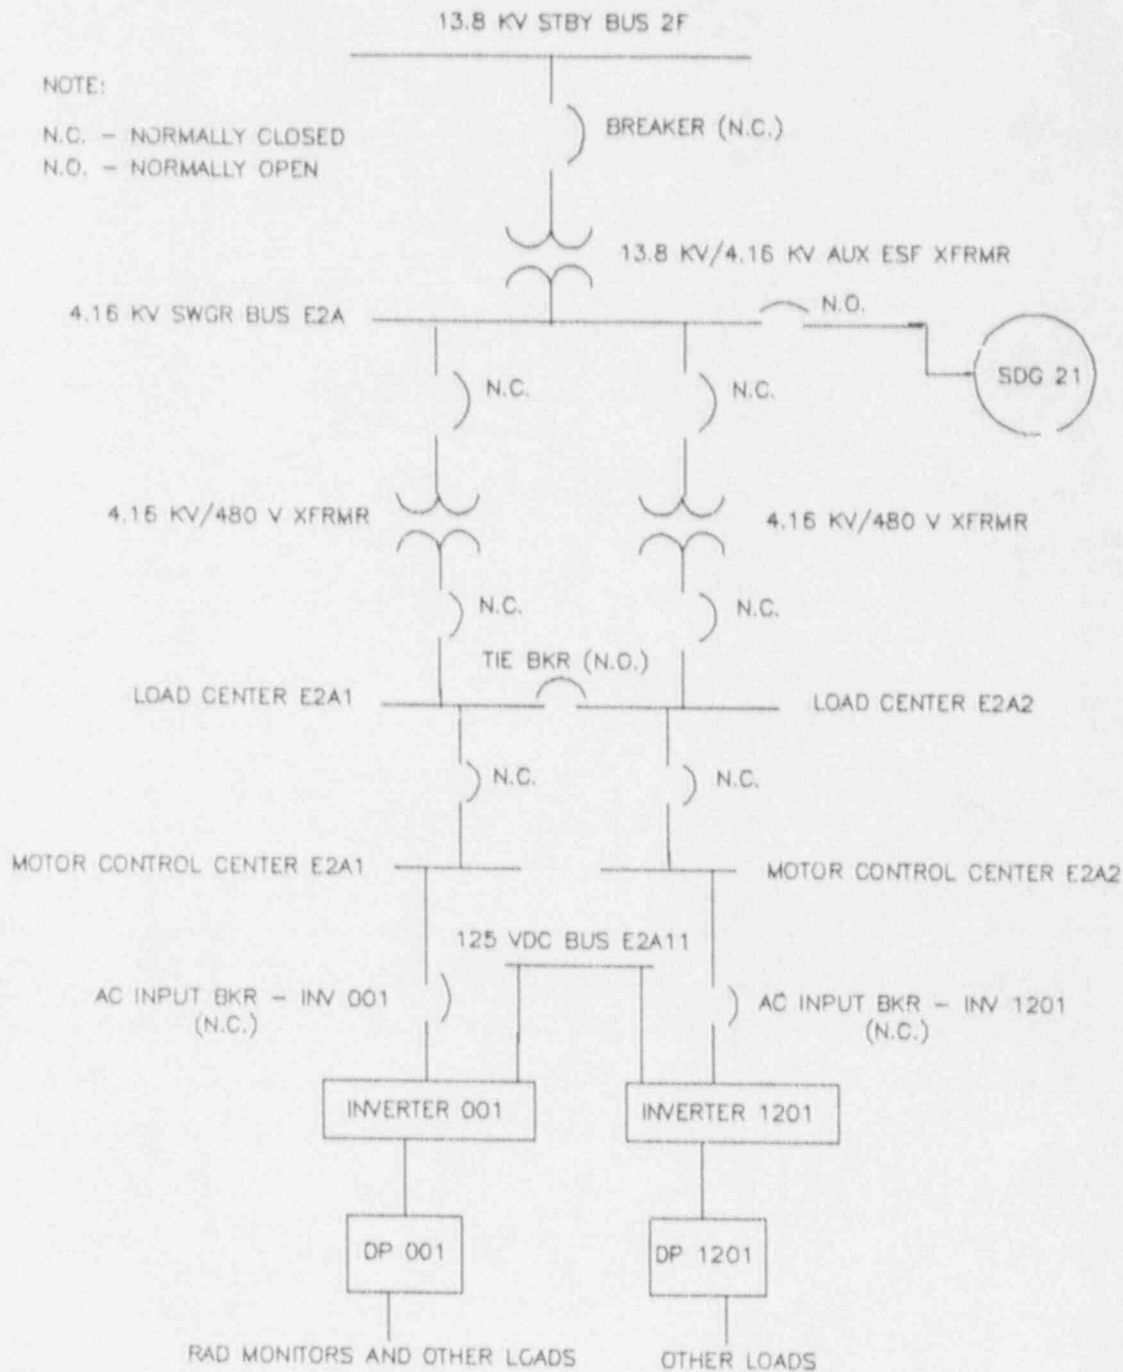
FIGURE 1
SIMPLIFIED ELECTRICAL LINE REFERENCE

This event occurred as a result of a voltage transient on DP001, the 120 volt AC vital distribution panel which powers the radiation monitors that initiated the actuation. This voltage transient occurred concurrently with the closure of the AC input breaker for Inverter 1201, but the source of the transient is not understood at this time. Extensive troubleshooting was performed. This troubleshooting included cycling the AC input breaker for Inverter 1201 and monitoring Inverter/DP001 for any voltage, frequency, current, or alarm transients. No abnormalities were detected during this test.

A contributing factor to this event was the opening of the AC input breaker to Inverter 1201. This breaker is designed to remain closed on a LOOP so that the inverter is automatically restored to its AC source when power is restored to the standby bus. The breaker opened on an overvoltage trip signal from its associated relay during voltage fluctuations as the SDG initially loaded onto the standby bus. Further investigation has revealed that the overvoltage trip setpoint for the relay had drifted low.

A simplified electrical line diagram is supplied in Figure 1.

1. The AC input breaker for Inverter 1201 was cycled and Inverter/DPO01 was monitored for any voltage or frequency transients. No abnormalities were detected. This action was completed on November 28, 1990.
2. The relay that signalled the AC input breaker for DP1201 to open was removed and inspected. The setpoint for an overvoltage protection trip signal on the relay was checked and determined to have drifted low. This setpoint was adjusted to its normal setting and the relay was reinstalled. This action was completed on November 28, 1990.
