In the Matter of  
CONSUMERS POWER COMPANY  
(Midland Plant, Units 1 and 2)  
Docket Nos. 50-329 OM & OL and 50-330 OM & OL

DOCKET NO. 50-312  
LICENSE NO. DPR-54  
REPORTABLE OCCURRENCE NO. 82-10

DOCKET NO. 50-312  
 LICENSE NO. DPR-54  
 AUXILIARY FEEDWATER HEADER MODIFICATION (SUPPLEMENT)

Reportable Occurrence 82-019  
Davis-Besse Nuclear Power Station Unit 1  
Date of Occurrence: April 26, 1982

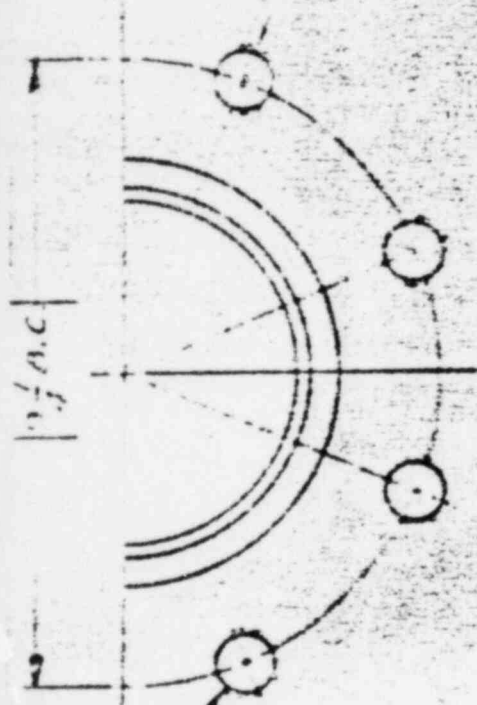
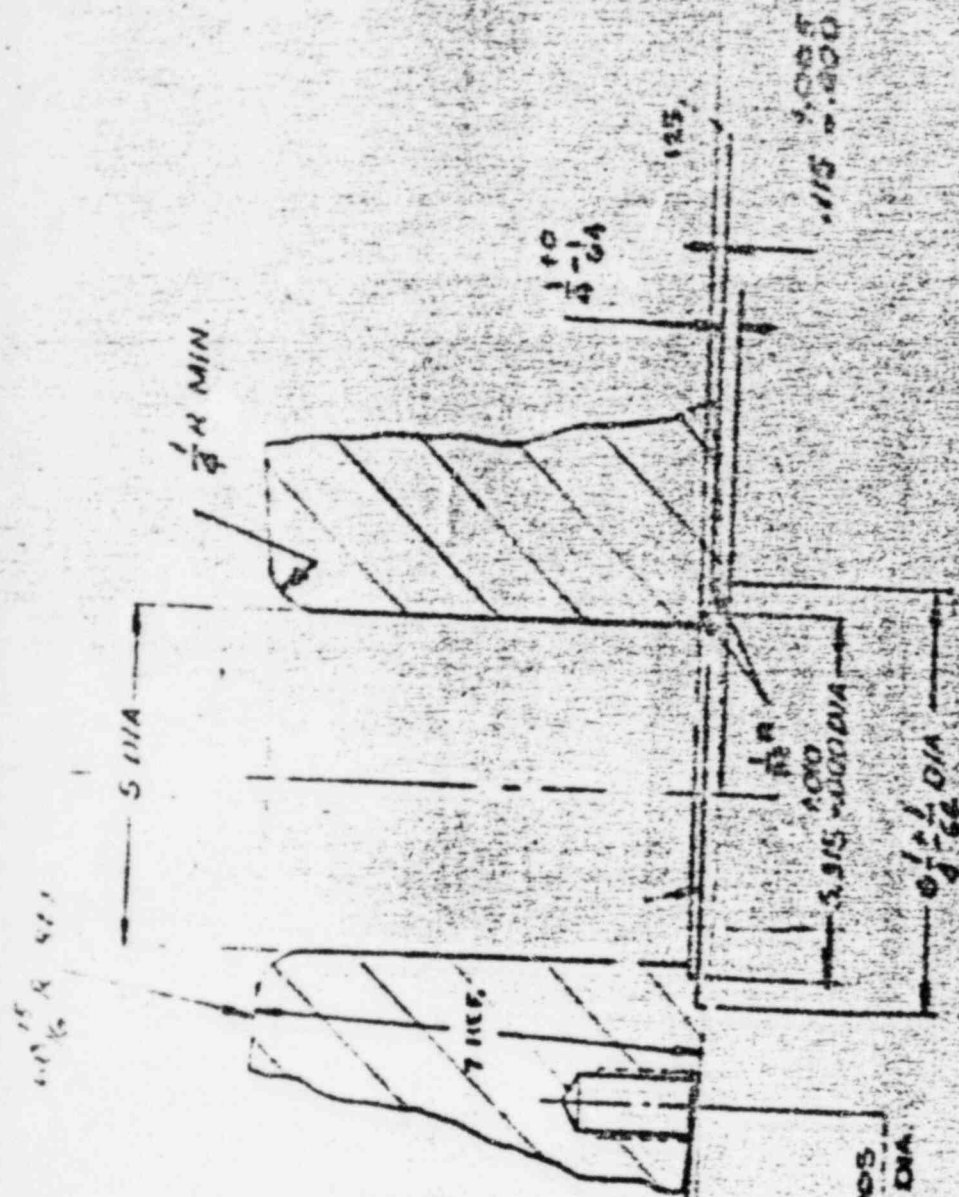
DETAIL A  
TYP 6 PLACES  
SCALE 1/2

DRILL 1/8 DIA X 1/4 DEEP TAP  
1-8 UNC 2 BA X 1/2 DEEP  
3 EQUALLY SPACED AND  
5 TRADDE VERTICAL C OF  
VESSEL

1" DIA C'BORE MAX DEPTH  
 NOT TO EXCEED JUNCTION  
 OF OUTSIDE EDGE OF C'BORE  
 AND SHELL CONTOUR  
 (REQ'D WHERE NECESSARY)

The replacement design incorporates an external Auxiliary Feedwater Header, and six new penetrations through the Steam Generator Shell and through the Upper Cylindrical Baffle (Steam Shroud). Stabilization of the internal Auxiliary Feedwater Header requires access at several points around the header. In order to ensure that loose parts are eliminated or captured, access is required to eight equally spaced header support/fixation locations around the Steam Generator. Two of these locations are accessible from the Steam Generator secondary side manway.

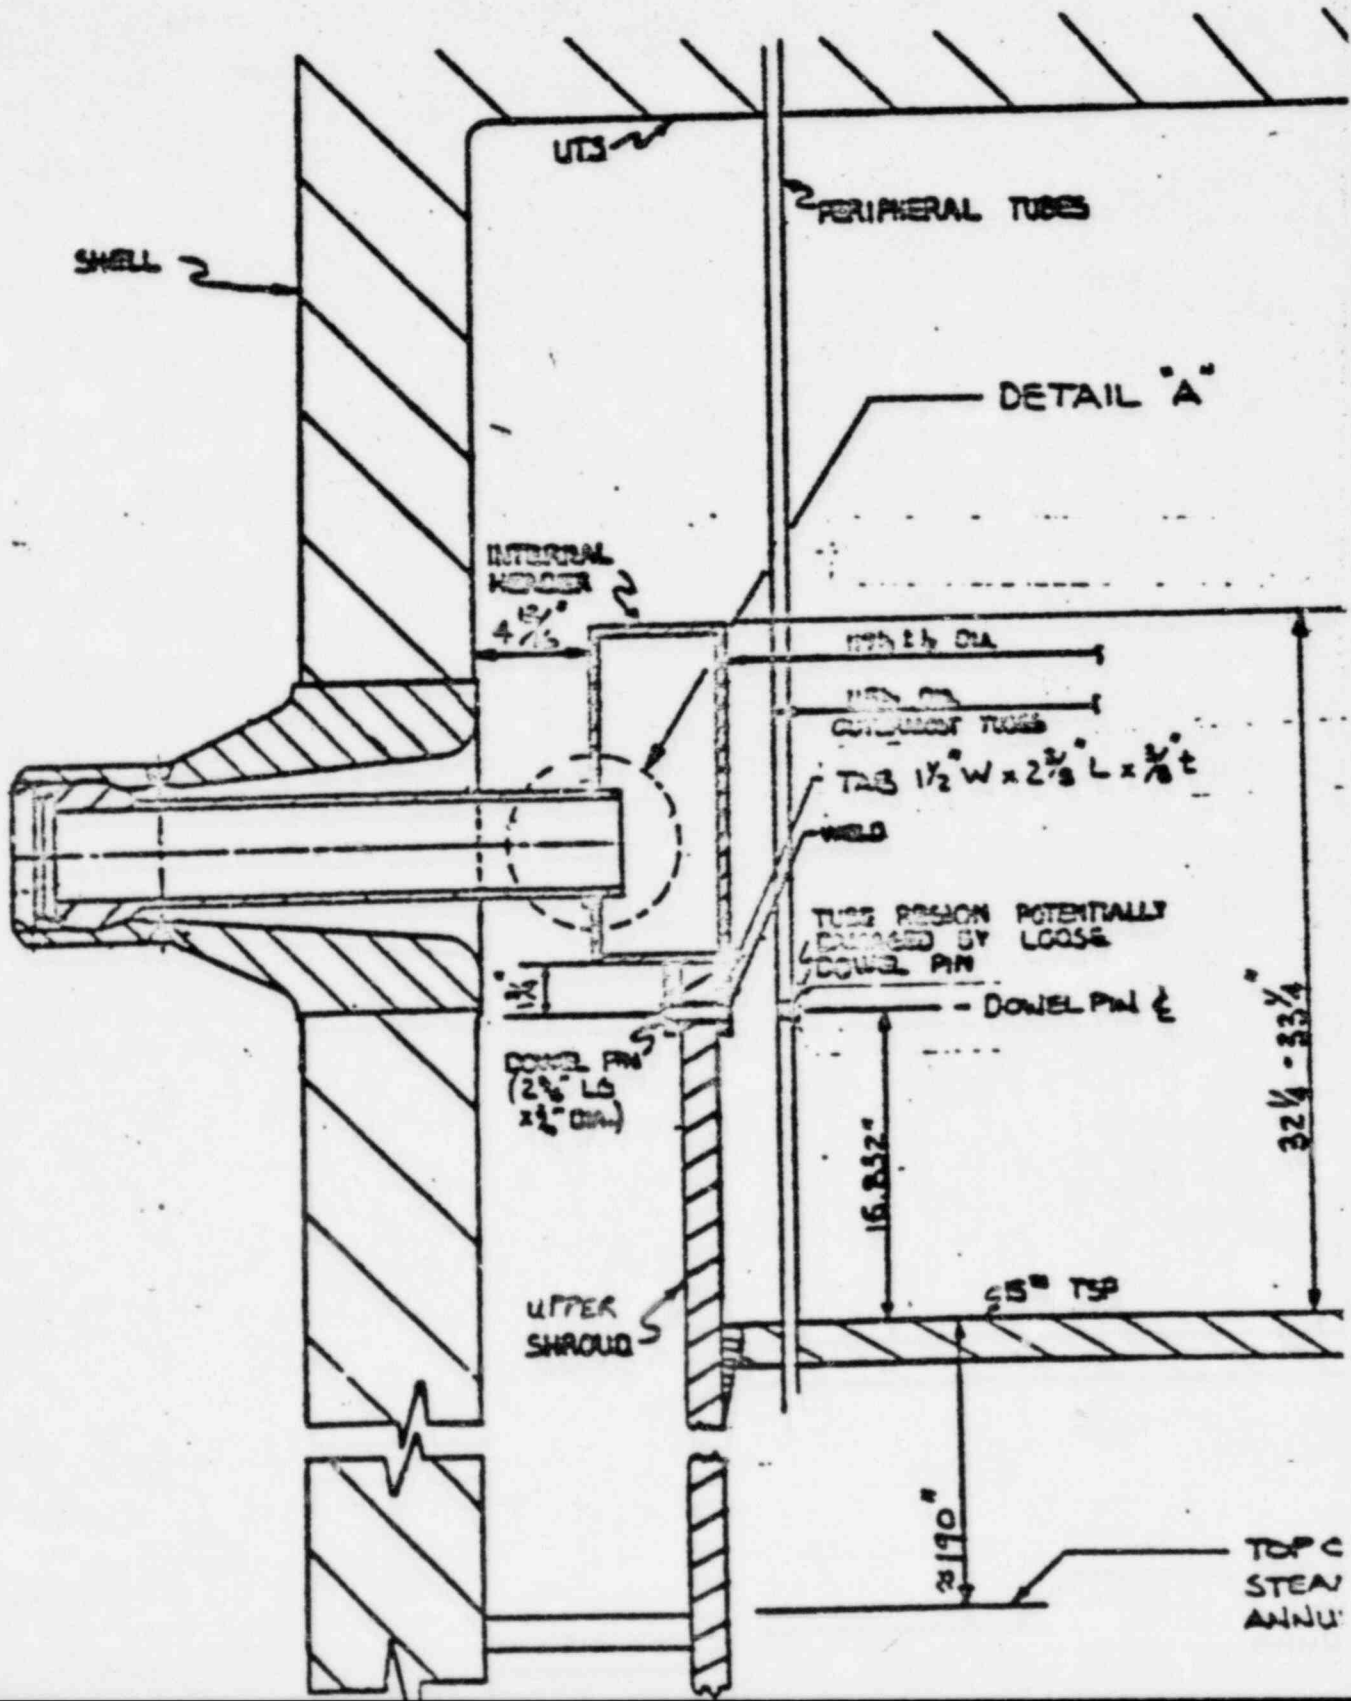
LONGITUDINAL SECTION AT DOWEL PIN

- (4) The outward wall of the header is distorted inward (concave) as much as 1/4".
- (5) Certain header support brackets are bent, and on some the bottom ligaments are torn out or have broken off.

- (6) Dowel pins are missing at six of eight locations inspected. Three dowel pins and two brackets have been retrieved from the steam annulus area in 1-2 SG.

- (7) There is evidence of wear on dowel pins and brackets.
- (8) The auxiliary feedwater nozzle thermal sleeve was not in alignment with the header on Unit #1 (1-1 SG).

To stabilize the internal header, eight holes will be drilled through the steam generator shell and shroud near each dowel pin and bracket location. Those dowel pins and brackets which are not or cannot be securely fastened to the header or the shroud will be removed. If any additional dowel pins or internal brackets are found to be missing they will be located and retrieved. The header will then be centered on the shroud and the assembly will be securely fastened to the shroud. Although the exact method by which the header will be attached to the shroud has not yet been identified, several methods are being considered. The concept of header stabilization is still under review. The seismic and accident loads to which the header may be subjected are currently being evaluated to ensure that the header will remain in place.

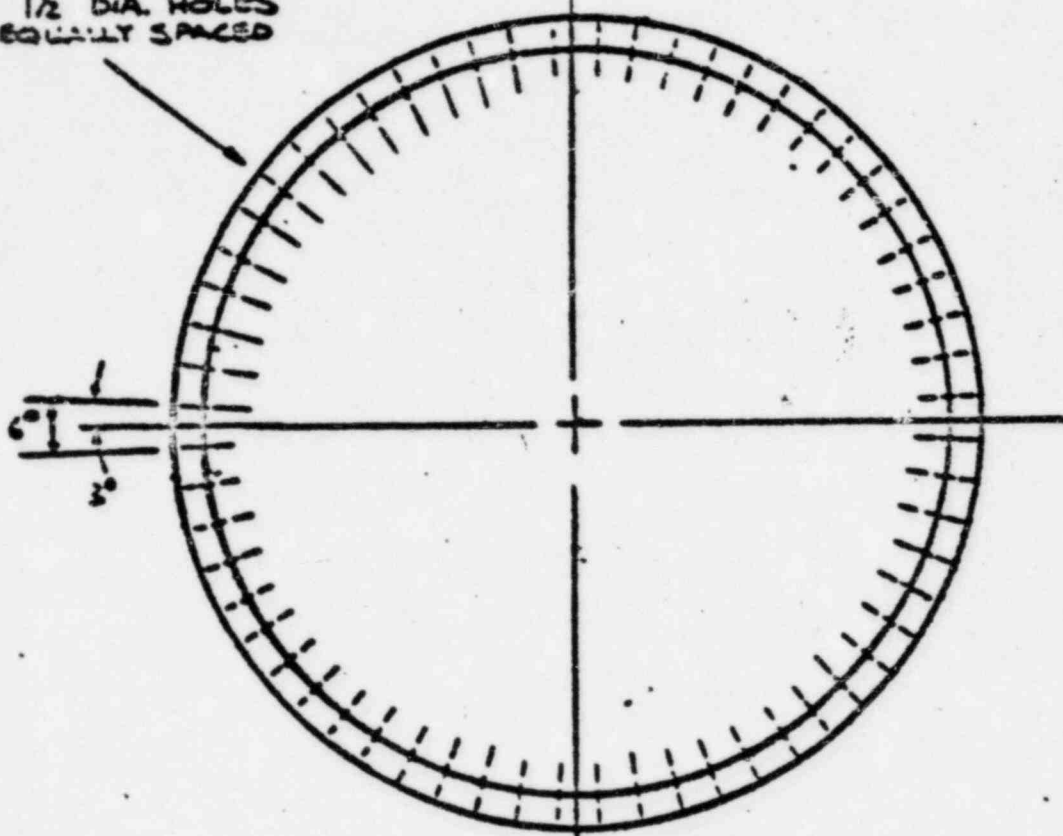
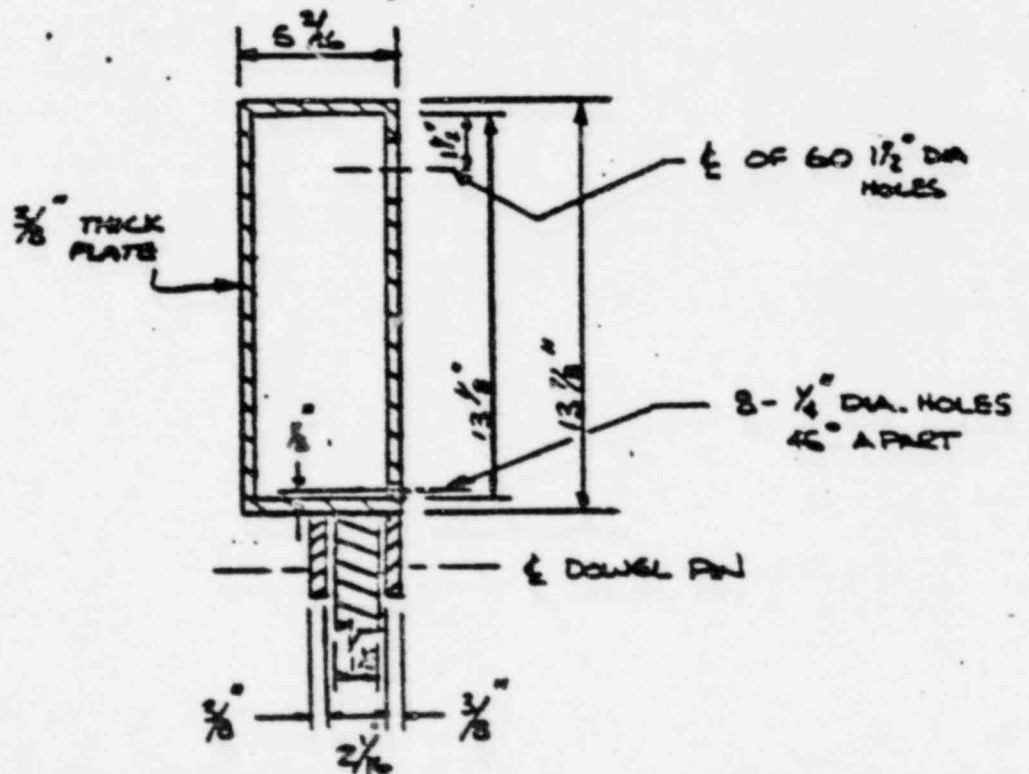
LOCATION OF AUXILIARY FEEDWATER

60 1/2" DIA. HOLES  
EQUALLY SPACED

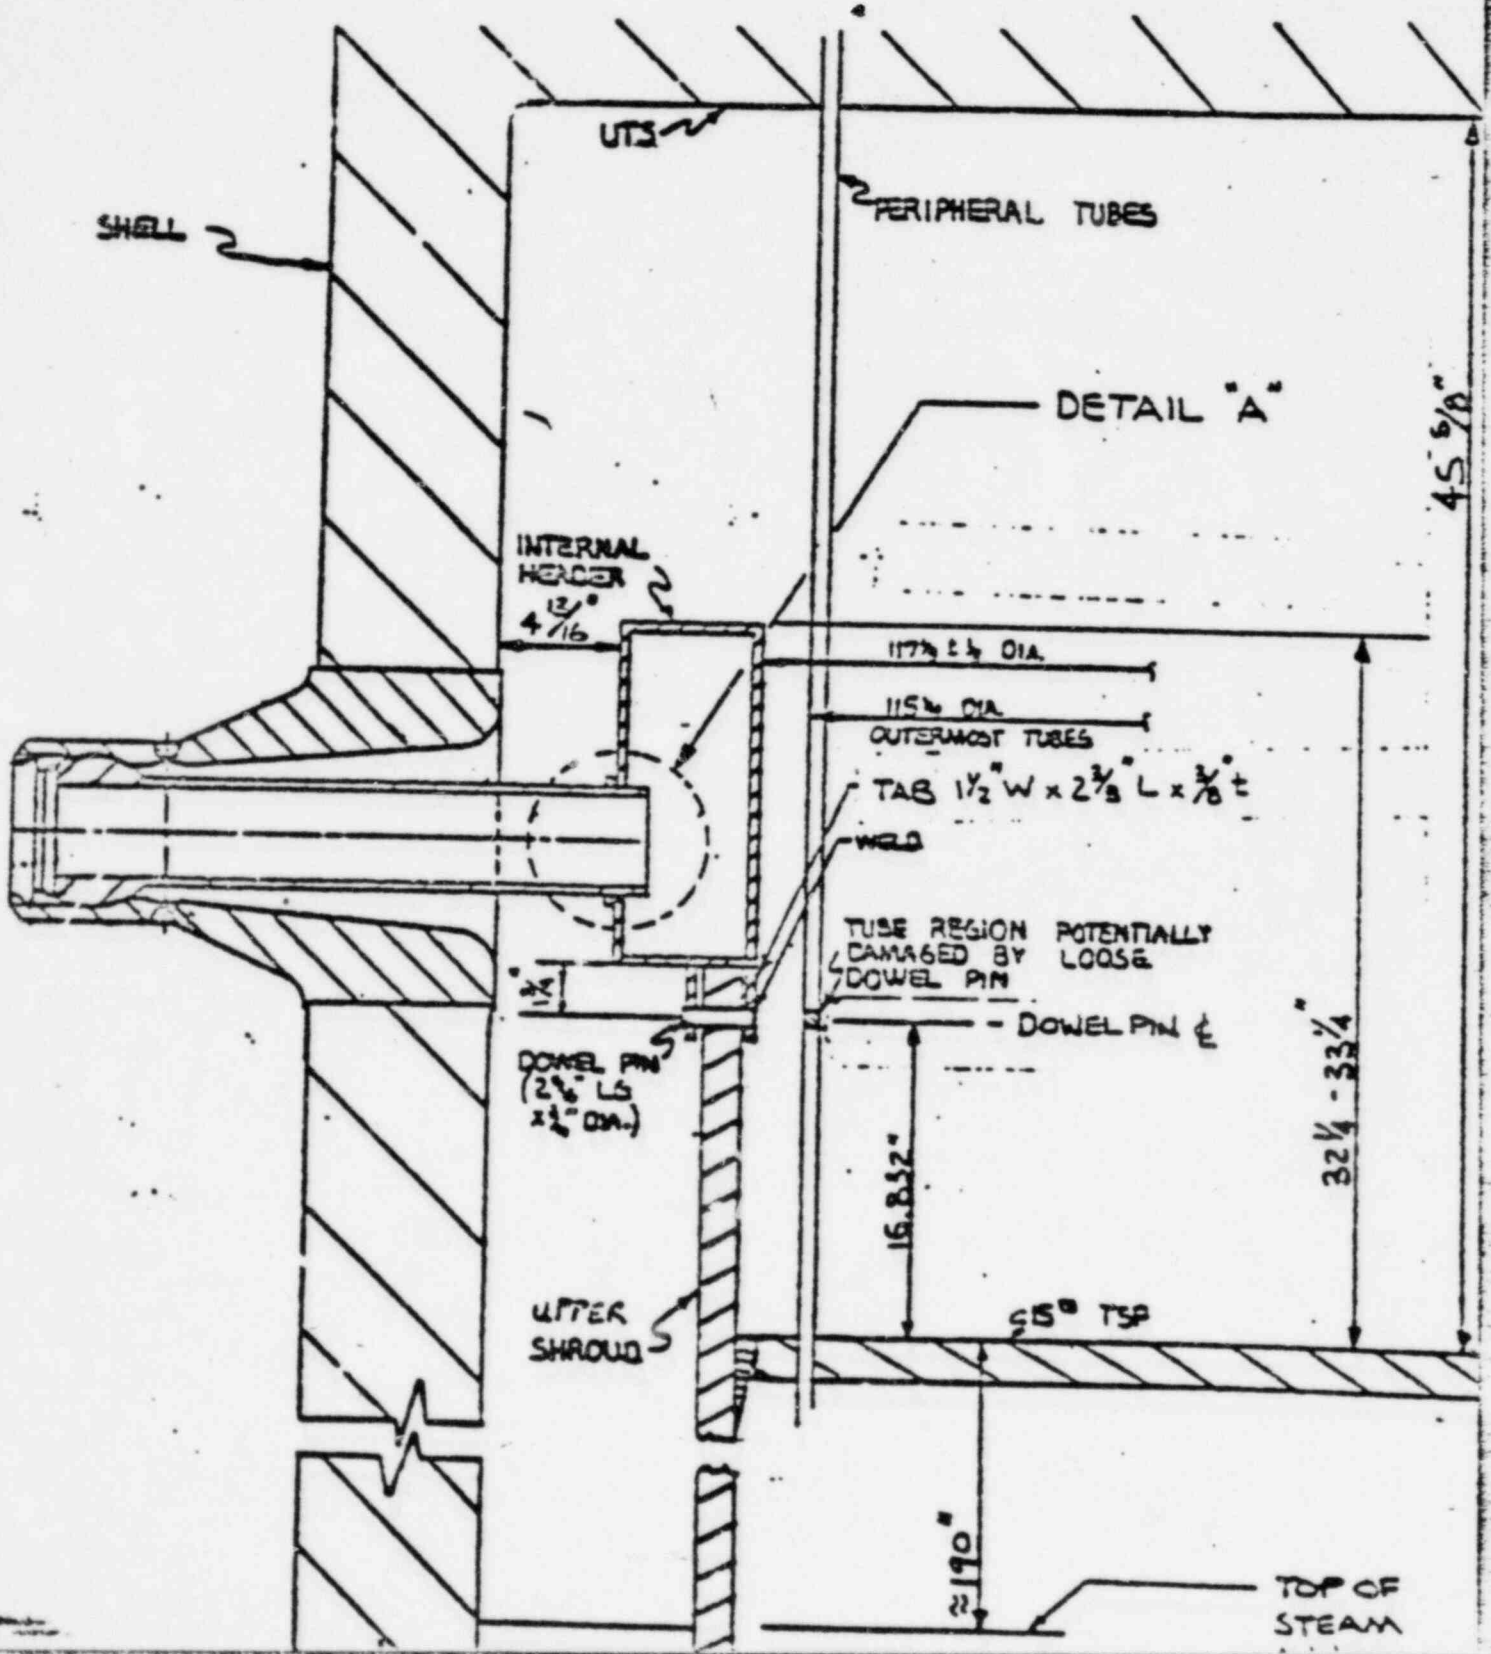
LONGITUDINAL SECTION AT DOWEL PIN

- (4) The outboard wall of the header is distorted inward (concave) as much as  $\frac{1}{4}$ ".
- (5) Certain header support brackets are bent, and on some the bottom ligaments are torn out or have broken off.

- (6) Dowel pins are missing at six of eight locations inspected. Three dowel pins and two brackets have been retrieved from the steam annulus area in 1-2 SG.

- (7) There is evidence of wear on dowel pins and brackets.
- (8) The auxiliary feedwater nozzle thermal sleeve was not in alignment with the header on Unit #1 (1-1 SG).

The results of the video inspections indicate conditions similar to those previously reported. Six of the eight dowel pins in steam generator 1-2 and two in generator 1-1 are no longer in place. No broken brackets other than the two previously reported on generator 1-2 have been identified. The deformation of the header is not symmetrical; in some locations the outboard wall is indented (concave) as much as  $\frac{1}{2}$ " while in other areas little or no damage is noted. This non-uniform deformation has led to gaps between the header and shroud of as much as half an inch on generator 1-2 with less noticeable gaps in generator 1-1. In steam generator 1-2 the entire header has been rotated approximately  $\frac{1}{2}$  inch with respect to its vertical axis through the center of the steam generator and has shifted approximately  $\frac{1}{2}$ " away from the manway. No corresponding rotation was noted in steam generator 1-1, although a small off-axis shift has occurred.

Designation of Apparent Cause of Occurrence: Although the possible failure mechanisms are still being evaluated the damage appears to have been caused by the localized collapse of the steam bubble within the header during injection of cold auxiliary feedwater, resulting in large differential pressures across the walls of the header. This problem may have been complicated by the large thermal gradients which develop across the walls of the header material during an injection. The new external ring header design will not be subjected to similar failure mechanisms.

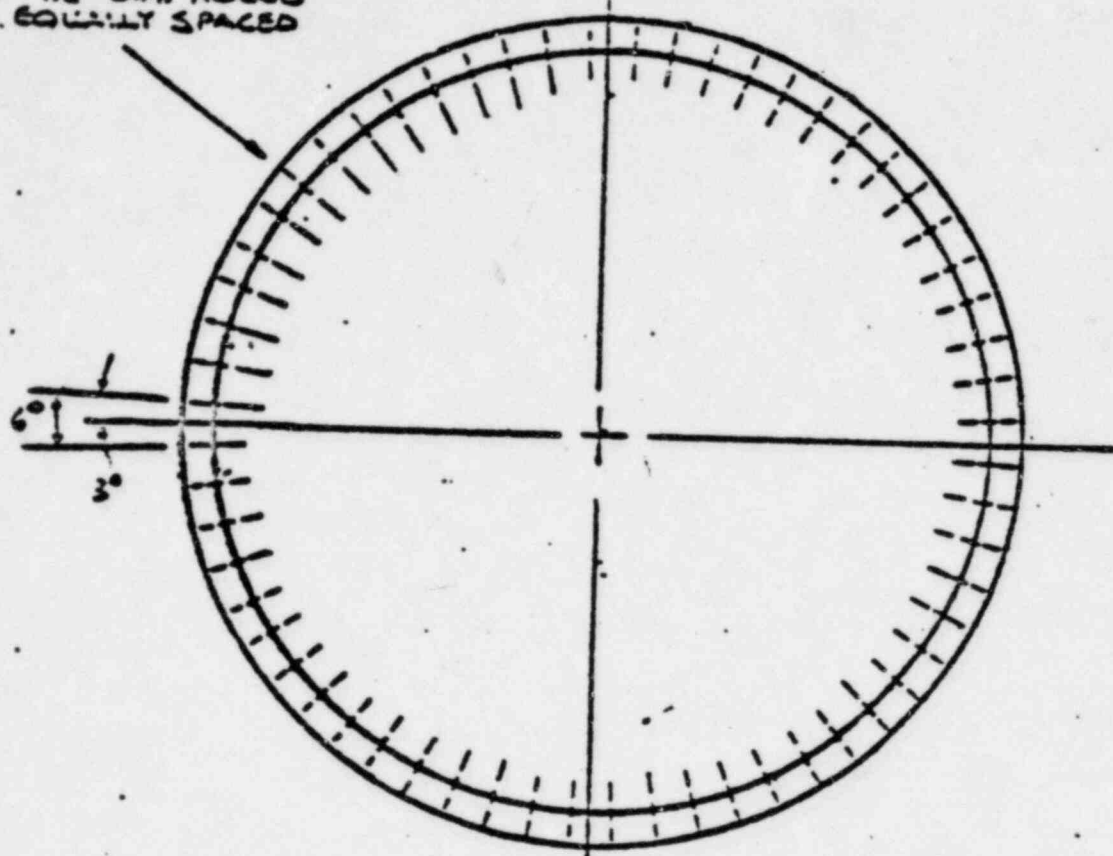
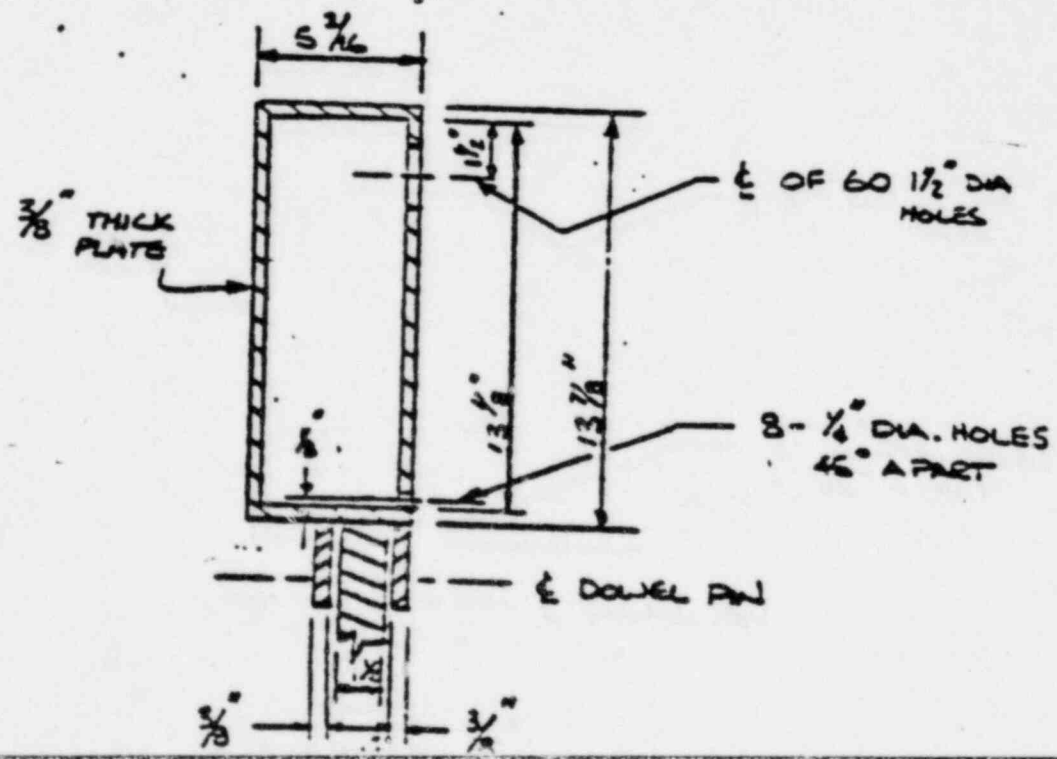
LOCATION OF AUXILIARY FEEDWATER

60 1/2" DIA. HOLES  
EQUALLY SPACED

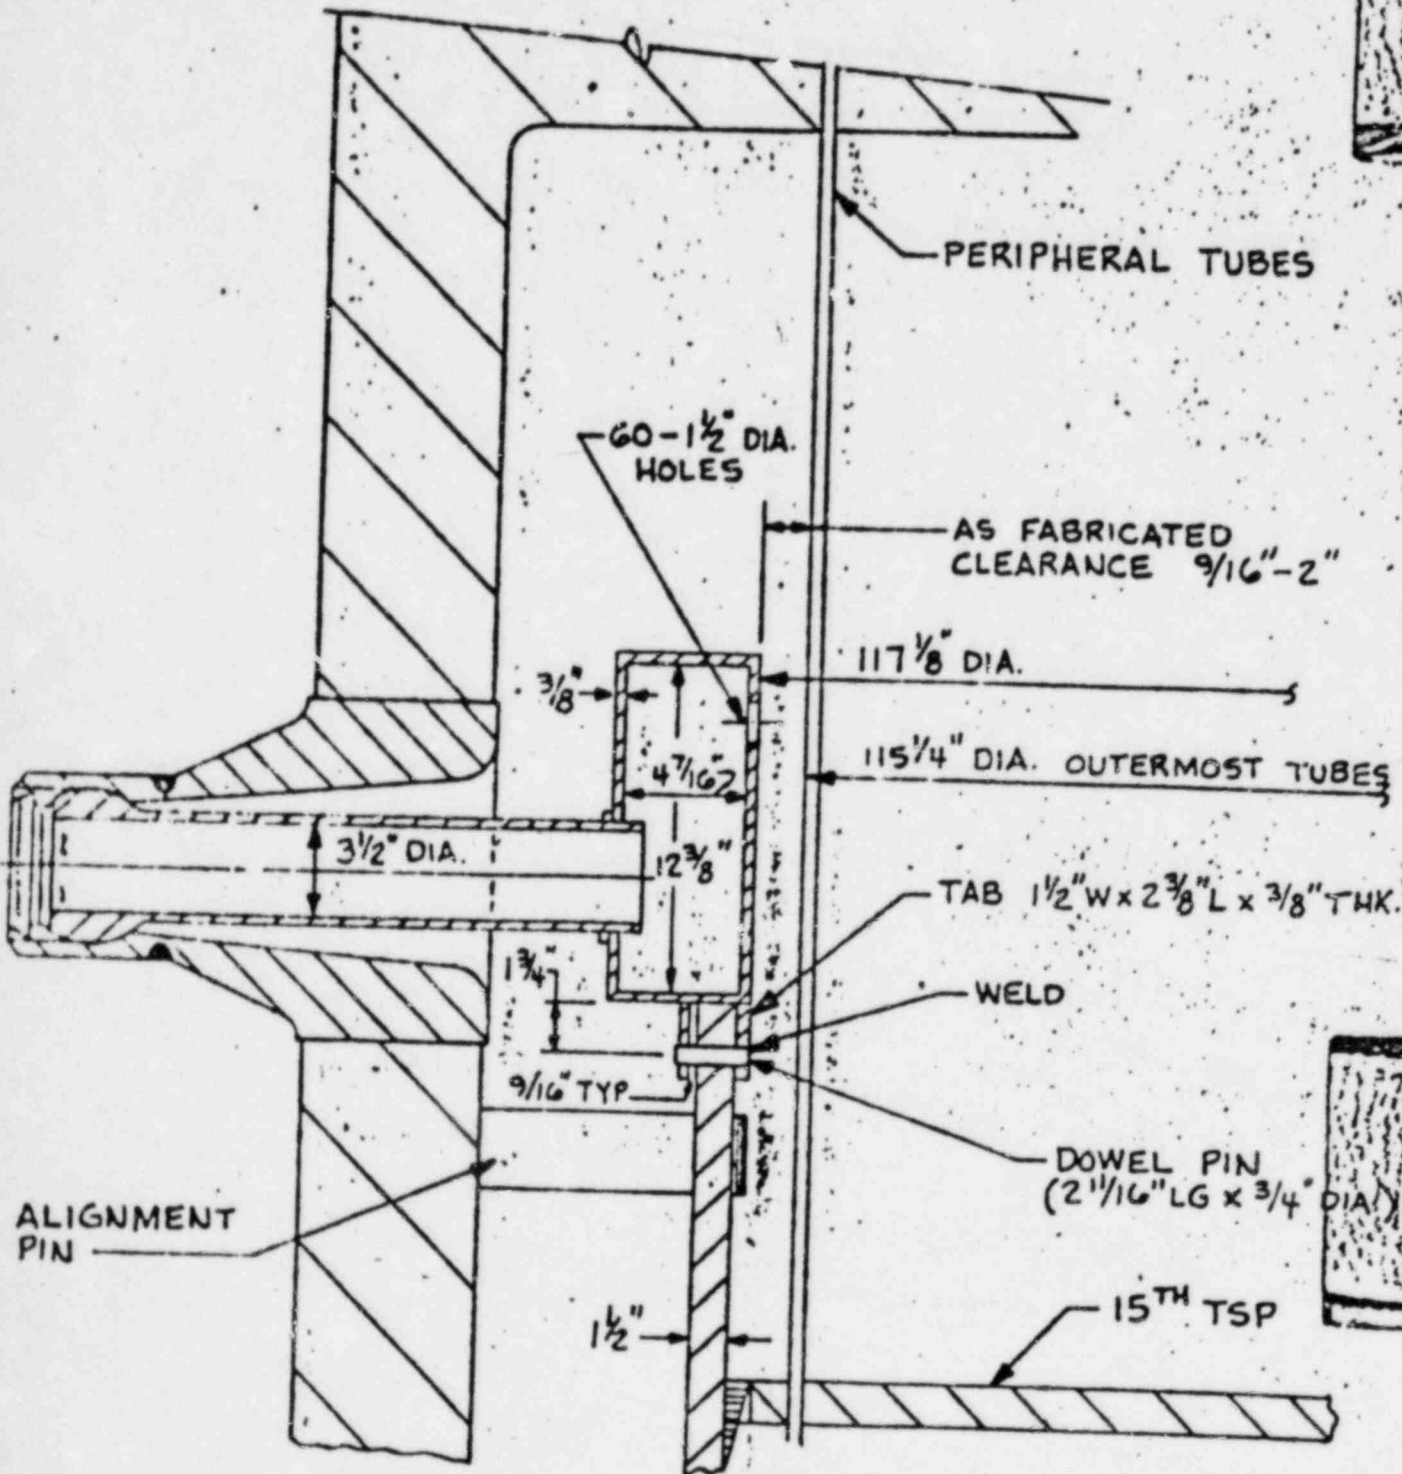
# Internal AFW Header Design Longitudinal Section

Apparent Cause of Occurrence: While analysis is still in progress, the apparent cause of the deformation of the internal auxiliary feedwater header is inadequate design to withstand the large thermal and pressure forces generated when cold auxiliary feedwater is injected into the header. During normal operation the header would be filled with super-heated steam as the header sits in the upper super heat region of the OTSG. When cold auxiliary feedwater (~80°F) is injected into the rectangular header, very large local pressure differences can occur with large steam-water contact areas which cannot be locally compensated for quickly enough through the 1½ inch diameter flow holes. Except for the extra strength weld areas the 3/8 inch plate walls are not reinforced and are apparently inadequate for the loads generated under these conditions. In addition to the possibly large pressure drop areas the header itself experiences very high thermal differences when the cold AFW enters the header and begins to fill from the bottom up and flows around the header from the single nozzle. While the exact failure process is not totally known, the above forces are believed to be the dominant factors.

Bracket No. 1 - This bracket was intact. The dowel pin was in place and protruding from the bracket approximately  $\frac{1}{4}$  inch towards the shell. There appeared to be some possible wear on the pin, but neither the bracket nor the pin were significantly bent or damaged. In the general area between Bracket No. 1 and Bracket No. 2, a gap of  $< \frac{3}{8}$  inch was observed over a distance of several feet between the bottom of the ring header and the top of the shroud. Tubes could be seen through the gap.

Bracket No. 2 - This bracket was very slightly bent towards the shell. There was no significant wear or ovalization of the bracket hole. The pin was observed to be recessed approximately  $\frac{1}{4}$  inch into the shroud. Some wear was observed on the face of the pin. The bracket header weld was intact.

Bracket No. 3 - This bracket was very slightly bent towards the shell. Slight wear was observed on the bracket hole, but no significant ovalization of the hole was observed. The dowel pin was completely out of the bracket but could be seen recessed into the shroud hole approximately  $\frac{1}{4}$  inch. The pin appeared to be in good shape. The bracket weld was not cracked. This bracket location was also observed from the inside of the header. The inside bracket was bent towards the tubes approximately one inch. The plug weld holding the pin to the bracket was broken. The pin was displaced from the bracket towards the tubes approximately  $\frac{3}{4}$  inch resulting in the pin almost and possibly touching a tube. There appeared to have been some erosion or wear on the tube where the dowel pin was in close proximity to the tube.

Bracket No. 4 - This bracket was bent approximately one inch out at the bottom. Some wear was observed on the dowel pin. The pin appeared to have

moved towards the bundle but was still in the shroud and bracket. The dowel pin and the hole in the bracket were slightly misaligned due to the bracket being bent. The hole in the bracket did not appear to be ovalized or have any significant wear. The bracket weld was intact.

Corrective Action: While exact repair plans are still being developed and are not yet finalized, the reuse of the internal AFW header is not likely. Depending on the findings of additional inspections the current plan is to stabilize the internal header in place and remove the AFW nozzle. The internal header would serve then merely as an extension of the inner shroud and would maintain steam cross flow at present distance above the 15th TSP.
