Nebraska Public Power District

CNSS903986

LICENSEE EVENT REPORT (LER)

TITLE (4)
Valve Stem Clamp Setscrew and Trim Failures Due to Vendor Design Deficiencies

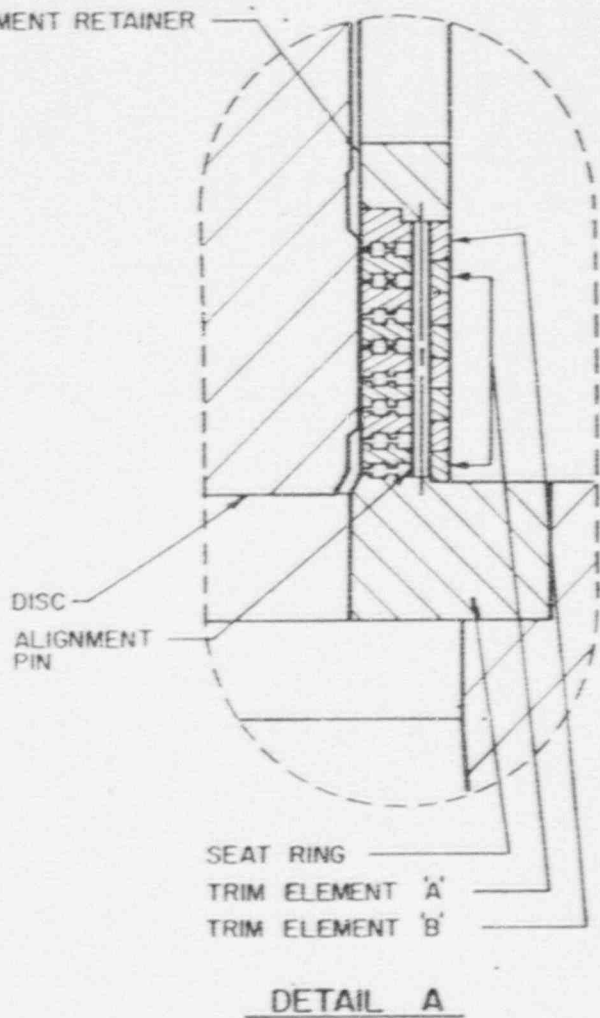
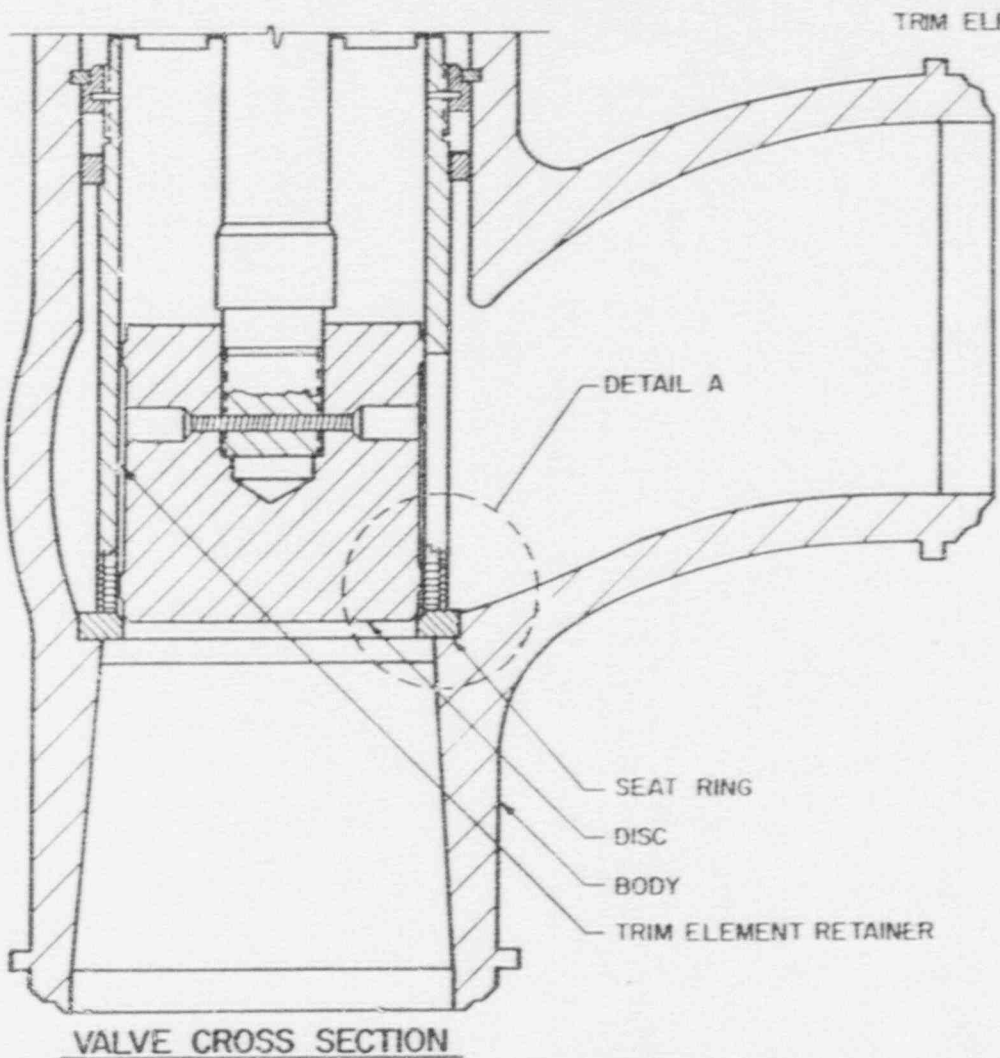
RHR-MOV-M027B

The throttling trim installed during the 1990 Refueling Outage (refer to the attached illustration) consisted of eight stainless steel rings approximately 1.5 inches wide and 0.25 inch high, with an outside diameter of approximately 18.5 inches. The rings included bosses approximately 0.38 inch by 1 inch by 0.25 inch high, on approximately 6 inch spacing, to separate the rings. The rings were held in alignment by two pins (approximately 0.38 inch diameter by 3.5 inches long). This trim was intended to improve the throttling characteristics of the valve and eliminate cavitation at the valve wall.

Upon disassembly, it was found that the two trim ring alignment pins, several bosses, and one piece of trim (approximately 6 inches long) were missing. The 6 inch piece of trim was recovered; the remaining parts are believed to have been carried through the RHR and recirculation piping and jet pumps, and now reside in the lower plenum region of the Reactor Vessel. Operation with the lost parts was evaluated by General Electric and determined to be acceptable. Temporary trim was designed and installed, and, following testing, the system was declared operable at 7:00 PM on October 29.

In the case of RHR-MOV-MO27B, it has been determined that the valve trim as designed and installed by Anchor/Darling was inadequate to withstand the internal dynamics of the valve while throttling flow, resulting in fatigue failure. This valve failed after approximately 130 hours of operation.

Following discovery of the RHR-MOV-MO27B failure, independent consultants and the vendor were engaged to conduct an intensive analysis to determine the cause of the failure. Based on the preliminary root cause determination, fatigue failure, it was decided not to install identical replacement trim. New trim was designed and installed on a temporary basis, and system testing accomplished satisfactorily.

The trim modification was designed, and parts supplied, for both RHR-MOV-MO27A and B. Since system testing required fuel in the Reactor Vessel, and fuel would be off-loaded for the 1990 Outage, the "A" train modifications were delayed. The trim for RHR-MOV-MO27A and B will be redesigned, and the temporary trim in RHR-MOV-MO27B replaced. Since this trim design is unique to RHR-MOV-MO27A and B, no additional components are affected.
