UNITED STATES  
NUCLEAR REGULATORY COMMISSION

SUBJECT: MARCH 16, 1994, MANAGEMENT MEETINGS

# South Texas Project Standby Diesel Generator Presentation To NRC Region IV Management

## Damaged Piston Photograph Legend

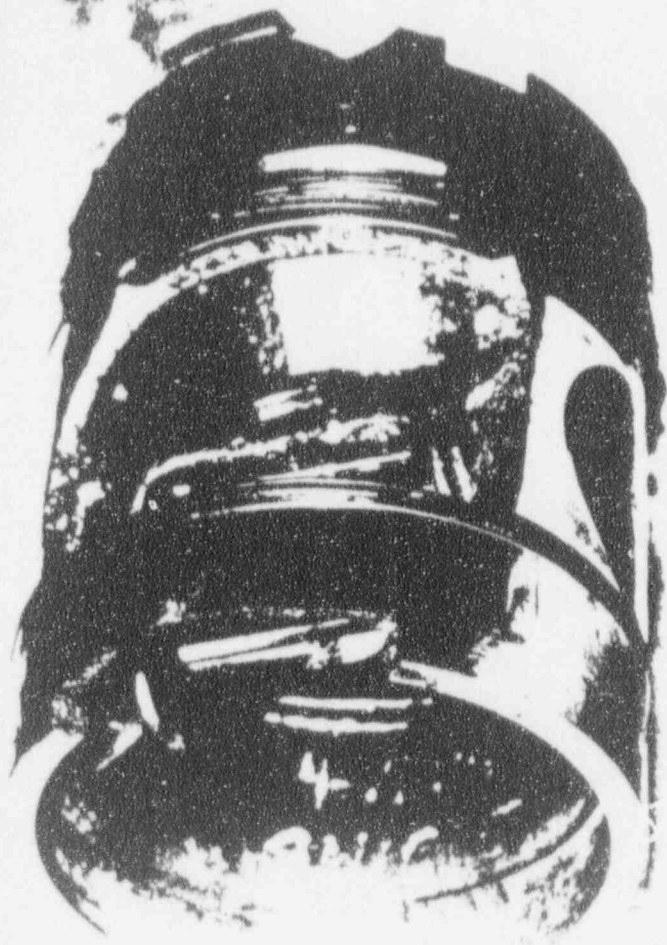
- NO. 4R PISTON
  - THRUST SIDE OF PISTON FRACTURED (FIGURE 1)
  - HEAT DISCOLORATION (FIGURE 3)
  - TIN LOSS (FIGURES 2 AND 3)

1. Damage to #4R piston as viewed from thrust side (piston laying on side). Heat discoloration and tin loss apparent from lower piston skirt.
2. #4R piston as viewed from the non-thrust side (piston upright). Tin loss on non-thrust side visible.

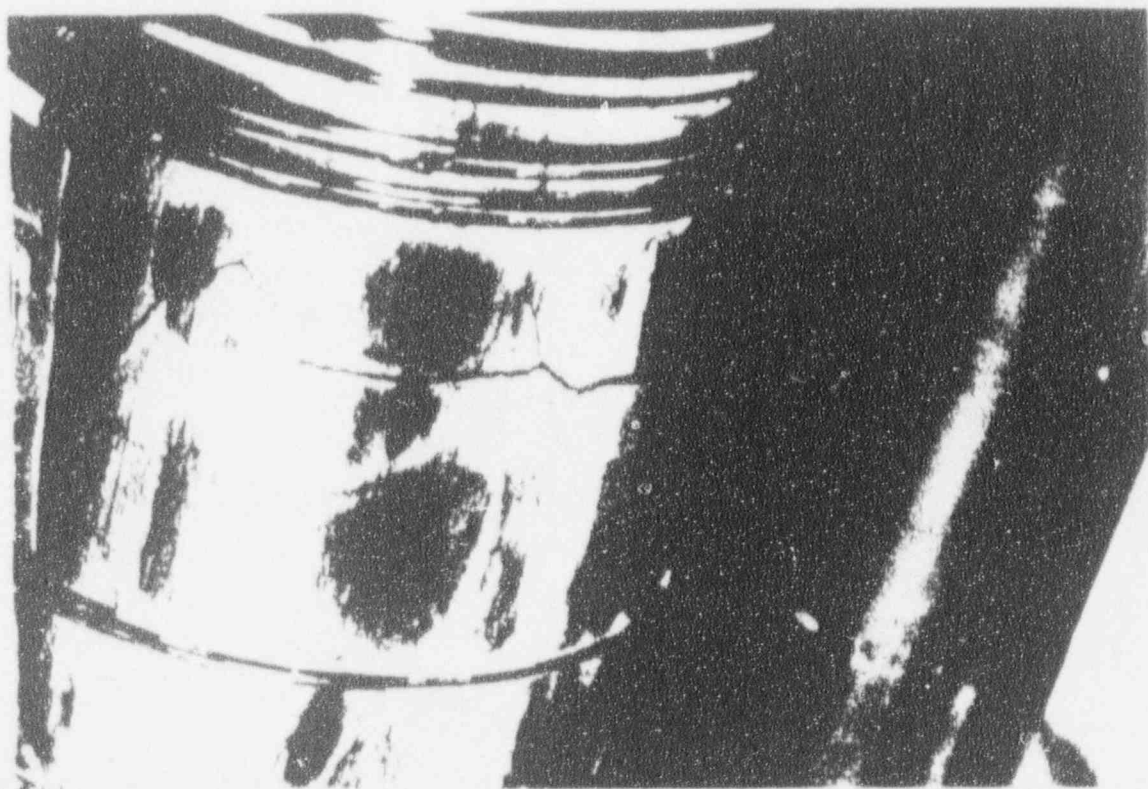
- SCUFF ORIGINATED ON LOWER SKIRT - THRUST SIDE
- TIN EMBEDDED IN LINER FROM SCUFF REDUCED LUBRICATION ON THRUST SIDE OF LINER
- REDUCED LUBRICATION CAUSED CONTINUED SCUFF/LOSS OF MORE TIN
- HIGH FORCES ON THRUST SIDE RESULTED IN HIGH SECTIONAL HEATING AND MECHANICAL FORCES
- HIGH TEMPERATURES CAUSED REDUCED MATERIAL STRENGTH, THERMAL GROWTH AND THERMAL STRESSES
- REDUCED MATERIAL STRENGTH RESULTED IN THRUST SIDE FAILURE
- NON-THRUST SIDE TIN TRANSFER DUE TO THERMAL GROWTH
- INITIAL SCUFF CAUSE UNKNOWN BUT COULD BE THE RESULT OF GRIT, DIRT, PISTON/LINER IRREGULARITY OR POTENTIAL IMPACTS FROM THE 1989 EVENT

3. #4R piston thrust side damage between #6 & #7 oil control rings with fractured pieces installed (piston laying on side). Heat discoloration, tin loss and scuffing visible.

- NO. 4R PISTON AND LINER REPLACEMENT
- OTHER SDG NO. 22 PISTON AND LINER REPLACEMENTS
- REMOVAL OF LOWER OIL RINGS AND END CAPS ON ALL OTHER SDG NO. 22 PISTONS

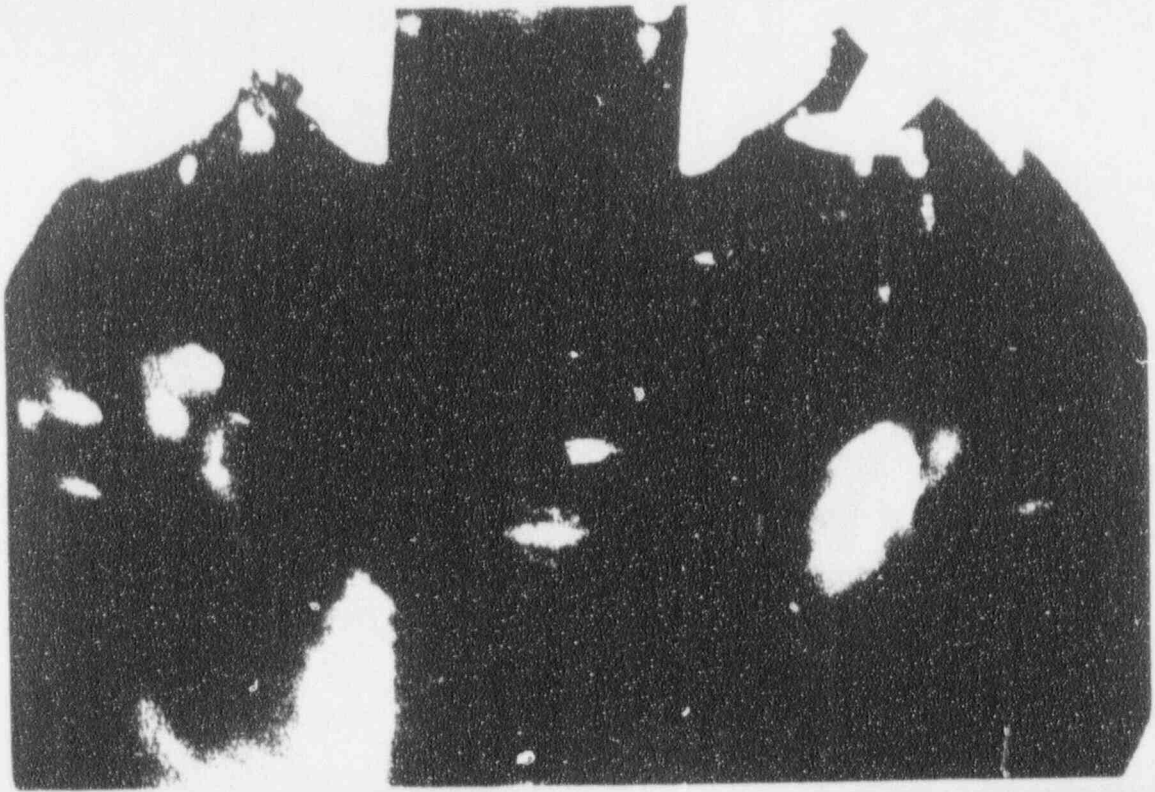
4. View of the thrust side #4R cylinder liner. Scuffing visible.
5. Damage to #4R piston as viewed from thrust side (piston upright). Heat discoloration of piston skirt remaining intact is visible. No damage to piston pin boss and bushing are visible from this picture.

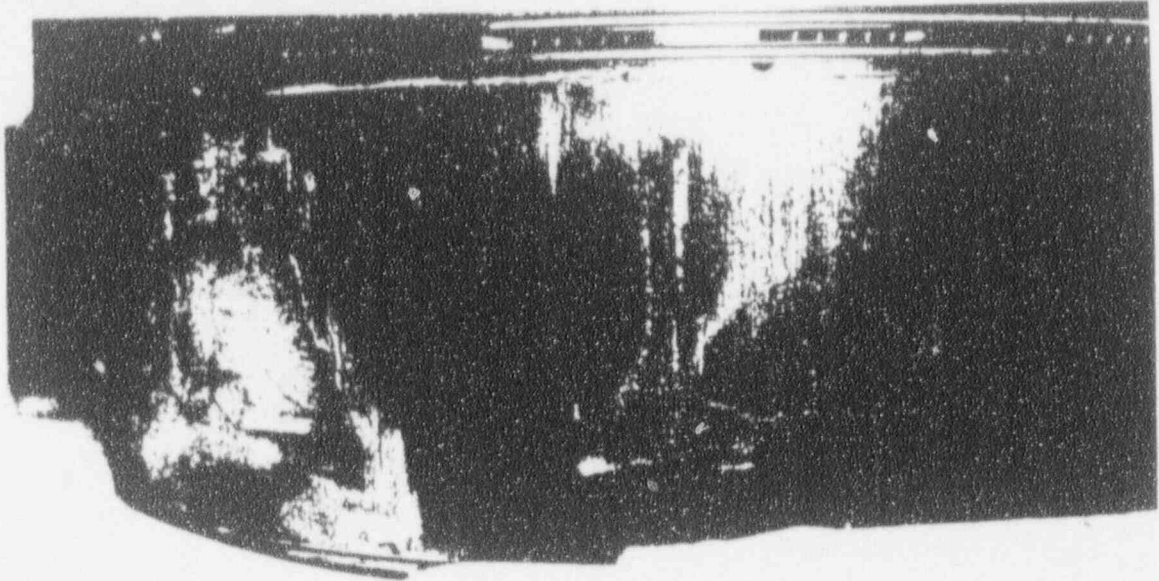
7. Lower #4R piston skirt damage on the thrust side at about the 2 o'clock position. Heat discoloration, tin loss and scuffing are all visible.
8. View from the bottom of the fractured #4R piston at the #6 ring land area. Fracture of the piston at the #6 oil control ring land, but below the oil drain hole, is visible.

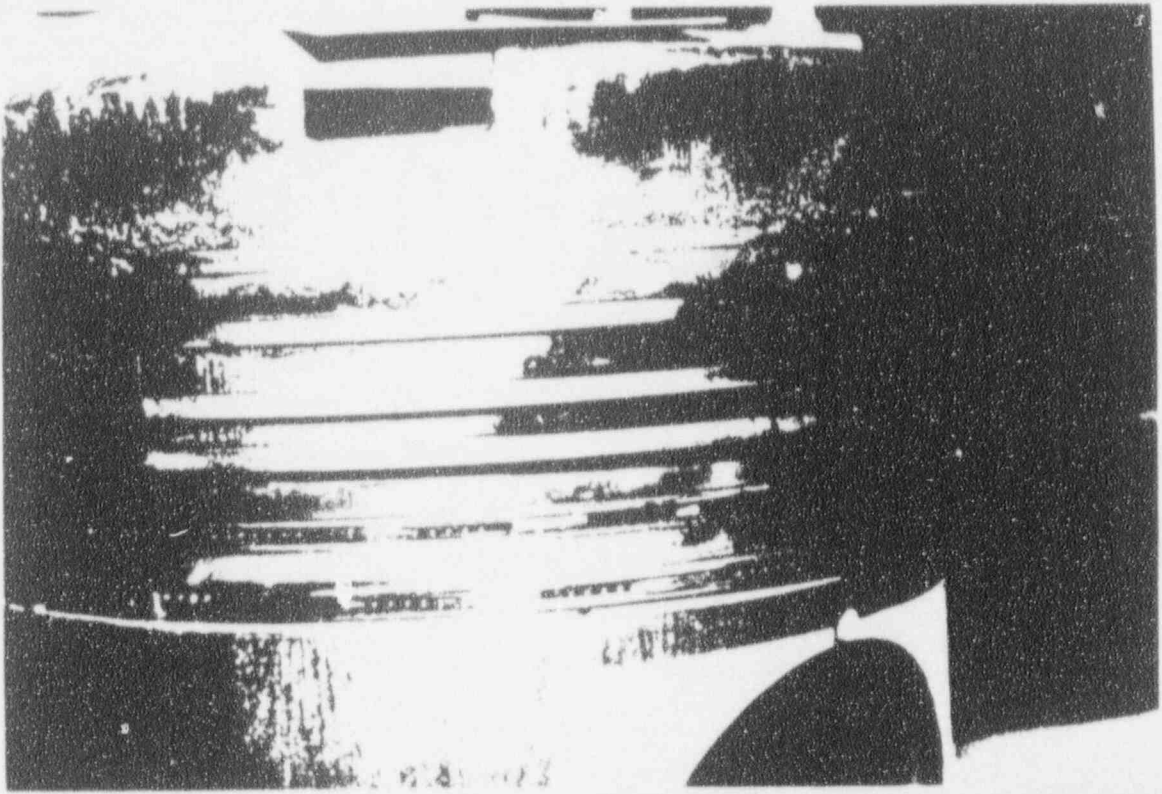
9

9. #4R piston upper ring land area as viewed from the non-thrust side (piston upright). Some carbon build-up above the top compression ring is visible with relatively insignificant amounts of carbon down to the fourth (and last) compression ring. No carbon is visible below that point. None of the rings were found stuck due to carbon.

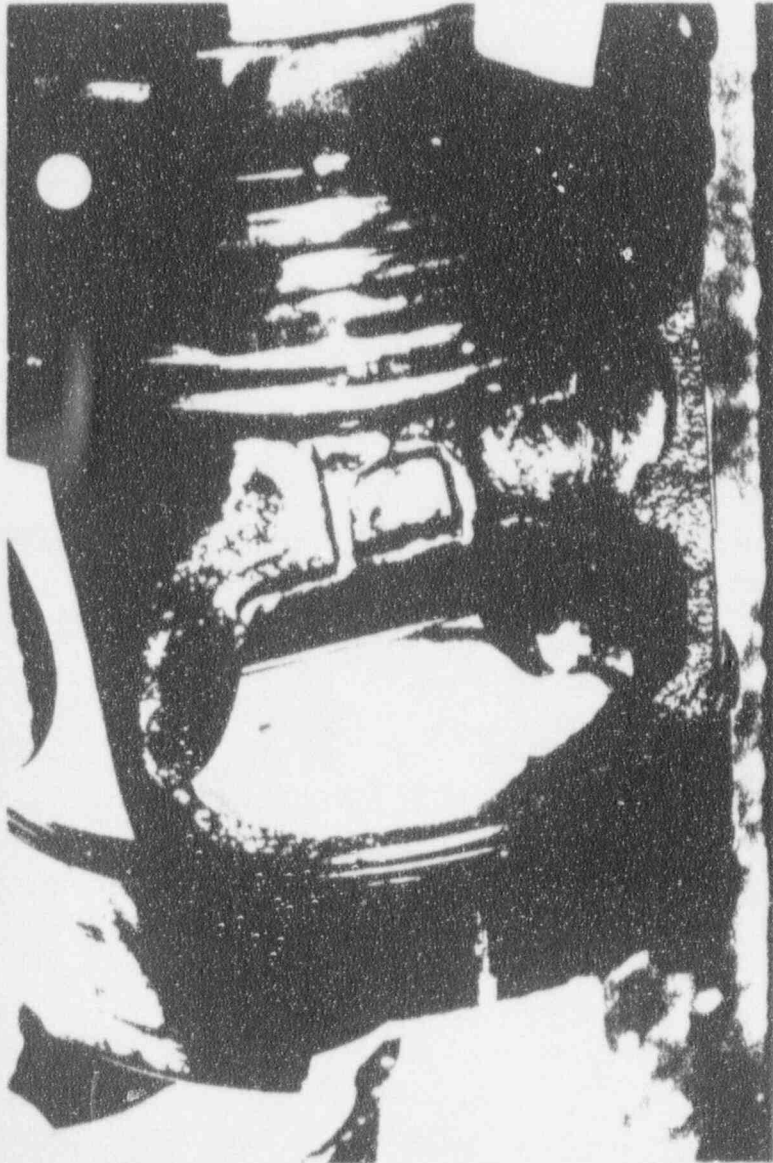
10

10. #4R piston damage as viewed from thrust side with piston pin installed (piston upright). The lower (#7) oil control ring fracture area is visible.
11. #4R piston damage as viewed from thrust side with piston pin removed (piston upright). Full view of damage to the thrust side is visible.
