COMMONWEALTH EDISON
ZION STATION UNITS 1 AND 2

STEAM GENERATOR
GIRTH WELD REPORT

DECEMBER, 1990

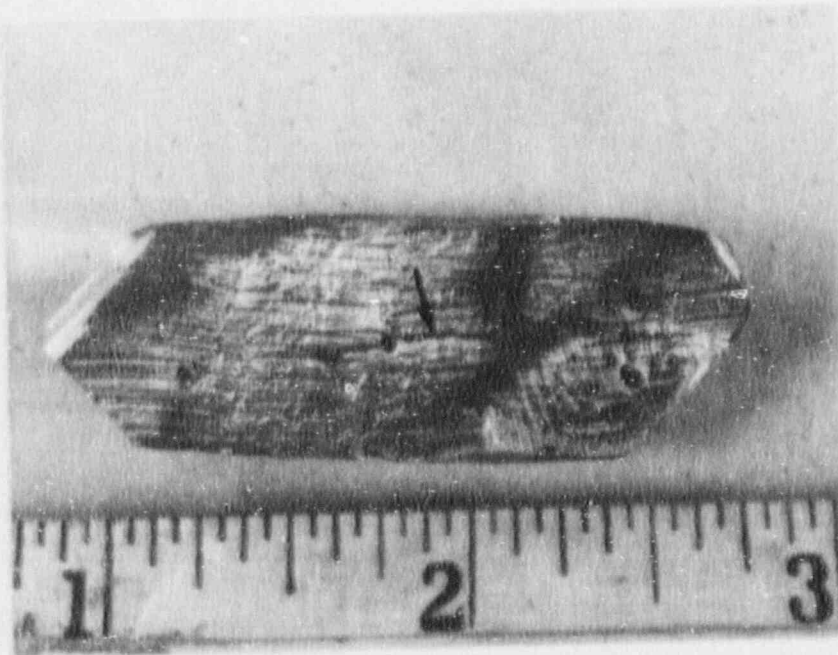
The as-removed boat sample is shown in Figure 1. The surface indication which appeared as a crack measured 5/8" in length and appeared filled with oxide. Several deep pits were observed at random locations on the surface of the sample.

Figure 1. The boat-shaped sample as-removed from the 1A S/G at Zion Station. The arrow indicates the location of the surface flaw. Note the extent of pitting attack on the surface of the sample.

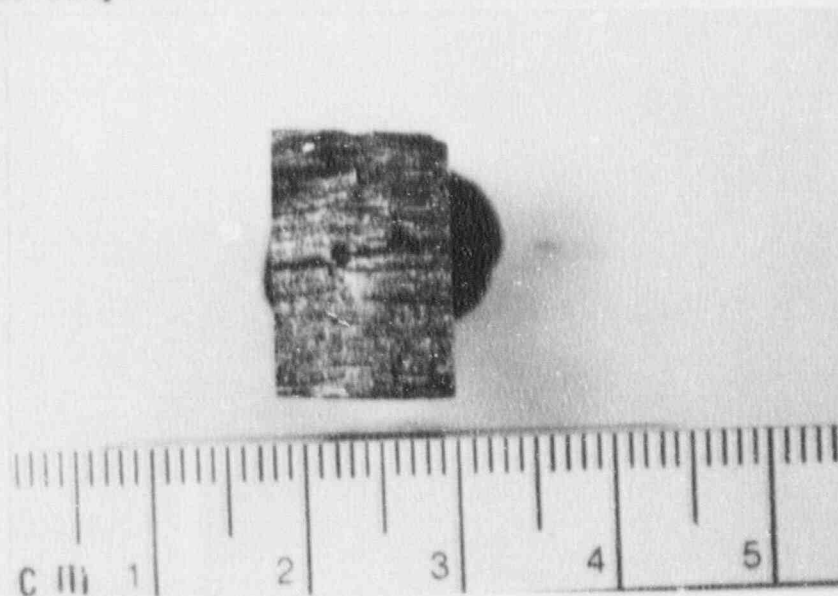
The sample was downsized (as shown in Figure 2) by sectioning it into three pieces. This was done so that SRI could perform the FRASTA method on the largest portion of the crack tip. The remaining sections of the sample were evaluated by CeCo. After the sample was sectioned at SRI, the crack depth was measured to be 0.220".

Figure 2. The portion of the boat-shaped sample after it was sectioned at SRI for the FRASTA evaluation.

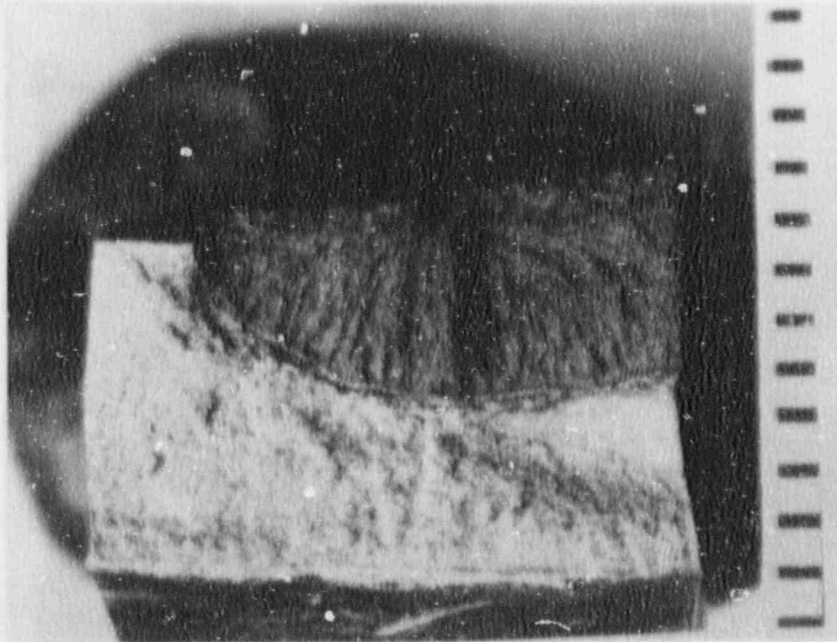
The largest section of the sample was fractured open at -320°F to examine preexisting crack surfaces. An examination of the crack surfaces revealed a heavily oxidized appearance with a configuration similar to a "thumbnail" shape (refer to Figure 3). Radial markings observed on the crack surface appeared to emanate from the base of a large surface pit.

Figure 3. View of one of the crack surfaces showing an oxidized texture and 'thumbnail' shaped appearance.

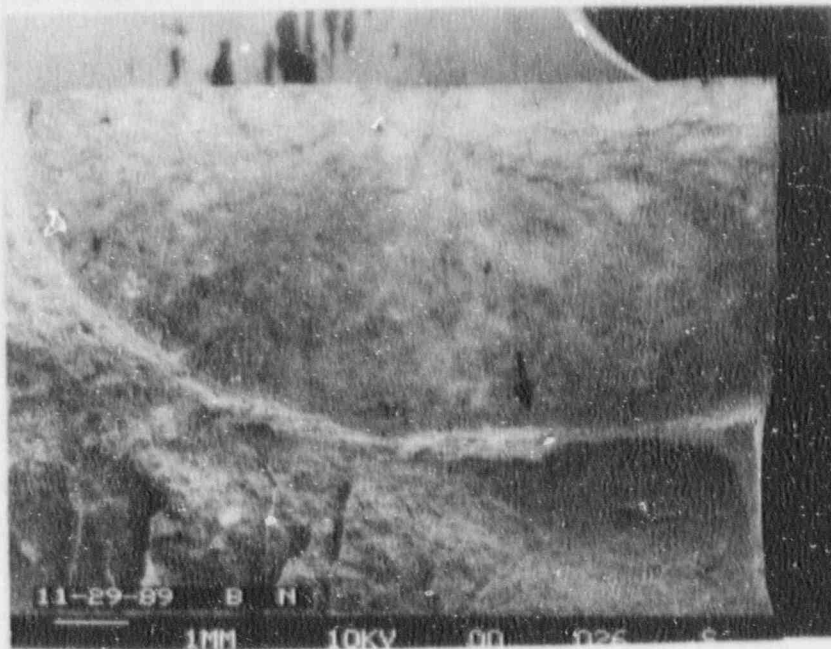
Scanning Electron Microscopy (SEM) was performed at SRI on the conjugate crack surfaces. One of the surfaces, as shown in Figure 4, exhibited a heavily oxidized texture and adjacent to the crack tip there was a change in the oxide morphology. This region was narrow (approximately 400 microns), less oxidized and had a flat fracture appearance (refer to Figure 5). Numerous secondary cracks in this region that were observed were fissures

Figure 4. Scanning electron micrograph (SEM) showing the crack surface morphology and crack tip region (arrow).

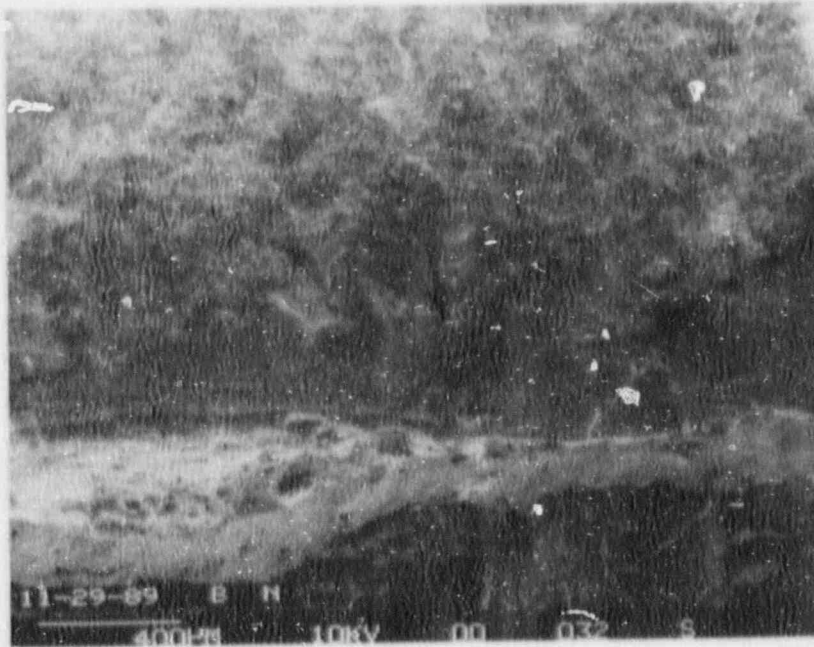
Figure 5. SEM photograph showing the narrow, flat fracture region at the crack tip (arrow).

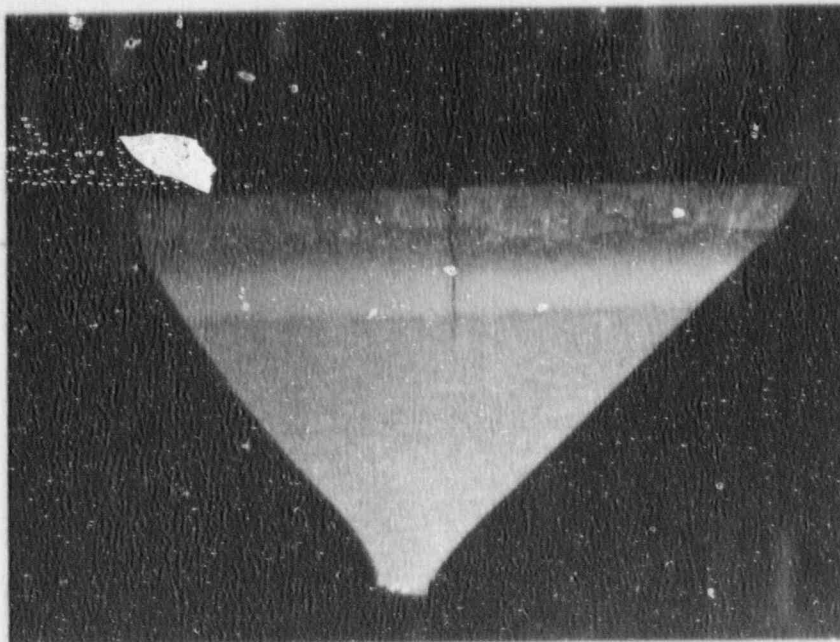
The sample was prepared for metallographic examination and the cross-section of the entire sample (approximately 3/8" away from one end of the crack) is shown in Figure 6. A 1/16" layer of weld deposit was discovered on the steam generator ID surface of the sample. This weld deposit appeared uniform in thickness. An EDS of the weld metal revealed an Fe K (alpha) peak and a smaller Ni K (alpha) peak. The chemical composition of the steam generator shell base material was verified to meet the requirements of ASME SA-533, Grade A, Class 1 material.

The crack exhibited minor branching and appeared to have initiated at the base of a corrosion pit (refer to Figure 6). The crack surfaces were oxidized and the crack tip, shown in Figure 7, was transgranular and filled with oxide. These types of features are indicative of corrosion fatigue crack propagation. While the FRASTA evaluation was unable to quantitatively define crack growth rates, the crack growth rates were found to be slow in the weld material, slightly increased in the heat affected zone (HAZ) and slowed again in the base metal. The cracks appeared to become blunted in the base metal and may become arrested there.

Figure 6. Cross-section of the crack-containing sample showing the crack location, corrosion pit and weld deposit.

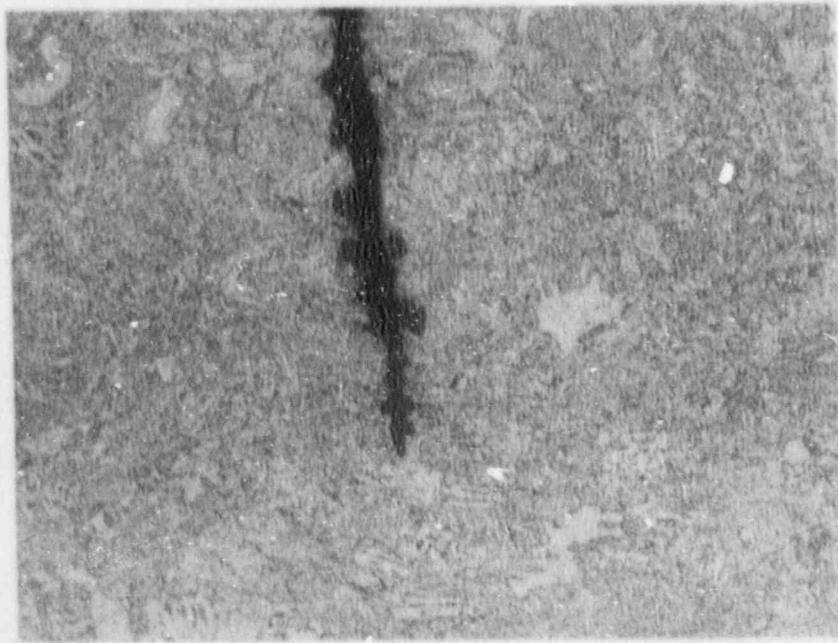
Figure 7

The indication removed (s a boat sample from steam generator A was identified as a corrosion fatigue crack that initiated and propagated from the base of an oxide filled pit.

Photomicrograph showing the transgranular crack morphology and oxide-filled crack tip. These features are characteristic of corrosion fatigue crack propagation.

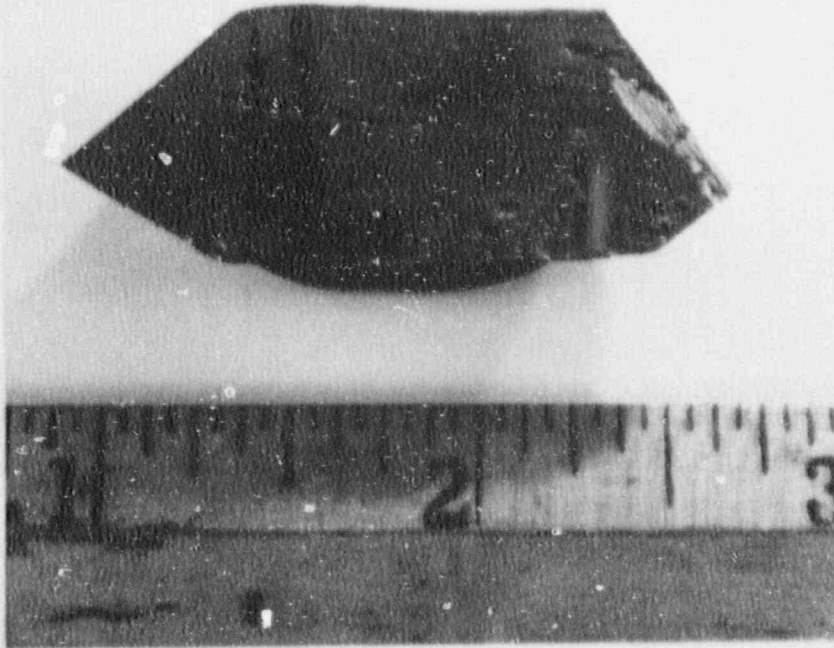
The boat sample removed from the A steam generator is shown in Figure 1. Visual examination of the sample revealed a 1/2" long crack, which upon closer examination was a series of corrosion pits that linked-up. The crack was linear and filled with oxide. Also, the surface of the boat sample representing the ID of the steam generator had a uniform layer of oxide (magnetite).

Figure 1
Sample removed from the Unit 2, 'A' S/G at Zion Station.
The crack on the ID surface is indicated by the arrow.
Note the corrosion pits on the sample surface.

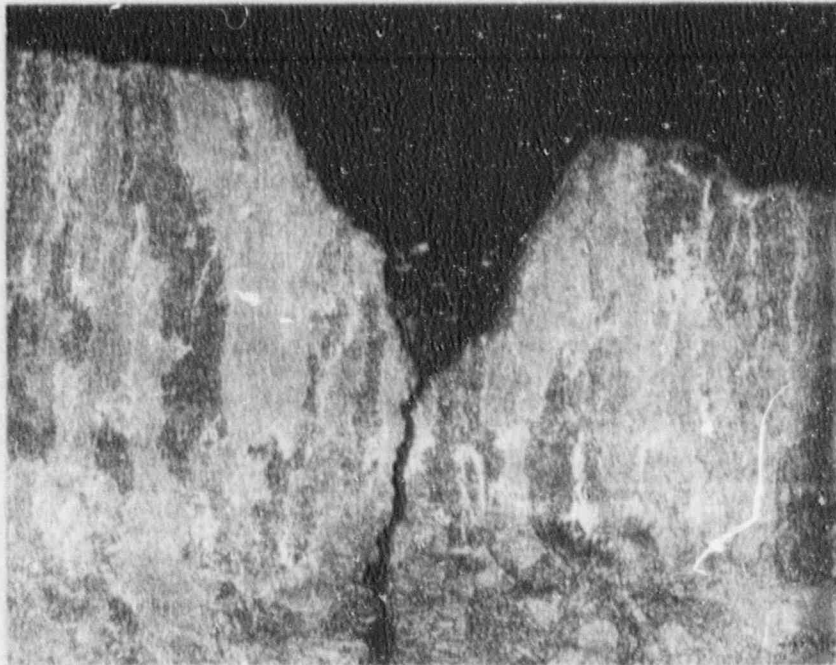
The sample was cross-sectioned at a location approximately 1/4" from one end of the crack to examine the crack morphology. This revealed the crack had propagated from the base of the corrosion pits into the heat affected zone (HAZ) and base metal of the steam generator shell. The crack depth was approximately 0.150". The corrosion pits which preceded the crack measured 0.020" to 0.030" in depth in the girth weld metal, as shown in Figure 2. The crack morphology was predominantly transgranular with a minor amount of branching at the crack tip, as shown in Figure 3.

Figure 2
Photomicrograph showing the crack at the base
of a surface pit. The pit is located in the
girth weld (50 x mag, etched: 2% Nital).

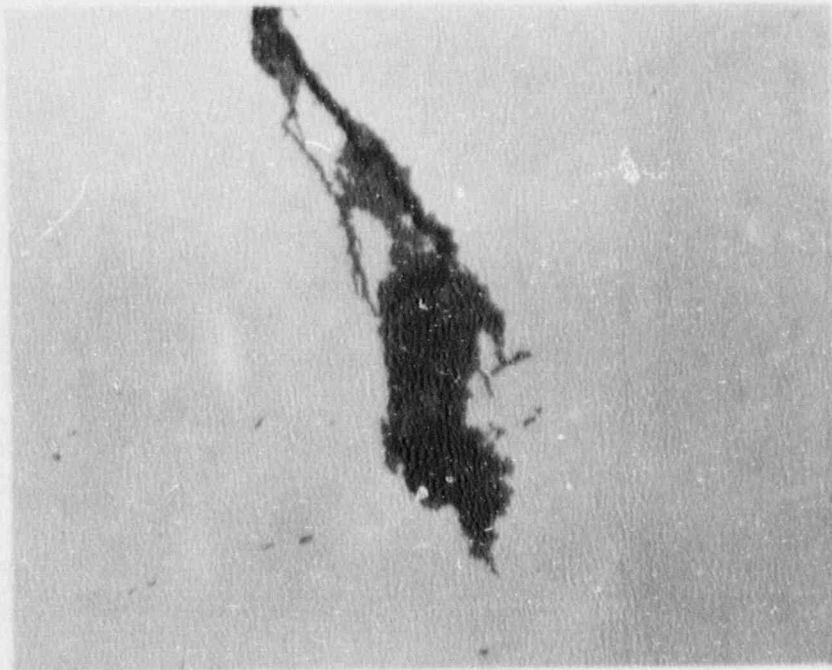
Figure 3
Photomicrograph showing the local corrosion
and branching at the crack tip
(200 x mag, unetched).

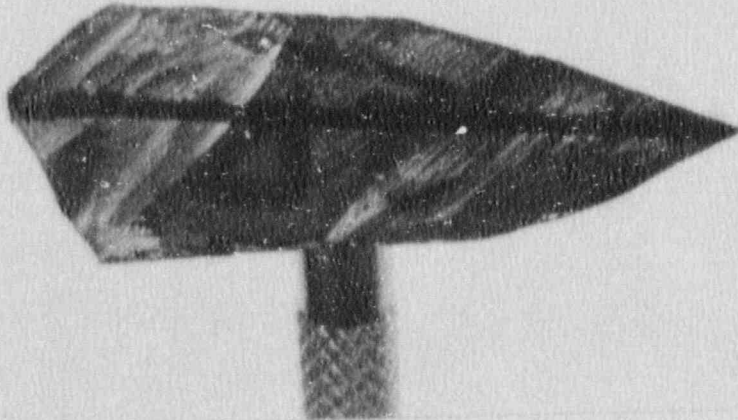
The sample from the D steam generator was similar in size to the sample from the A steam generator, except it was intended to contain a subsurface flaw and had an orientation perpendicular to the girth weld. The sample is shown in Figure 4. Visual examination of the sample surface (representing the ID surface of the steam generator) revealed random corrosion pits measuring up to 0.010" in depth and a uniform deposit of oxide (magnetite).

Figure 4
The as-received sample from the Unit 2 'D'
steam generator at Zion Station. The sample
measures 2.5" in length x .150" in depth.

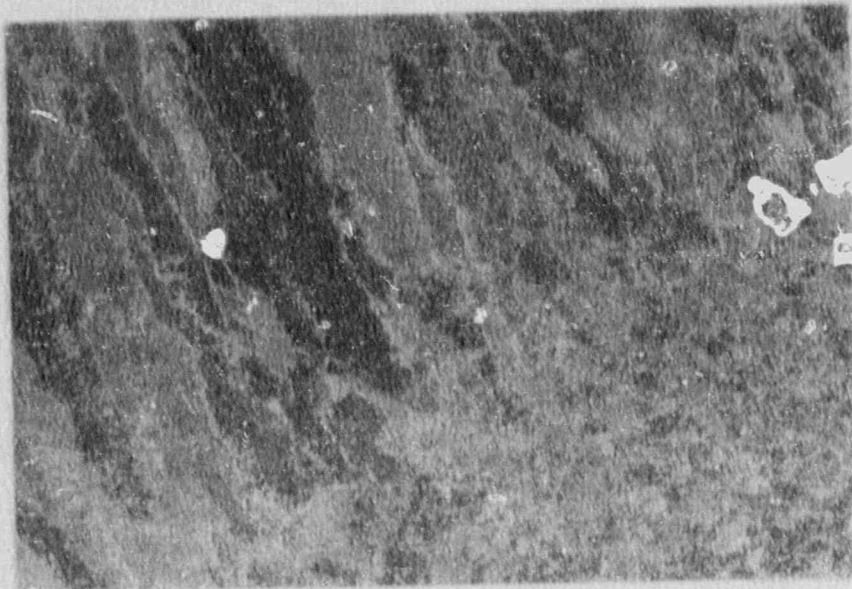
Microhardness testing was performed on the girth weld, HAZ and the steam generator shell base metal. The results of the microhardness tests revealed a hardness of 200 VHN for the weld, 330 VHN for the HAZ and 190 VHN for the base metal. The girth weld and HAZ microstructures are shown in Figure 5.

Figure 5
Photomicrograph showing a section of the girth
weld fusion zone in sample 2D. The HAZ microstructure
consisted of slightly tempered martensite and bainite.
(50x Mag., etched: 2% Nital)
