NORTH ANNA UNIT 1
STEAM GENERATOR IMPACTED TUBE ENDS
RECOVERY EVALUATION

OCTOBER 1982

WESTINGHOUSE ELECTRIC CORPORATION
NUCLEAR SERVICE INTEGRATION DIVISION
P.O. BOX 2728
PITTSBURGH, PA 15230

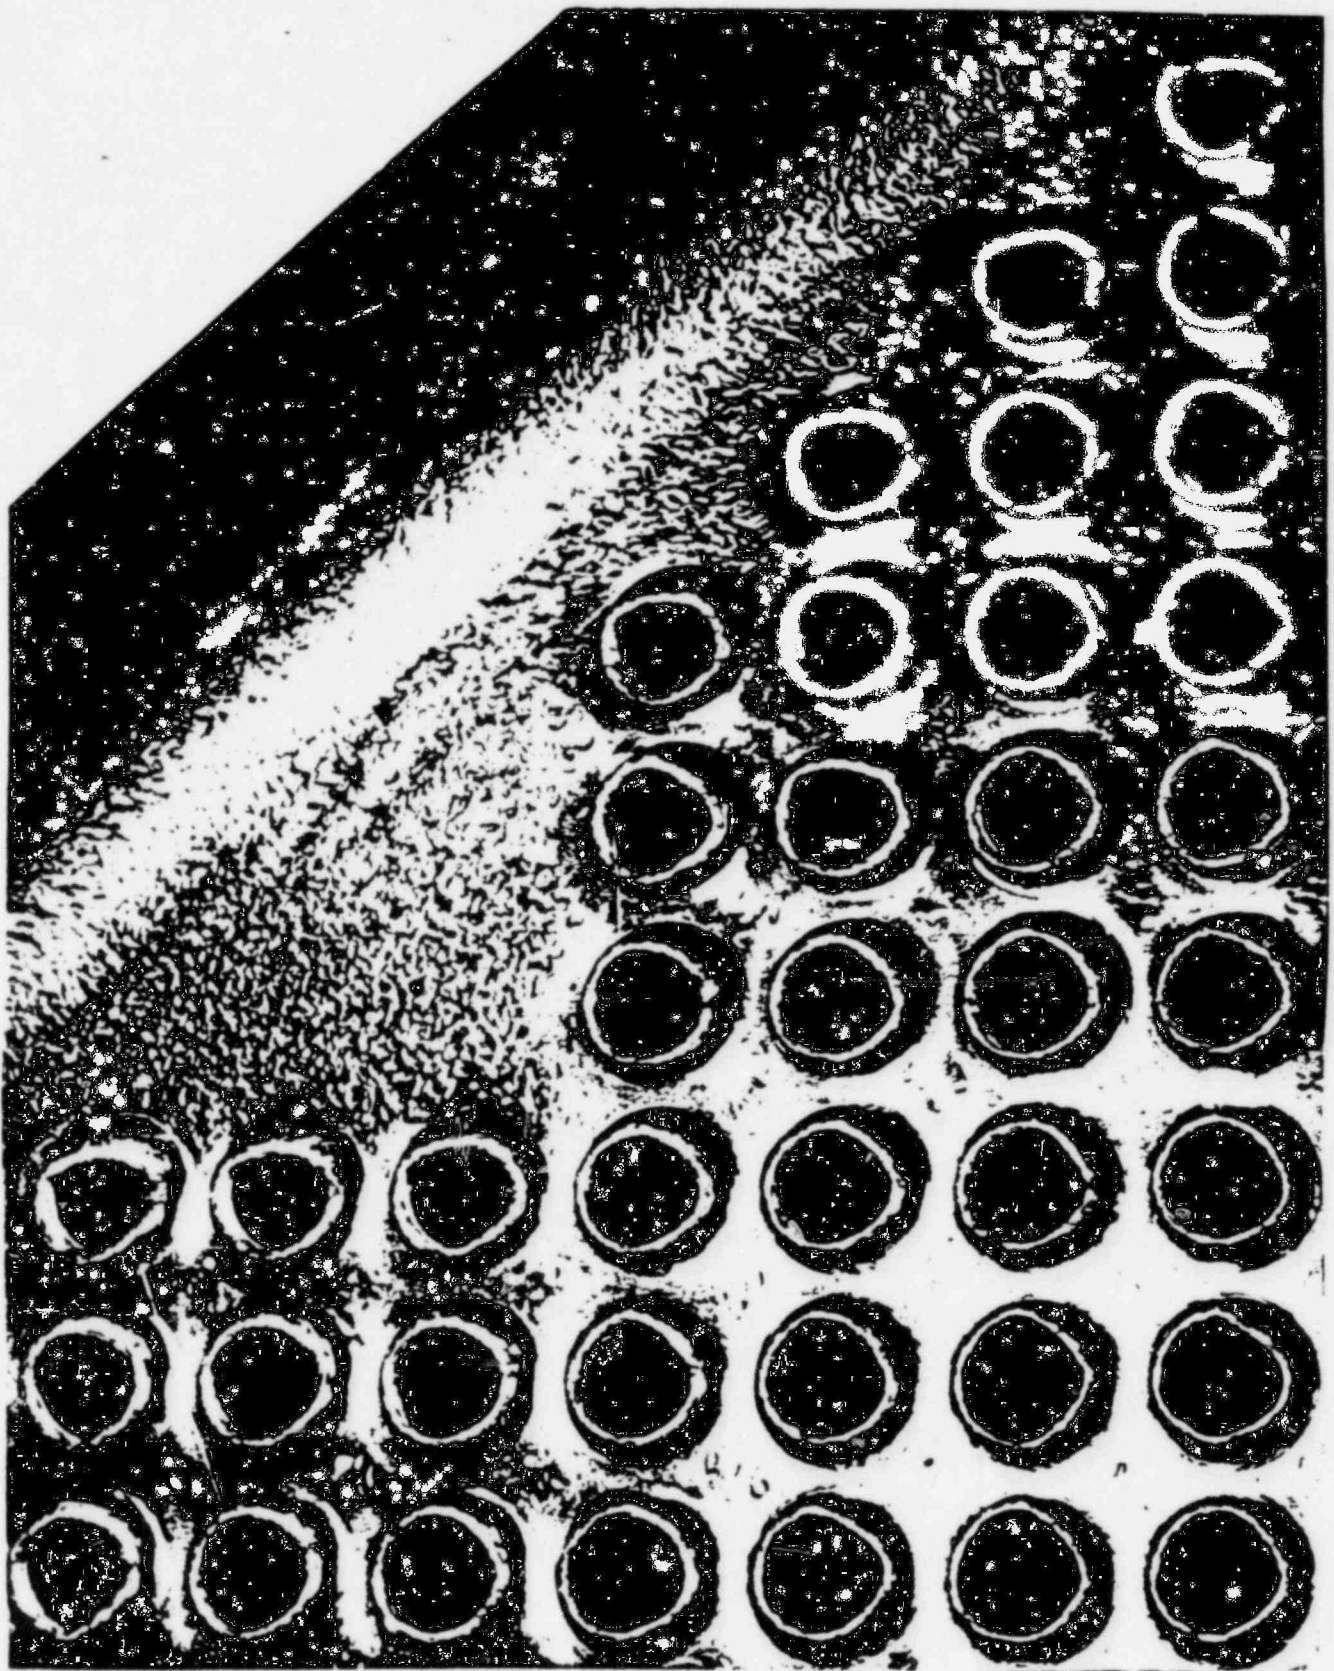
Figure 3 Steam Generator C Inlet
Tubesheet, Rows 29-37,
Columns 13-19, -1X

Figure 3 shows a typical region in Steam Generator "C" that includes the tube sheet to channel head bowl joint. Note that the tube end peening is light, the tube sheet peening is light, and the channel head bowl peening is extensive, though moderate. Note also that the tube ends have been bent more than was observed in Steam Generator "A", particularly in the region adjacent to the channel head bowl. The shape of the bending, coupled with the channel head bowl peening, suggests that the impacting object(s) ricocheted off of the channel head bowl and against the tube ends from the side.

Figure 3 also shows that many of the tube ends away from the channel head bowl sustained very minor deformation. This condition is typical of a large portion of the tube sheet in Steam Generator "C".

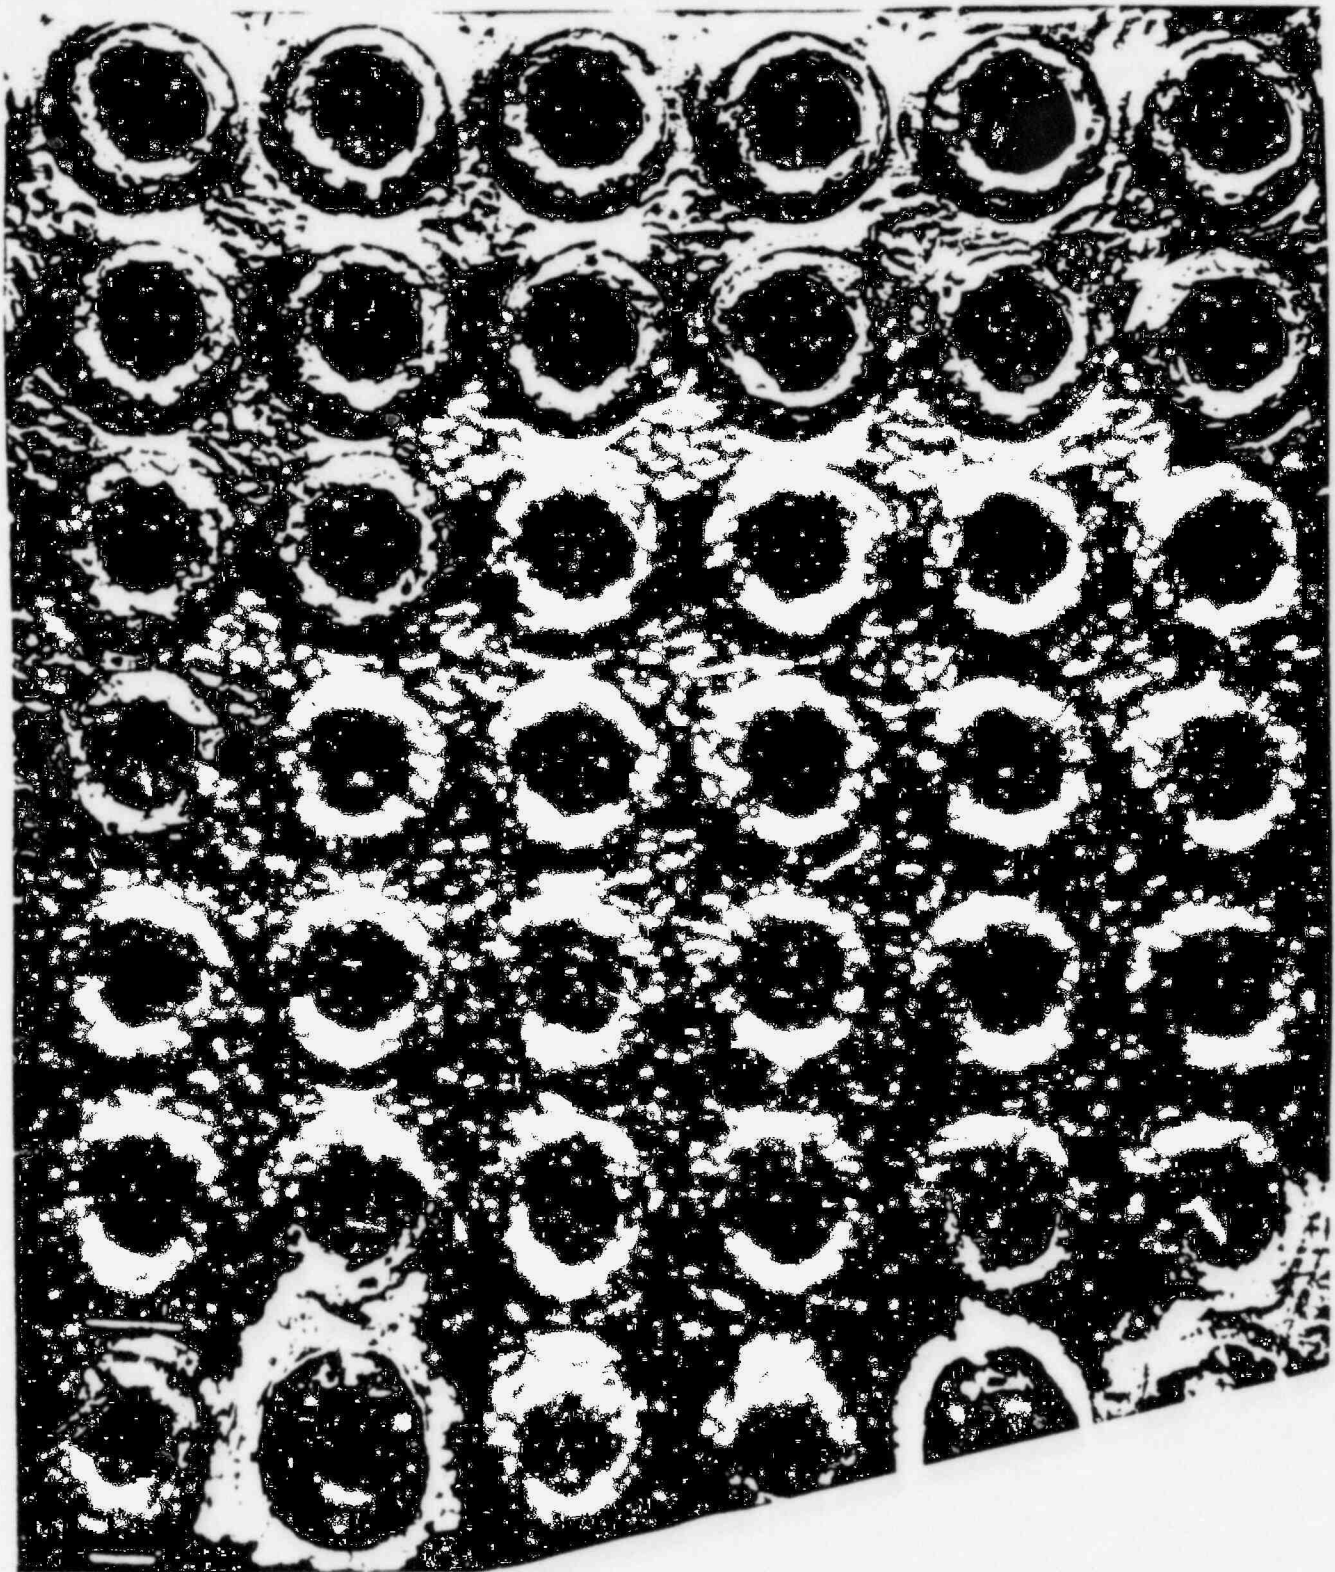
Figure 5 Steam Generator C Inlet
Tubesheet, Rows 1-7,
Columns 40-45, -1X

Figure 5 is typical of the tube ends in the central region of Steam Generator "C" adjacent to the divider plate (first 8 to 10 rows). Note the heavy tube end peening, the missing and potentially missing tube end fragments, and the reduced tube end flow passages.

fragments of material that are missing from the tube ends. It has also produced fragments that are partially separated from the tube ends and are "potentially missing". (See, for example, Figures 5 and 8b.)

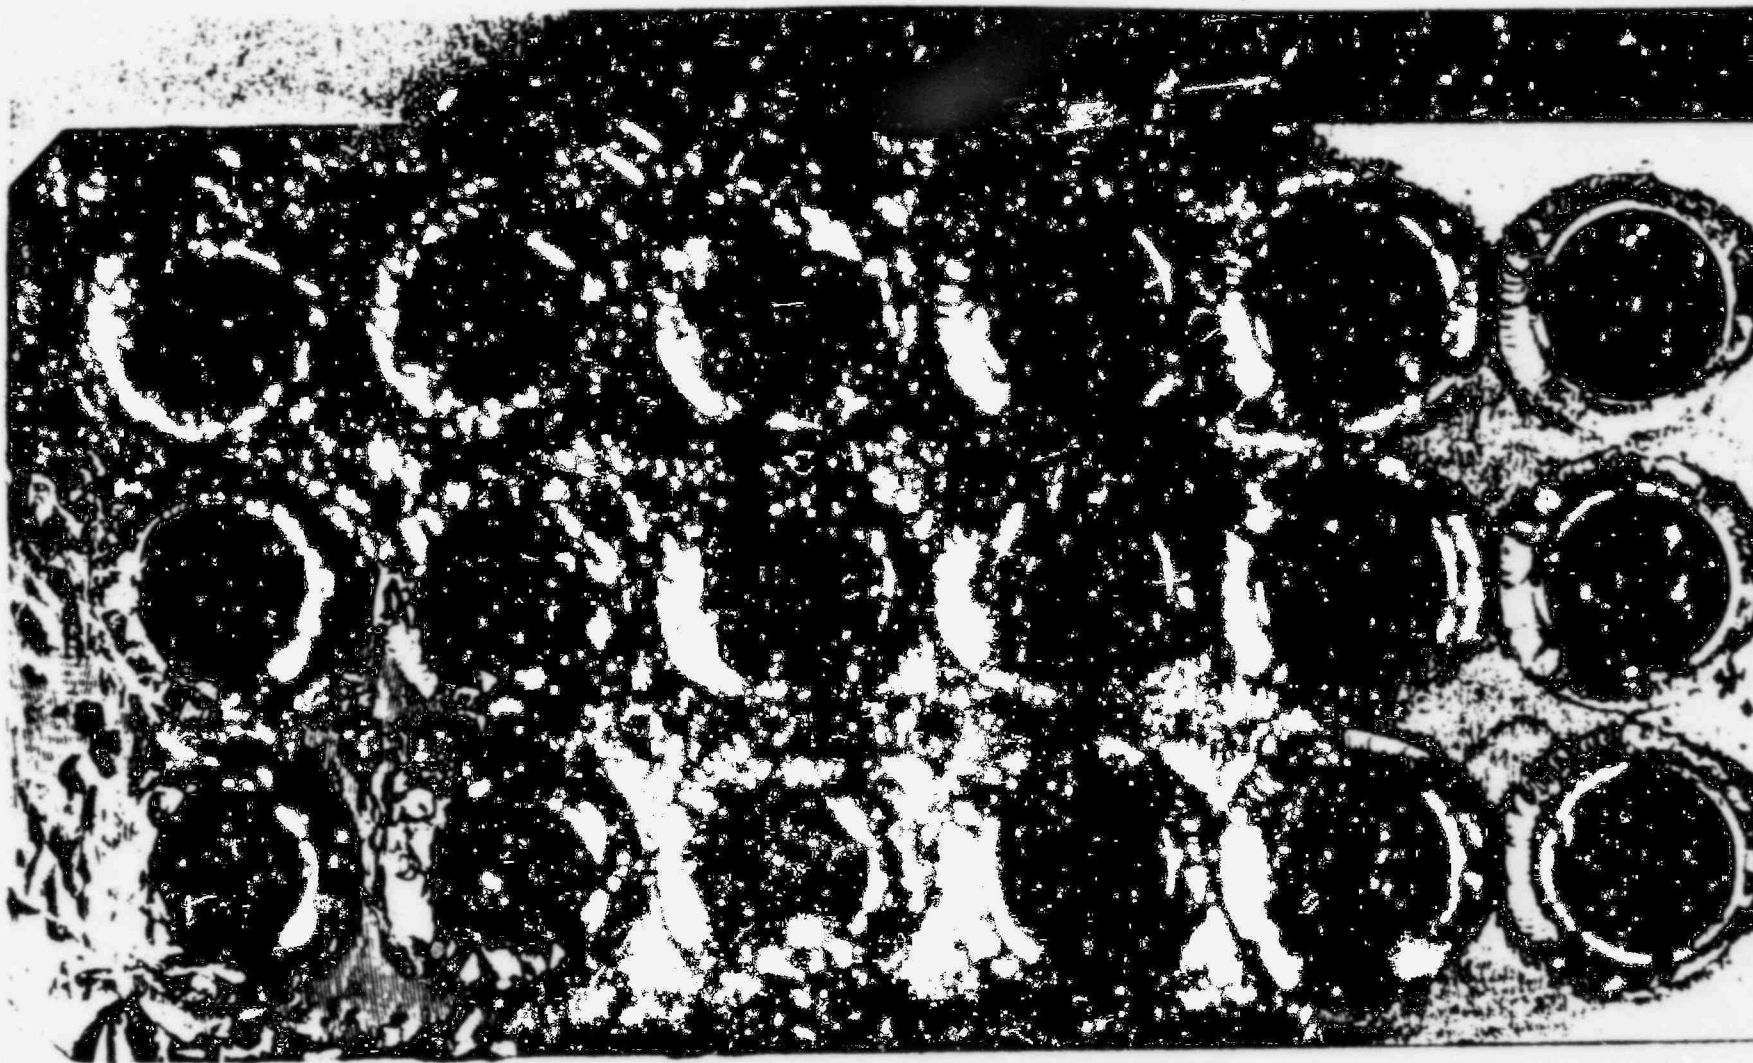
Fig. 12 Steam Generator Tubesheet Mockup Before (9 tubes) and After (9 tubes) intentional Representative Impaction, Rows 1-3, Columns 1-6, -IX

tional photographs were taken of the test block. Figure 12, the test block at a magnification of 1X, shows nine tube ends before impactation and nine tube ends after impactation. Figure 13 shows four of the more heavily affected tube ends at a magnification of 3X. The three worse impacted tube ends were selected for metallurgical examination. These tube ends, include heavy peening and cracking (type b.), peening (type c.) and peening on the weld area (type e.). Figure 14, 15 and 16 show representative macrographs, at 7X, of tube and tubesheet mockup axial sections.

The results of the test showed that some of the fillet welding had been flattened and covered by the deformed tube ends. However, the photographic examination of the deformed tubes showed no indication of weld degradation. Metallurgical macrographs through the weld/tube interface did not disclose any cracking. Cold work indications on the deformed area were observed.

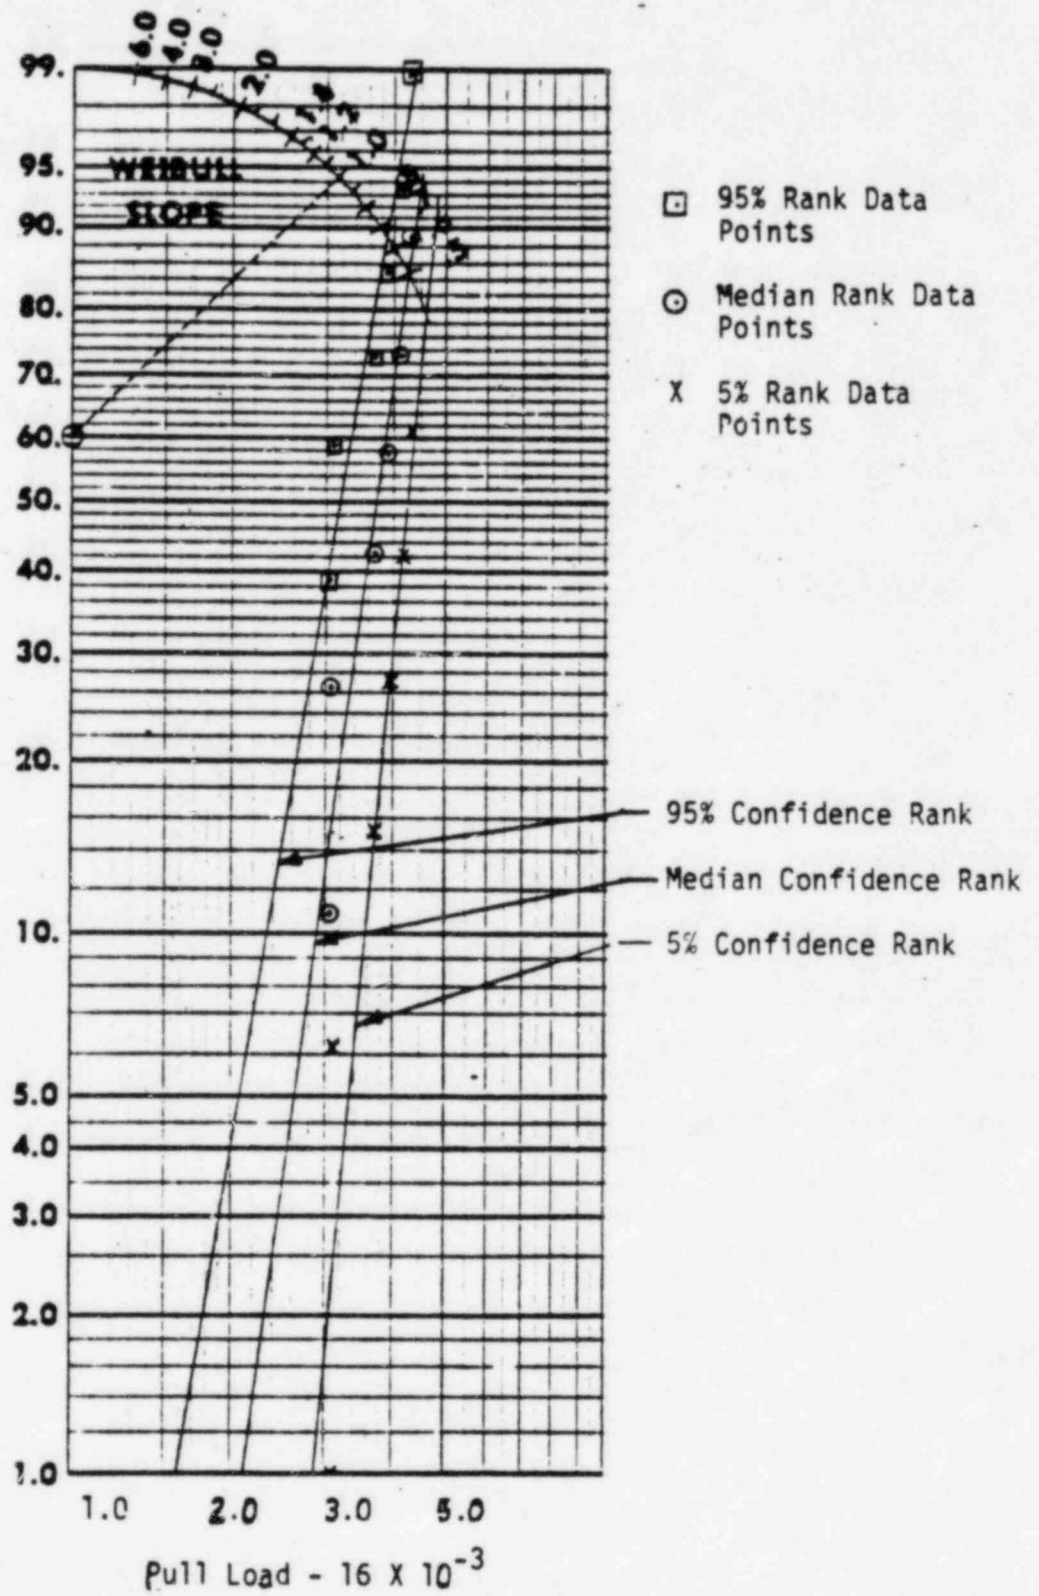
Figure 18 Weibull Distribution for Tube to Tubesheet Pull Tests

It is seen from Figure 18 that with 95% confidence the probability of failure is less than 1% and, therefore, the reliability is greater than 99%. These calculations are conservative due to the following:

From Figure 18, it is seen that with 95% confidence the probability of failure is less than 1.0% and, therefore, the probability that the joint will hold (its reliability) is greater than 99%.

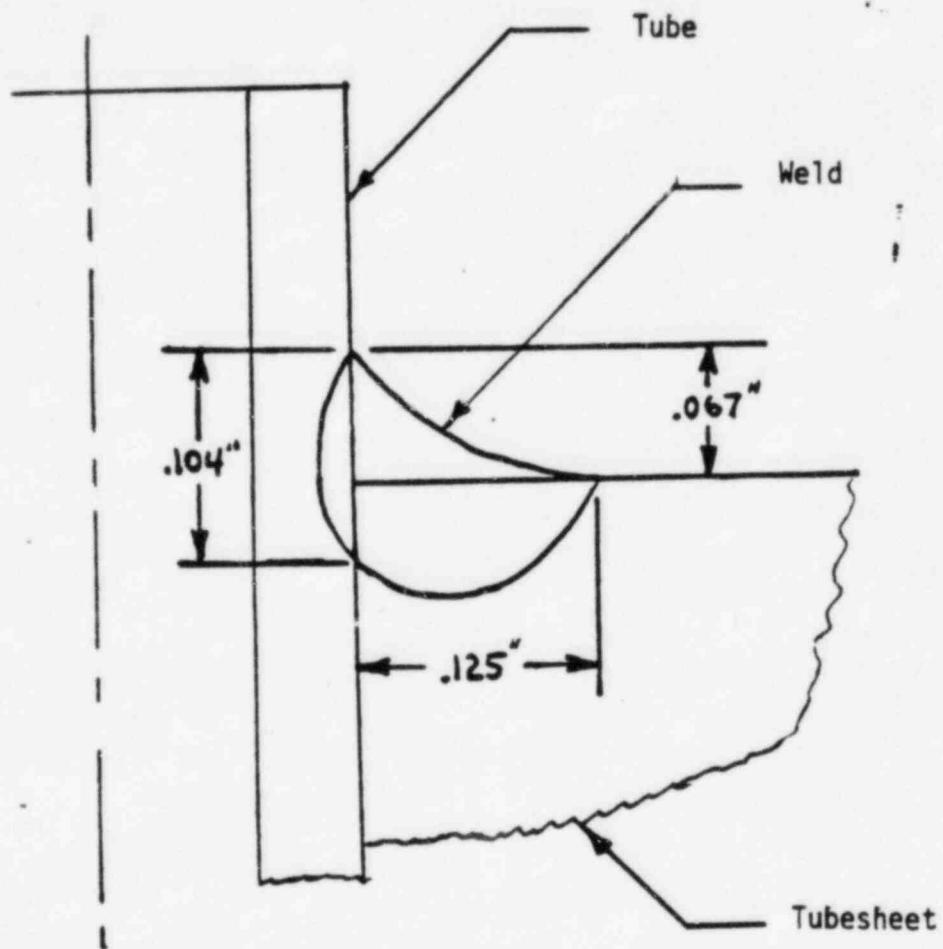
Figure 19 Tube-To-Tubesheet Weld Geometry

From evaluation of the macrographs of the simulated impaction tube end tests, reasonable engineering judgement would indicate that the majority of weld below the primary side surface is still available to carry the load. From Figure 19 it is seen that approximately 0.037 in. of fused metal is below the primary side surface. These dimensions were determined during the initial weld qualification tests. For the Design Condition:

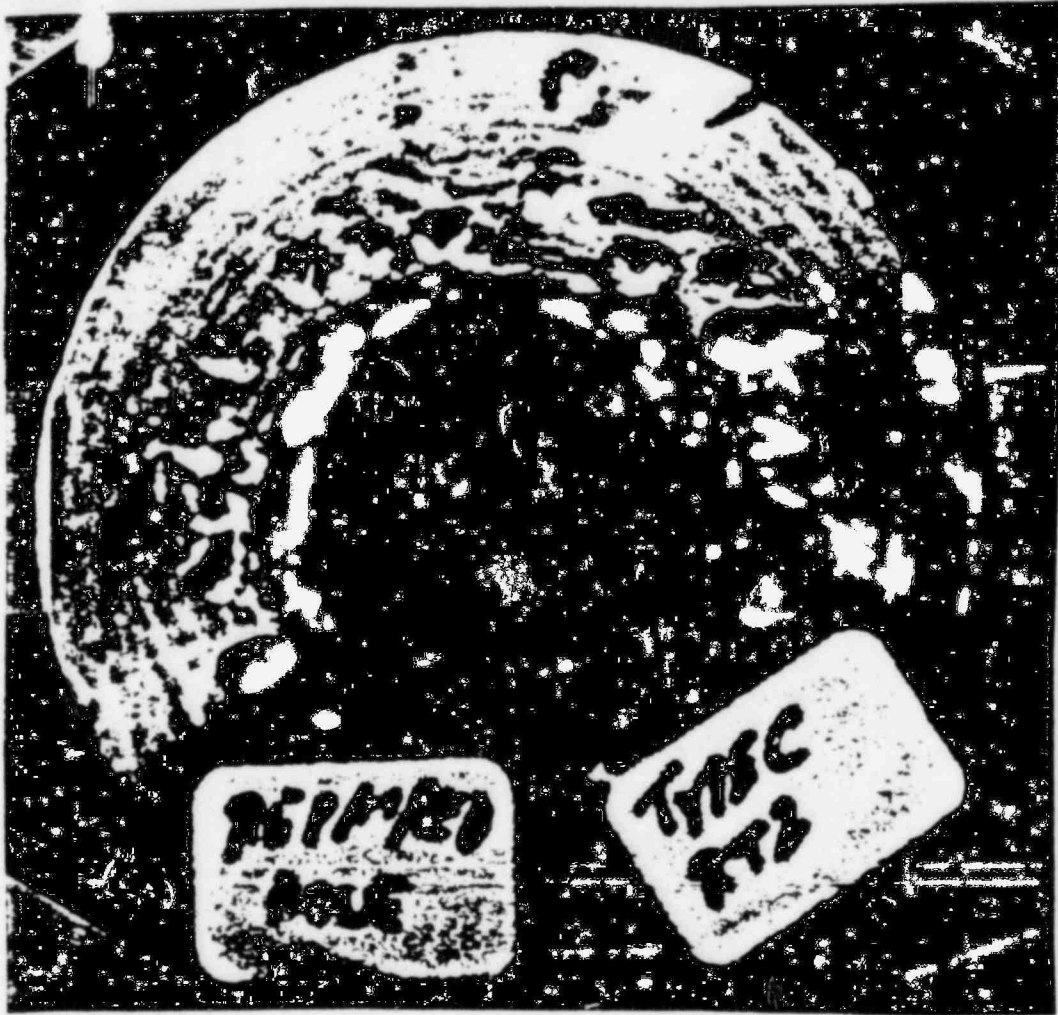
FIGURE 22

The rolling process opened up the tube I.D. near the weld and 1 in. inside to approximately 0.004 in. maximum, compared to the undamaged condition. The tube mouths diameter after repair was irregular and, in some cases, the inside lip became rather sharp. Many cases of the tube end "folding" inside the tube resulted, but in all cases the resulting inside diameter was satisfactory. Figure 22 shows the Figure 21 test collar (with a damaged tube end) after repair. This repair is typical of the appearance of the hard-rolled repaired tubes for both the test collars and test block.

INTENTIONALLY DEFORMED AND REPAIRED
TUBE END IN TEST COLLAR
(Same Tube End and Test Collar as
in Figure 21)

After producing the deformation, some of the tubes were repaired by the same hands-on process as was used in Plant III. This involved the use of a hammered-in taper pin to make the tube mouth large enough to receive a small hard roller. Then, the tube was hard rolled consecutively with larger hard rollers, using 120 in-lbs of roll torque in each case.
