New Hampshire Yankee

Subject: Licensee Event Report (LER) No. 90-026-00: Control Room Emergency Air
Cleanup and Filtration Subsystem Actuation

LICENSEE EVENT REPORT (LER)

TITLE (4)
Control Room Emergency Air Cleanup and Filtration Subsystem Actuation

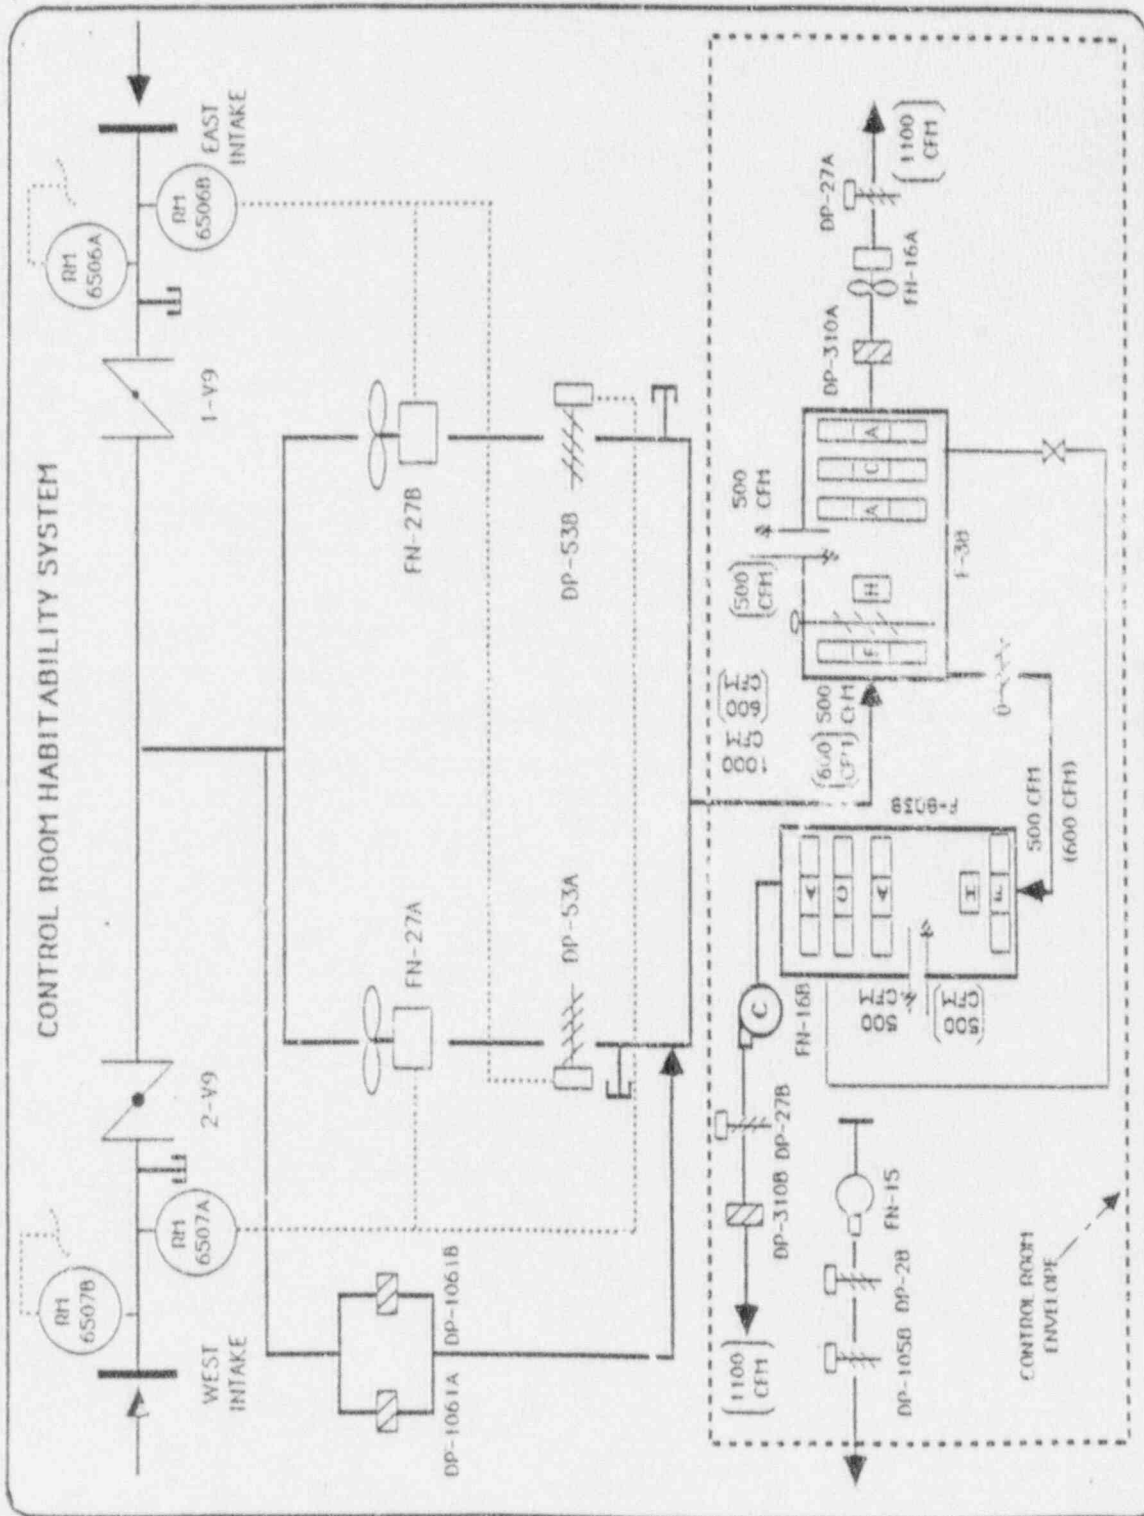
FIGURE 1

The Control Room Emergency Makeup Air and Filtration Subsystem consists of fans CBA-FN-16A and 16B and its corresponding discharge dampers CBA-DP-27A and 27B. In the auto mode, these dampers will open upon receipt of a high radiation signal or a safety injection ("S") signal. Opening of these dampers will automatically start the associated fan CBA-FN-16A or 16B. A high radiation signal or starting fans 16A and 16B will trip CBA-FN-27A and 27B. (See Figure 1 for a diagram of the CBA system).
