MONTICELLO NUCLEAR GENERATING PLANT
Docket No. 50-263 License No. DPR-22

Crack on Jet Pump Riser Brace Due to Fatigue

LICENSEE EVENT REPORT (LER)

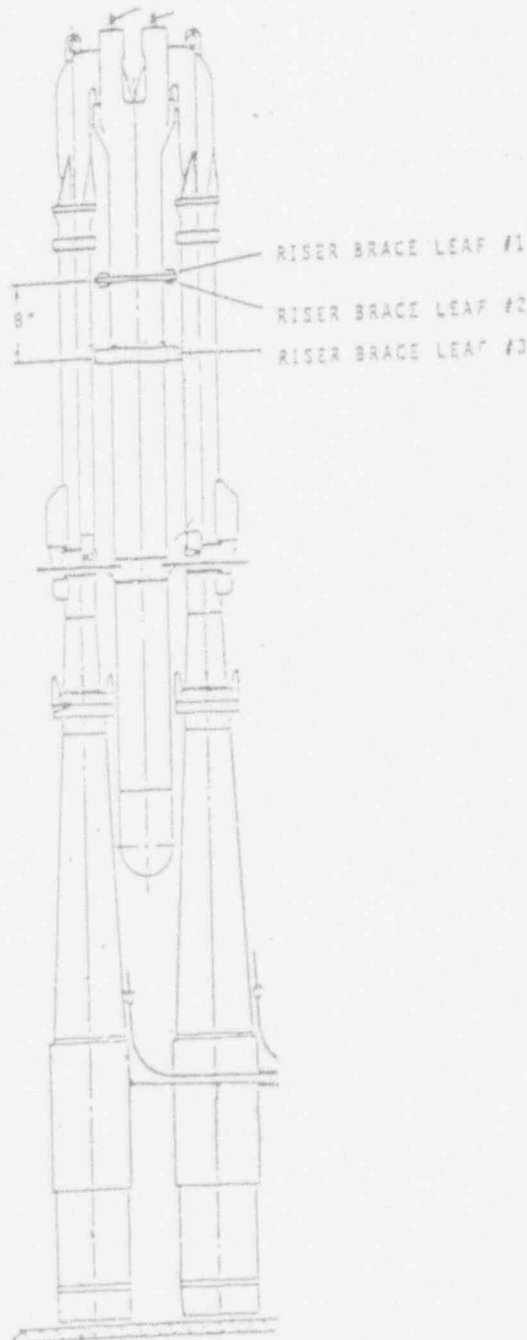
Figure 1. Jet Pump Assembly

The lower riser brace leaf (Leaf #3 in Figure 1) has a calculated natural frequency of 358 Hz, which is well removed from resonant conditions. Therefore resonance is not expected to occur at the lower brace. Evaluation of normal and accident jet pump loading indicates that stresses with only the lower brace in place are within acceptable limits. This shows that the loss of the entire upper brace would not affect the operability of the risers or the associated jet pumps.

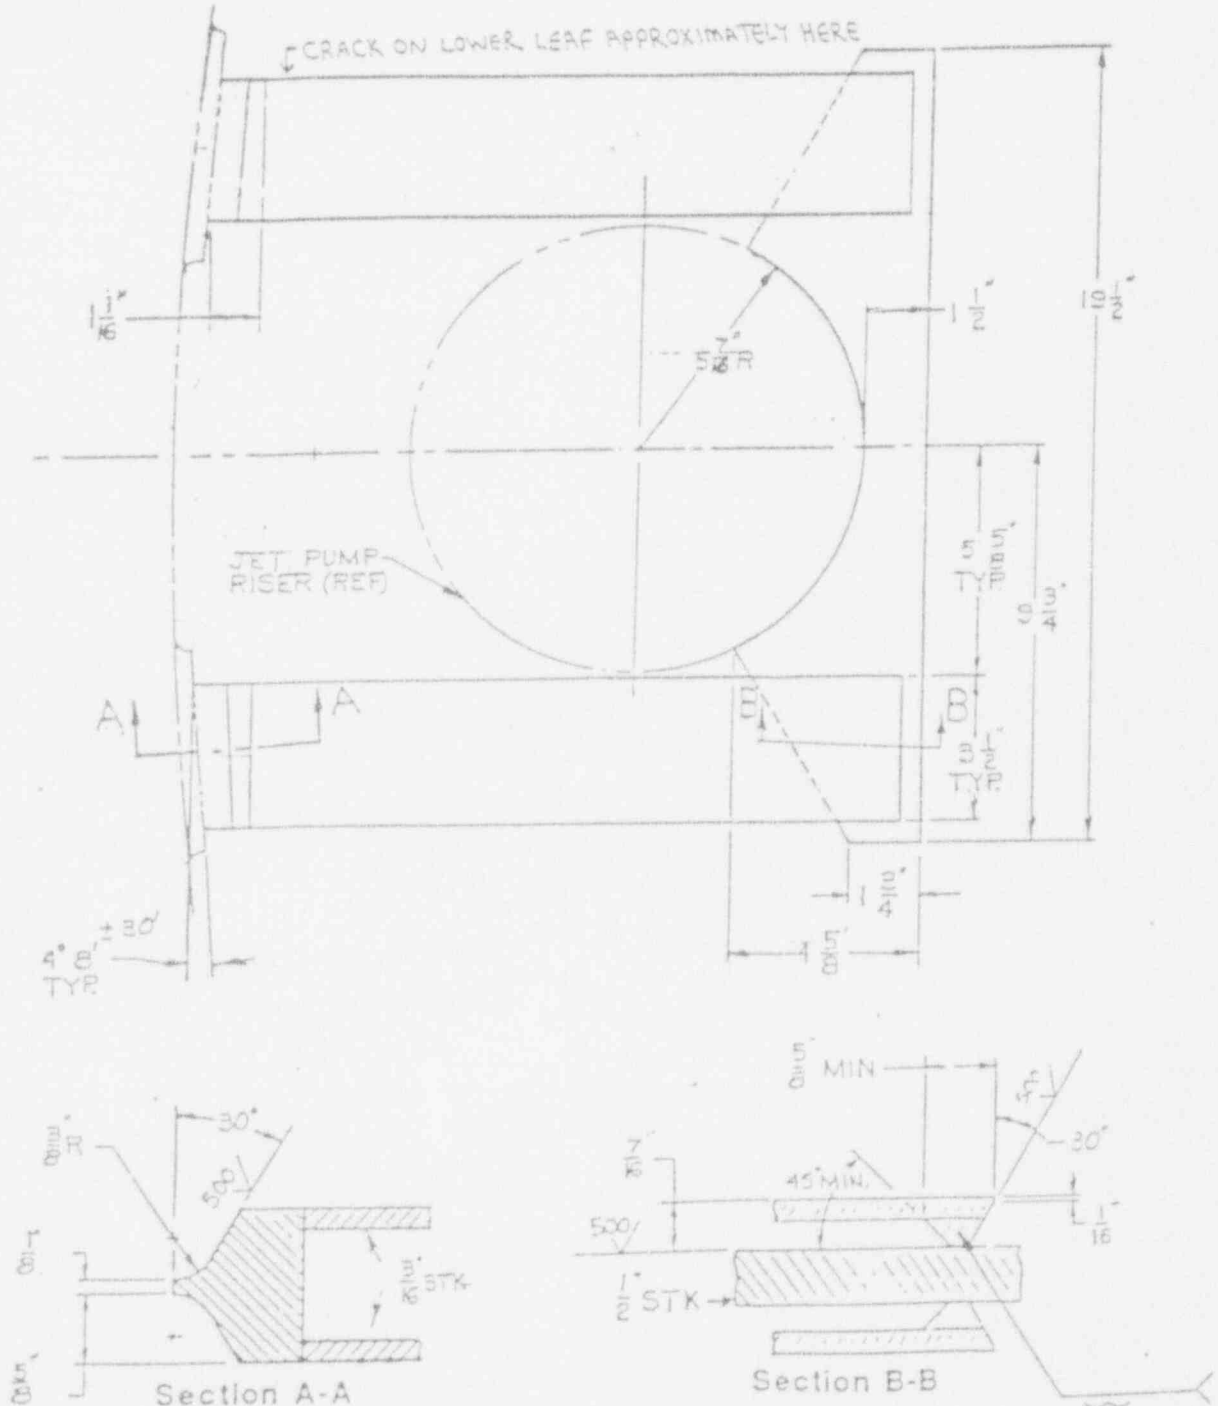
Figure 2. Upper Jet Pump Riser Brace

The crack is located on the lower leaf on the right side (facing out from the vessel centerline) of the upper support brace on the riser for jet pumps #7 and #8. The crack indication runs about 3/4 of the way across the top of the leaf about 1/2" from the point where it is welded to the vessel wall.

The risers are supported by an upper brace which consists of two leaves on each side of the riser and a lower brace which consists of one thicker leaf. All remaining leaves on this riser and the 9 other risers in the vessel were examined during the 1989 refueling outage with no other indications found. Subsequent re-examinations during the 1991 and 1993 refueling outages revealed no additional cracking of these components of the subject jet pump or any other jet pump.

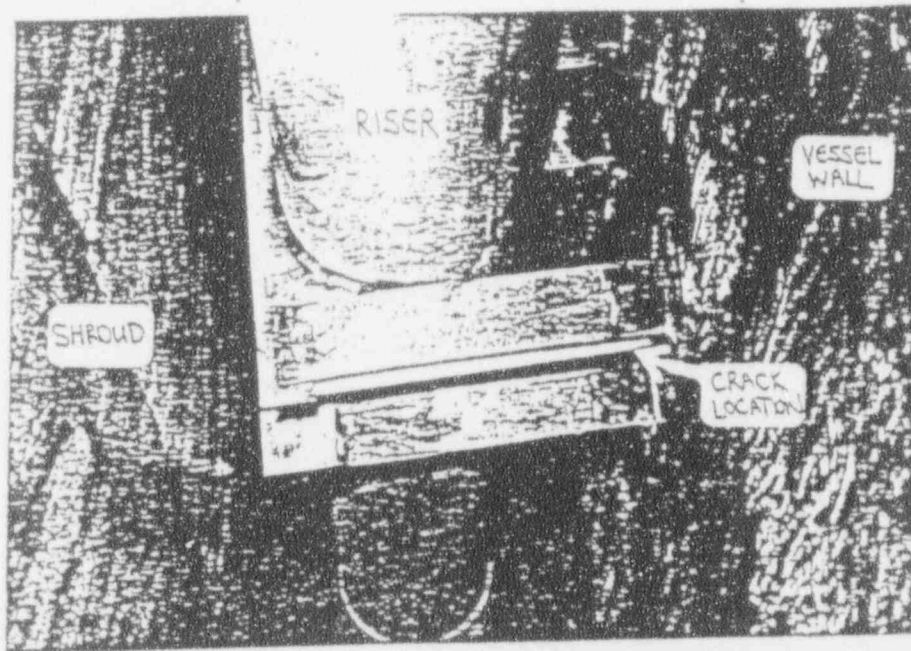
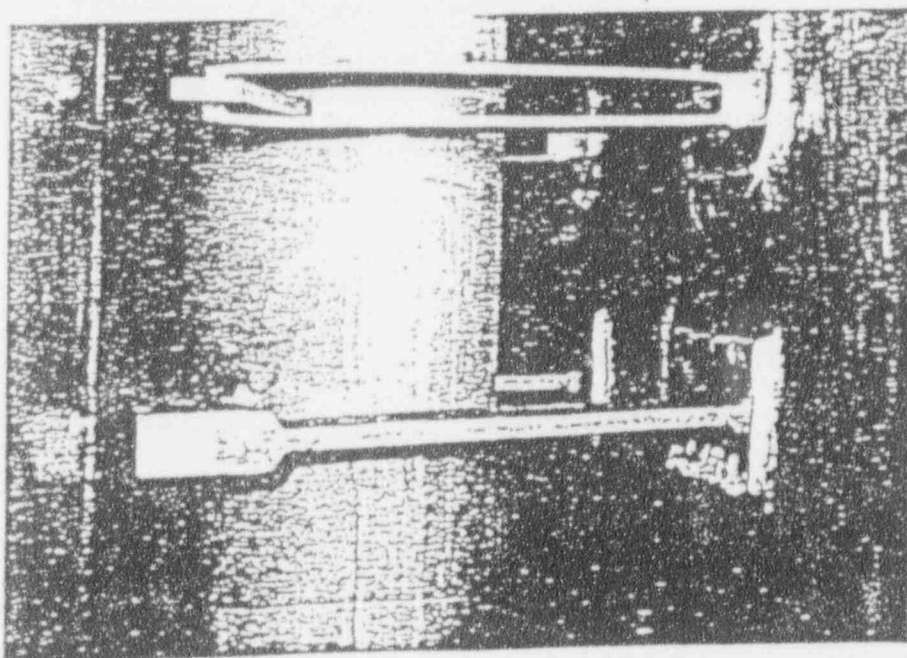
Figure 3. Construction Photos of Riser Braces

Visual inspections indicate that the cracked lower leaf has some cross-sectional reduction (thinning) which may have been caused by grinding performed during weld fit-up. This thinning is unique to this riser brace leaf and appears to have reduced the cross-sectional area by about 30%. It also appears that there is some lack of fusion in the weld at the point on the leaf where the crack initiated. These factors, thinning, work hardening from grinding and lack of weld fusion, may have contributed to the cracking of this riser leaf by making it more susceptible to any of the possible crack initiating mechanisms (i.e. resonance, IGSCC, ductile tearing)

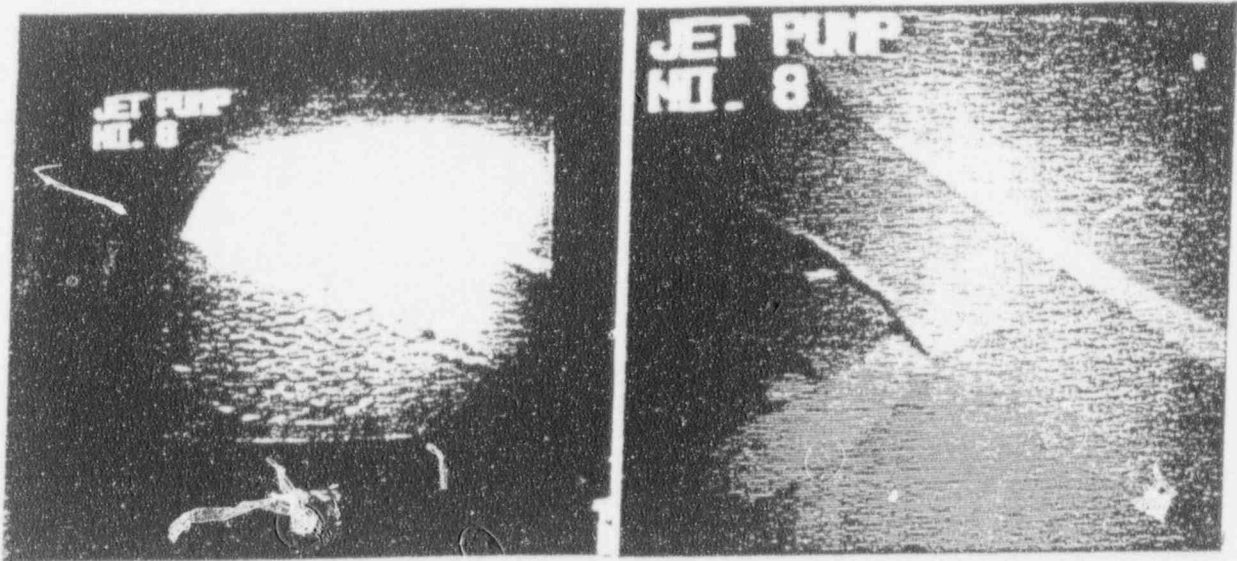
Figure 4. Top View of Cracked Leaf

The as-clad weld surface of the vessel has an additional weld pad buildup at these locations and riser braces are then welded to the pad. The crack is entirely within the base-metal of the brace, follows the toe of the weld and has no indications of branching. This is indicative of fatigue cracking and not IGSCC. Crack propagation into the weld metal by fatigue is highly unlikely because of geometry and the nature of the stress loading. Propagation into the weld metal by IGSCC is unlikely because of the greater weld metal resistance to IGSCC.

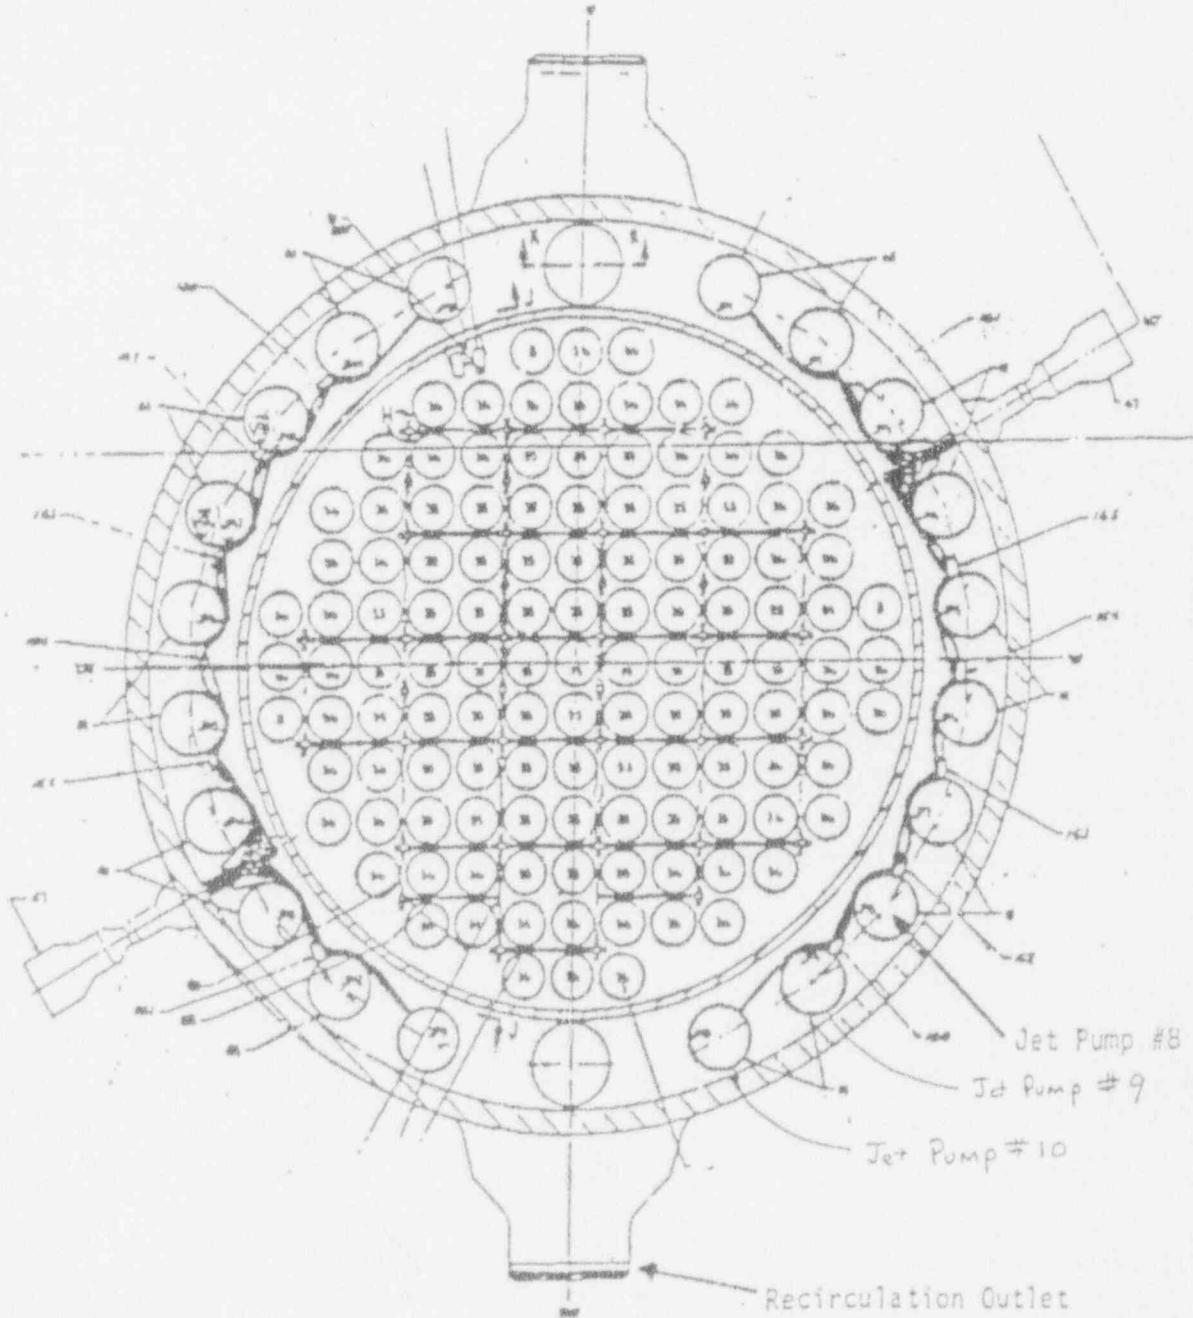
Figure 6. Jet Pump Arrangement

that the riser brace leaf is shielded from the recirculation inlet nozzle by jet pumps #8, #9 and #10 (See Figure 6) making it unlikely that it could be entrained by the recirculation suction flow during its fall to the bottom of the shroud annulus region. As the part is not expected to migrate to the core region via the recirculation loop flow, there is a negligible potential for fuel bundle flow blockage and subsequent fuel damage. For the same reason, there is virtually no potential for interference with control rod drive operation. However, if the jet pump riser brace directly above the recirculation loop suction nozzle is assumed to fail, the riser brace leaf may be carried into the recirculation piping due to suction flow. The following paragraphs describe the potential consequences of a loose part migrating to other portions of the recirculation system and reactor vessel.
