Subject: Potential Substantial Safety Hazard Report

# CLAMPSEAL VALVE - THREADED GLAND

Subject: Conval Forged Valve - Report of Potential Galling of Stem to Bonnet

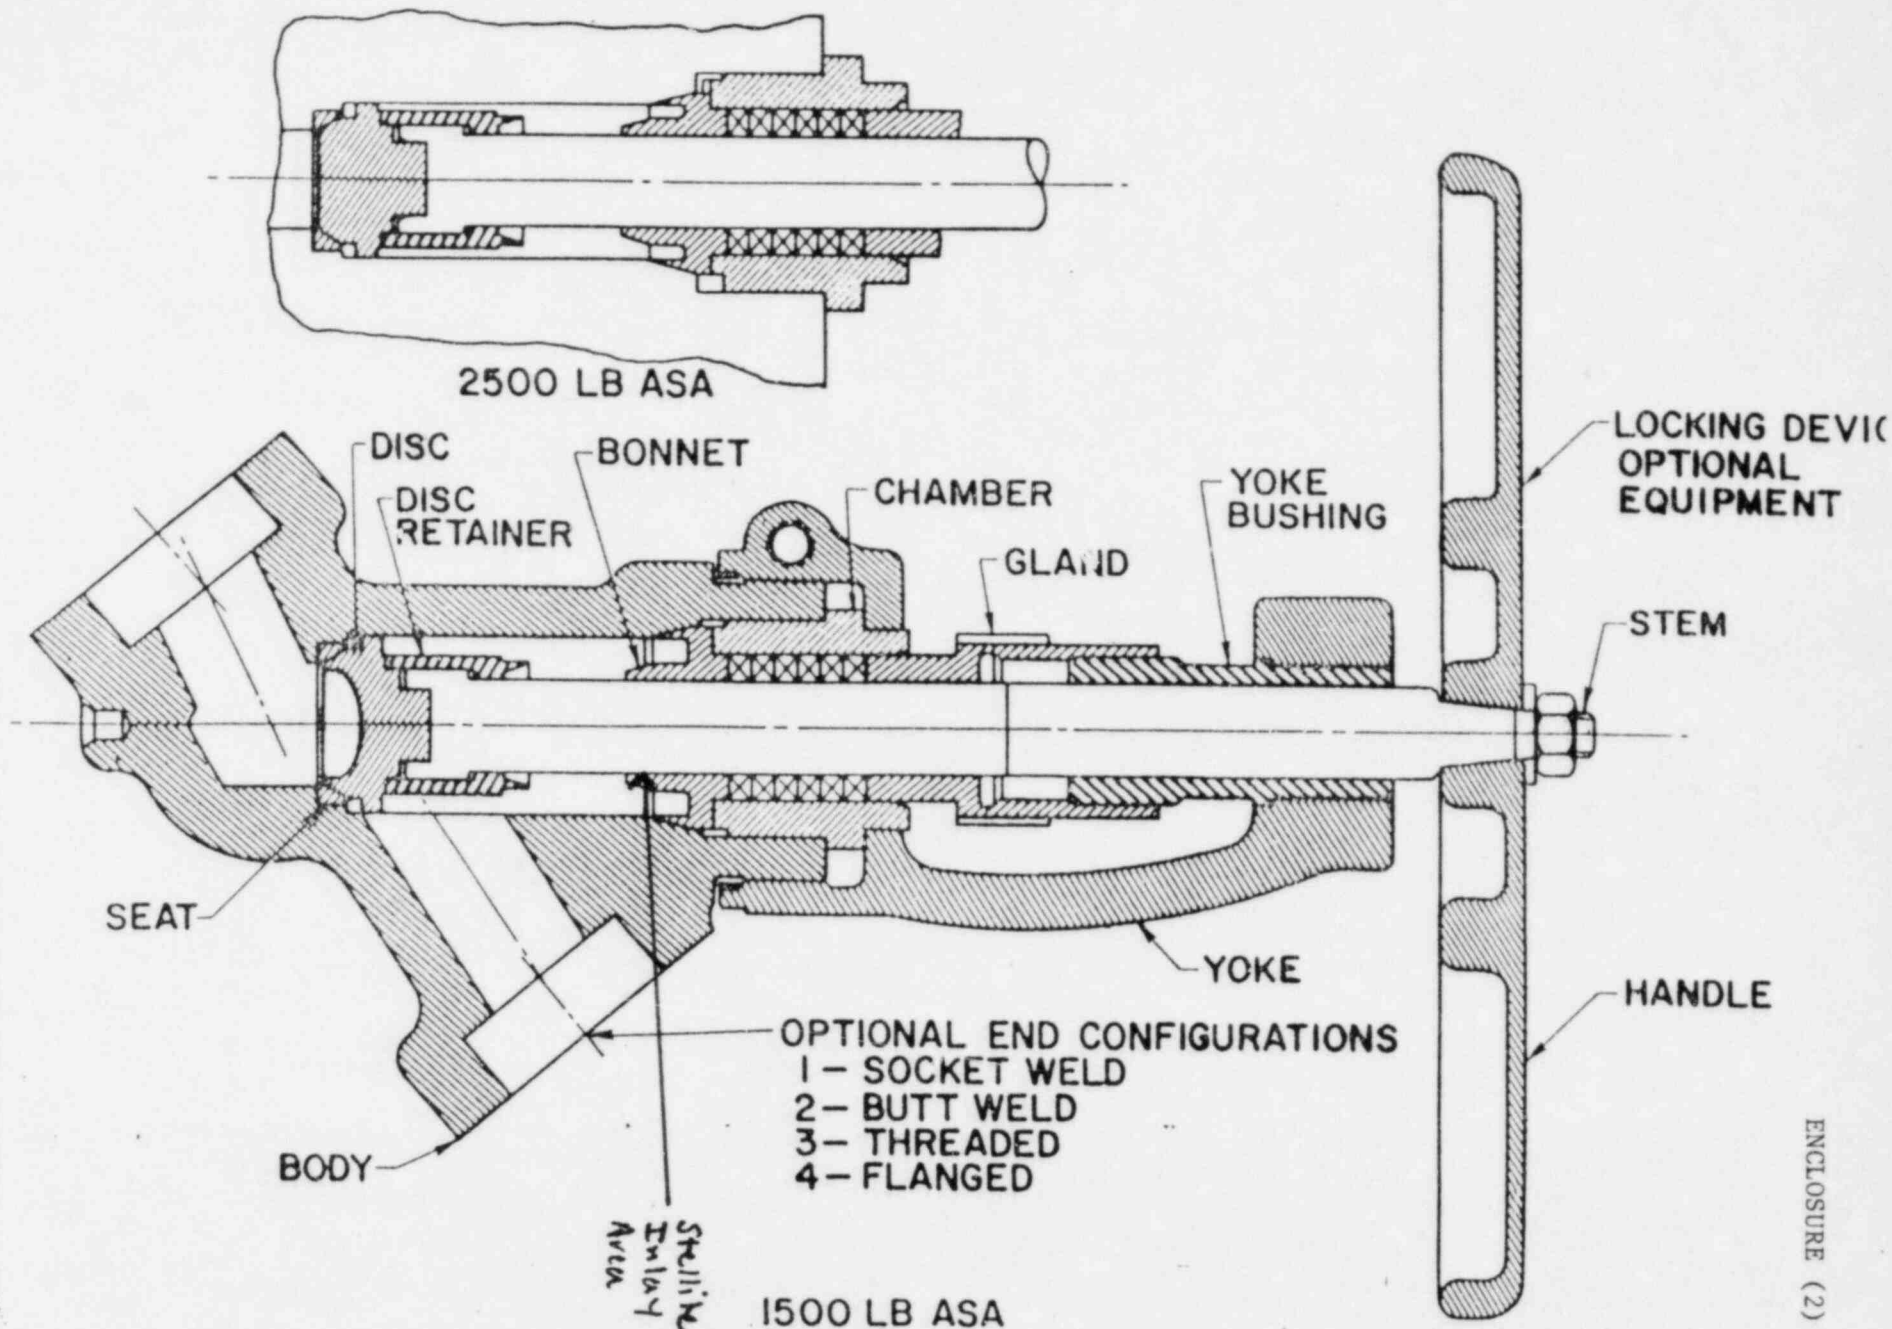
ENCLOSURE (2)

Conval has received reports and some parts returned from the field which alerted us to a galling problem. There have been no reports from nuclear plants. The most severe cases were observed to occur in fossil stations with steam temperatures above 600°F and pressures in the 2500 to 3500 psi range. The drawing, enclosure (2) illustrates the area of interest. We have determined that with a stellite guide area on the bonnet and a chrome plated stem, galling will not initiate even with considerable side thrust.

Conval has determined that in certain of our valves supplied with stem material of ASTM A582 416 stainless steel and bonnet material of Nitronic 60 (UNS S 21800), a galling action is possible between the stem and bonnet which could substantially increase operating torque and ultimately result in inability to operate the valve.

The onset of galling requires repeated operation of the valve and is most likely to occur at higher temperatures and where significant side thrust is experienced on the stem. For this reason, we recommend that those safety-related valves which contain the 416/Nitronic 60 materials be serviced at the earliest opportunity, and that the stem and/or the bonnet be replaced with one of new design. Replacement of either part will eliminate the susceptibility for galling.
