U. S. NUCLEAR REGULATORY COMMISSION
REGION I

Docket No.: 50-293
Report No.: 94-06
Licensee: Boston Edison Company
800 Boylston Street
Boston, Massachusetts 02199
Facility: Pilgrim Nuclear Power Station
Location: Plymouth, Massachusetts
Dates: February 22 - April 4, 1994
Inspectors: J. Macdonald, Senior Resident Inspector
D. Kern, Resident Inspector

Pilgrim Inspection Report 94-06

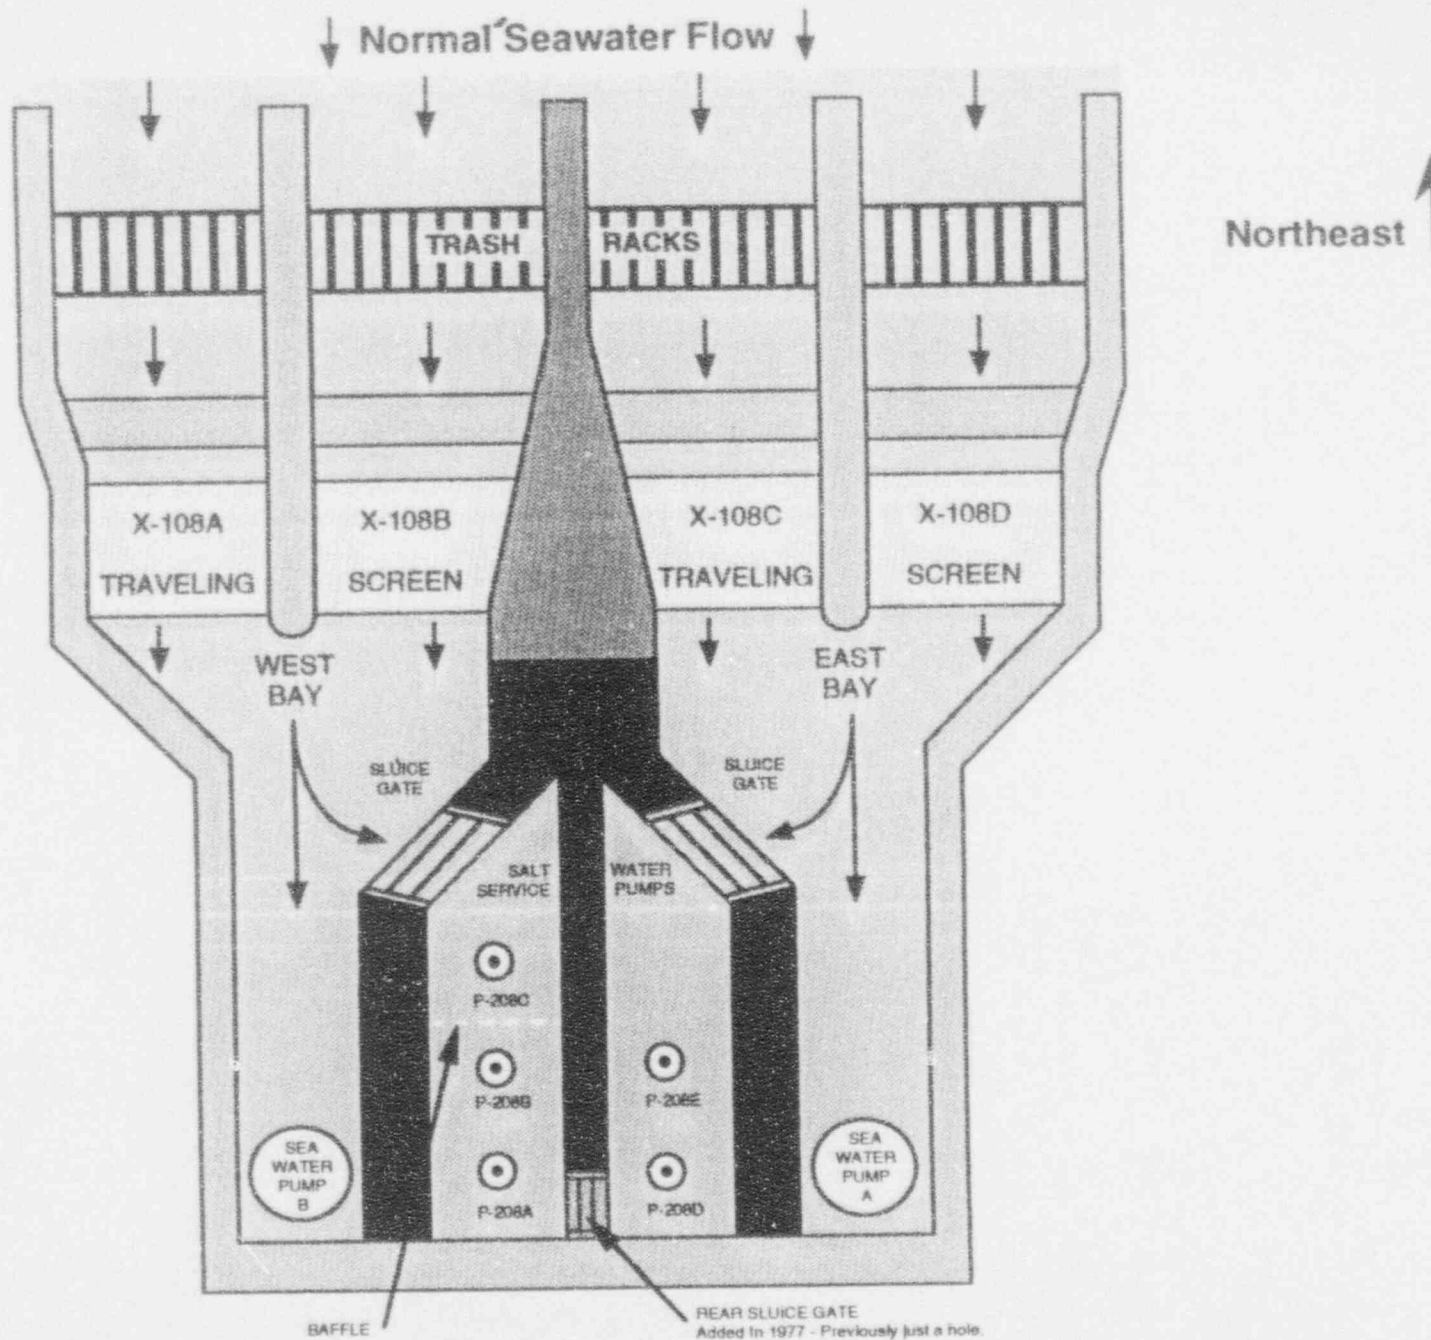
**INTAKE STRUCTURE 21'-6" LEVEL
PARTIAL PLAN VIEW**

- Second Operator in Screenhouse
- Seawater Bay Levels Oscillating Due to the Wave and Storm Effects.
- Heavy Seaweed Loading of the 'C' and 'D' Screens
- Traveling Screen Shear Pins Break

- **Heavy Influx of Seaweed During Storm**
 - Traveling Screen Shear Pin Failure
- **Contributing Causes**
 - 'C' & 'D' Traveling Screen Speed
 - 'A' Seawater Pump Operation
 - Annunciator Response Procedure
 - Training on Shear Pin Replacement
 - Intake Structure Level Alarms/ Level Monitoring
