SUBJECT: Calvert Cliffs Nuclear Power Plant
Unit Nos. 1 and 2; Docket Nos. 50-317 and 50-318;
License No. DPR 53 and DPR 69
Licensee Event Report 89-023, Revision 2

LICENSEE EVENT REPORT (LER) TEXT CONTINUATION

FACILITY NAME	DOCKET NUMBER	LER NUMBER	PAGE
Calvert Cliffs, Unit 1	05000317	89-023-02	02 OF 08

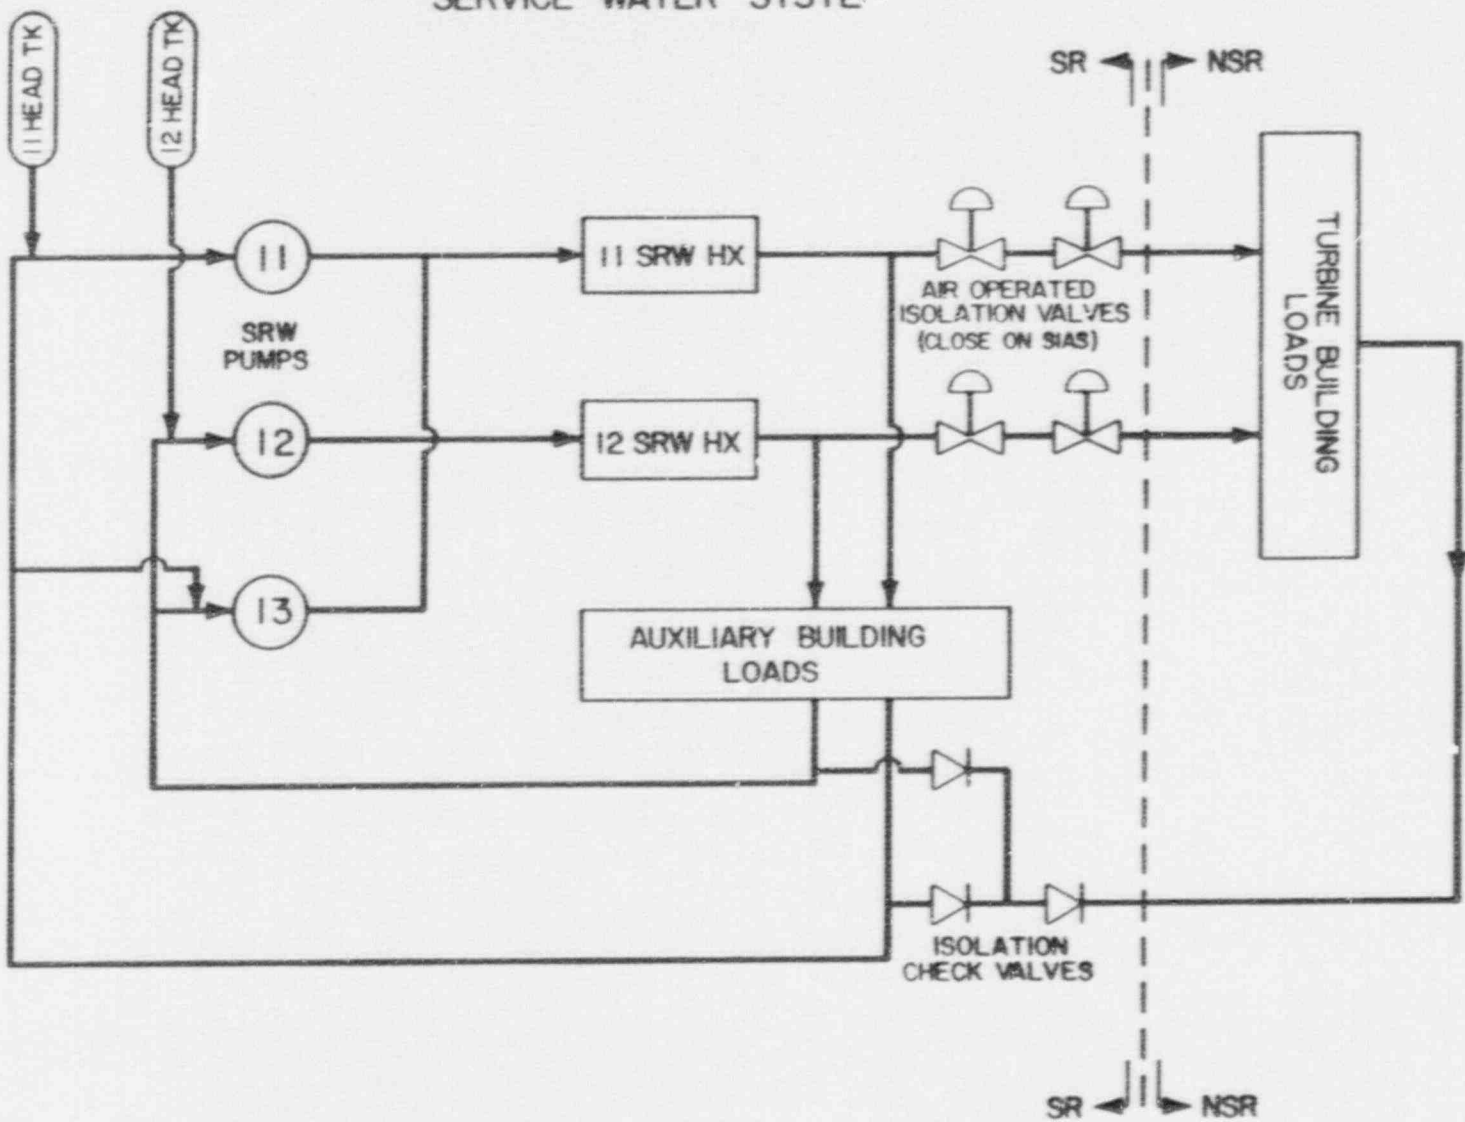
FIGURE 1
CALVERT CLIFFS UNIT 1
SERVICE WATER SYSTEM

Although the SRW piping configuration differs slightly between Unit 1 and Unit 2, each system is basically comprised of two independent, SR SRW subsystems serving Auxiliary Building heat loads and a single, NSR SRW subsystem serving Turbine Building heat loads. The subsystems operate in parallel to each other and are interconnected at certain points. For Unit 1 (Figure 1), the two SR Auxiliary Building subsystems are connected to the NSR Turbine Building subsystem by a common, NSR pipe located where the SRW System exits the Turbine Building and connects to the SRW suction header. For Unit 2 (Figure 2), the two SR Auxiliary Building subsystems are connected to the NSR Turbine Building subsystem by a common, NSR connection from the SRW discharge header where the SRW System enters the Turbine Building. As a result, the Turbine Building subsystem cross-connects the two SR Auxiliary Building subsystems.

The ability to isolate the Turbine Building subsystem from both Auxiliary Building subsystems is provided by dual, SR air operated isolation valves on the discharge header piping of each Auxiliary Building subsystem, and by check valves in the return piping from the Turbine Building subsystem to suction header of each Auxiliary Building subsystem. The isolation valves are located in the Auxiliary Building subsystem piping prior to connection with the Turbine Building subsystem piping. The SR check valves are located in the SR portions of the Turbine Building SRW subsystem return lines to the Auxiliary Building SRW

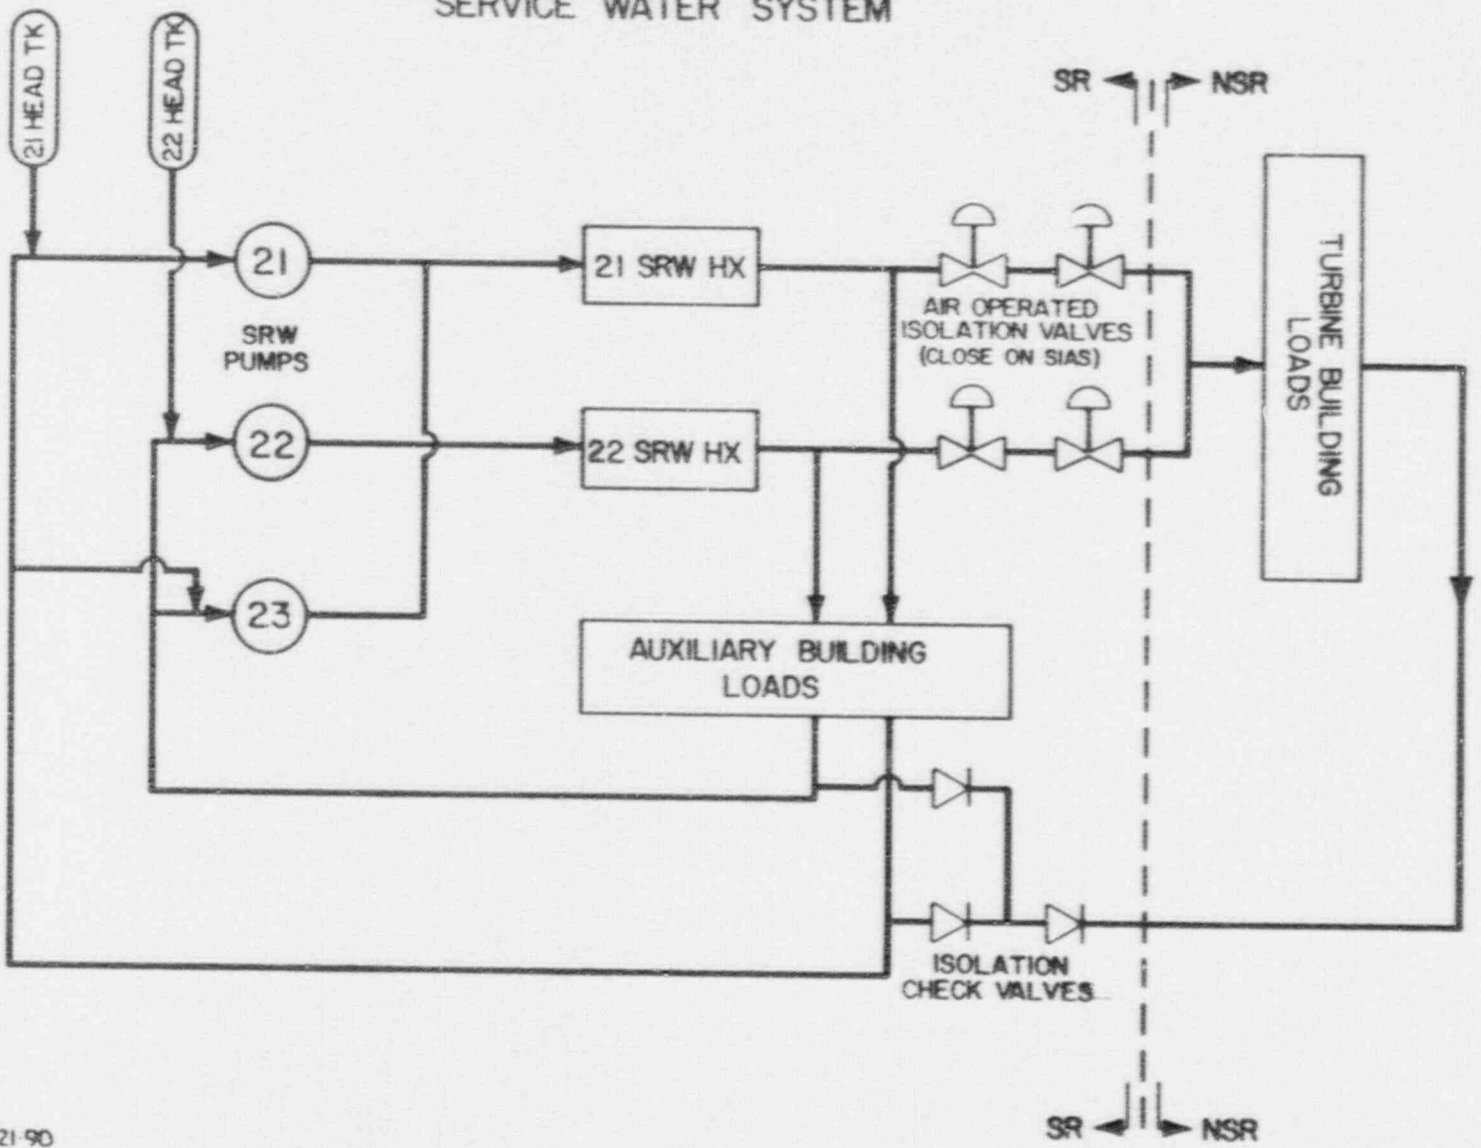
FIGURE 2
CALVERT CLIFFS UNIT 2
SERVICE WATER SYSTEM

Calculations have been performed assuming a worst-case, double-ended guillotine pipe break in the Unit 2 NSR Turbine Building SRW piping. The piping configuration for Unit 2 is less conservative than the Unit 1 configuration because the Unit 2 cross-connection occurs just downstream of the non-critical service water valves. The Unit 1 cross-connection is downstream of all Turbine Building loads. The calculations indicate that the SRW System could be drained before an operator could act to isolate the break under non-SIAS conditions. A double-ended guillotine type break is more conservative than is required under our licensing and design basis for a moderate energy line break (i.e., Seismic Category II ANSI B31.1). However, informal calculations indicate that even a moderately sized pipe break would result in a rapid loss of SRW inventory.
