TENNESSEE VALLEY AUTHORITY - SEQUOYAH NUCLEAR PLANT UNIT 1 - DOCKET NO.
50-327 - FACILITY OPERATING LICENSE DPR-77 - LICENSEE EVENT REPORT (LER)
50-327/90030

TITLE (4) Automatic start of the auxiliary feedwater system as a result of a trip of the 1A main feedwater pump turbine

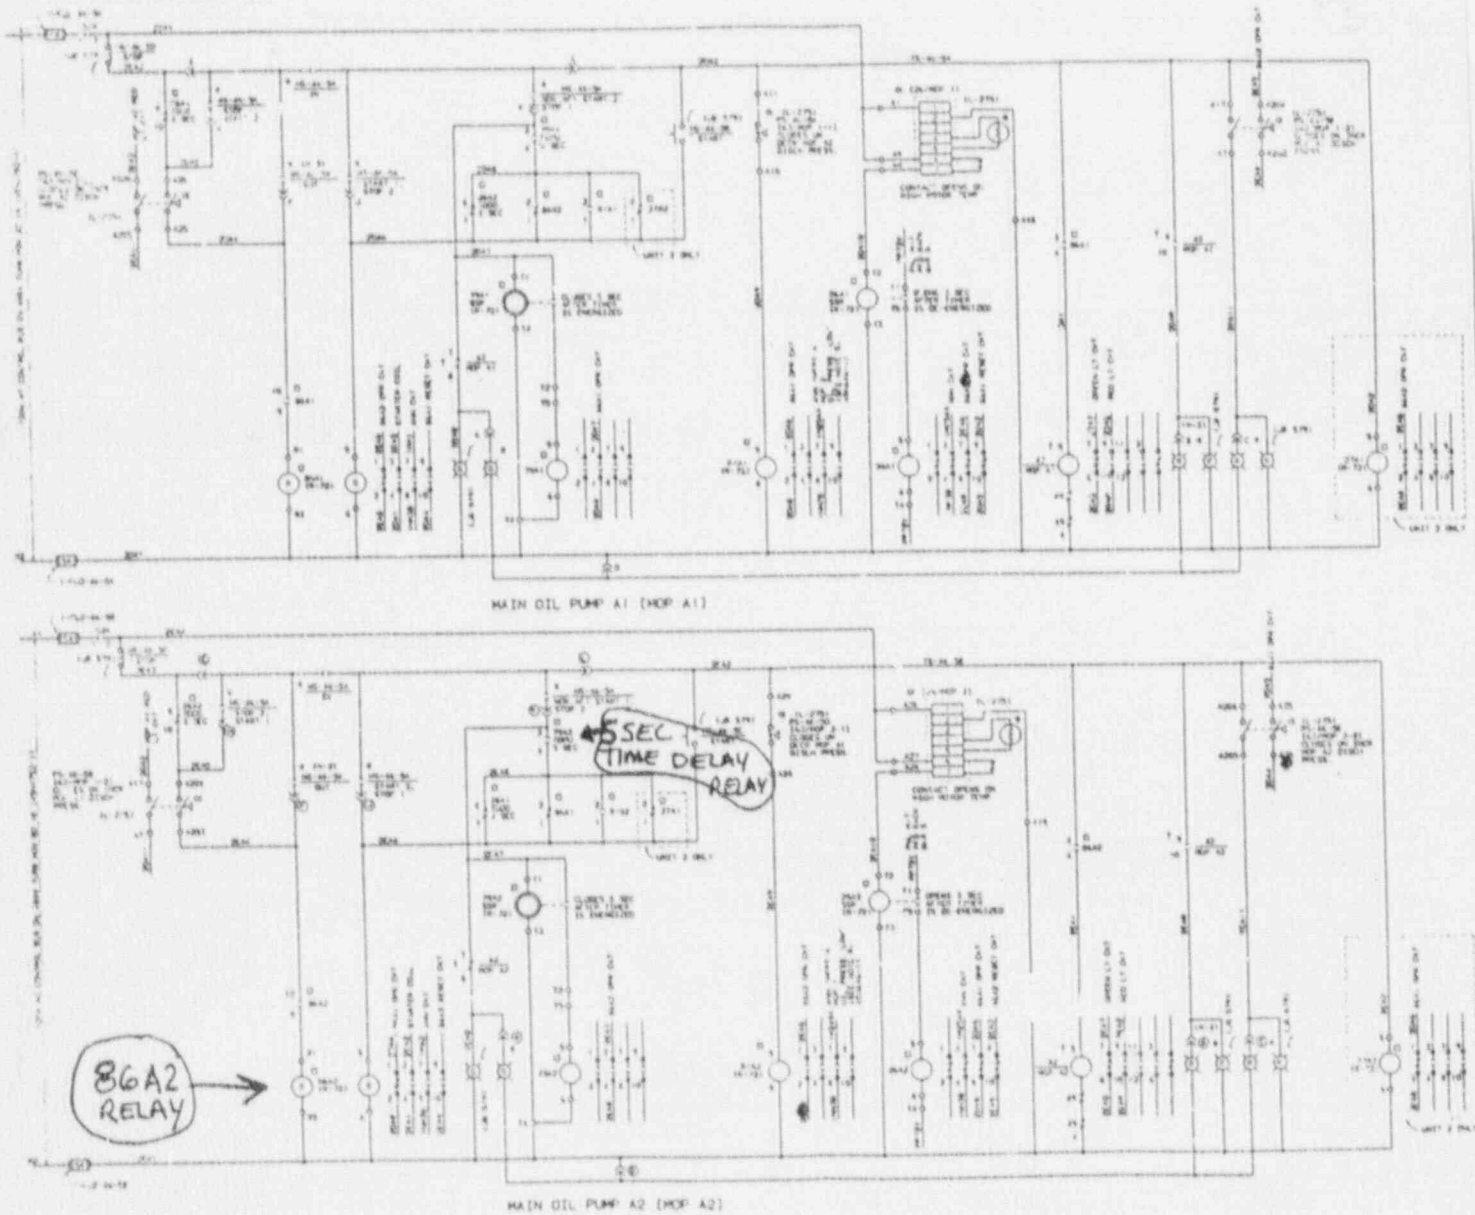
ATTACHMENT

At the time of the trip, the control switch on each main feedwater control panel was in the "Start 1 Stop 2" pump position. Operations' personnel reviewed the annunciator response and system drawings and concluded that the oil pump control switch for each main feedwater pump should be rotated to the "Start 2 Stop 1" position. This action would clear the "Reserve Oil Pump Running" alarm. The control switch for main feedwater pump 1A oil pumps was rotated to the desired position, and unexpectedly, the No. 2 oil pump tripped. The No. 1 oil pump started after a delay of five seconds, as designed. However, the drop in oil pressure during this delay resulted in a trip of the 1A main feedwater pump turbine (MFPT) on low oil pressure. The loss of one MFPT at 80 percent power or greater will automatically initiate the start of the auxiliary feedwater pumps. Operations' personnel responded to the event using Abnormal Operating Instruction 16, "Loss of Normal Feedwater." The main turbine ran back automatically to approximately 65 percent of rated load. Operators stabilized the unit load at 60 percent of rated load to ensure that the capability of the remaining feedwater pump was not exceeded. The systems and components that were required to actuate as a result of the event functioned as required. Troubleshooting revealed the No. 2 MOP tripped because of a faulty mechanical latch on the operator coil of the operate/reset relay (86A2) (EISS Code RLY). (see Attachment)

The cause of the MFP trip and subsequent start of AFW was a faulty mechanical latch on the operator coil of the relay for MOP 2 and is considered as an unforeseen failure.

To clear the alarm, the control switch was rotated to the "Start 2 Stop 1" position. The MFPT 1A tripped when this action was taken. The MOP start circuit has a five-second time-delay relay that prevents the opposite MOP from automatically starting while the selected MOP is trying to establish oil pressure. This time-delay prevented the automatic start of MOP 1 for five seconds after MOP 2 tripped and resulted in the trip of the MFPT 1A on low-oil pressure. Troubleshooting revealed the trip resulted from a faulty mechanical latch on the operate coil of the relay for MOP 2. This coil was energized as long as the control handswitch was in the "Start 1 Stop 2" position, which is an alternate supply path other than the normal operating path. This supply path was removed as soon as the handswitch was rotated to the "Start 2 Stop 1" position.

Immediate corrective action was to replace the faulty relay and functionally test the eight latching relays in the main oil pump's circuits of the MFPTs (1A, 1B, 2A, and 2B) to ensure that switching activities and MOP startups can be accomplished as designed.
