HOPE CREEK GENERATING STATION
DOCKET NO. 50-354
UNIT NO. 1
LICENSEE EVENT REPORT 90-028-00

FACILITY NAME (1) HOPE CREEK GENERATING STATION												DOCKET NUMBER (2) 0 5 0 0 0 3 5 4				PAGE (3) 1 OF 5	
TITLE (4): TURBINE TRIP ON MOISTURE SEPARATOR HIGH LEVEL RESULTS IN REACTOR SCRAM DUE TO MOISTURE SEPARATOR LEVEL CONTROL SYSTEM MALFUNCTION																	
EVENT DATE (5)			LER NUMBER (6)				REPORT DATE (7)			OTHER FACILITIES INVOLVED (8)							
MONTH	DAY	YEAR	YEAR	**	NUMBER	**	REV	MONTH	DAY	YEAR	FACILITY NAME(S)		DOCKET NUMBER(S)				
1	1	1790	90	-	028	-	00	1	2	1290							
OPERATING MODE (9)		1 THIS REPORT IS SUBMITTED PURSUANT TO THE REQUIREMENTS OF 10CFR: (CHECK ONE OR MORE BELOW) (11)

Turbine Trip on Moisture Separator High Level Results in Reactor Scram Due to Moisture Separator Level Control System Malfunction

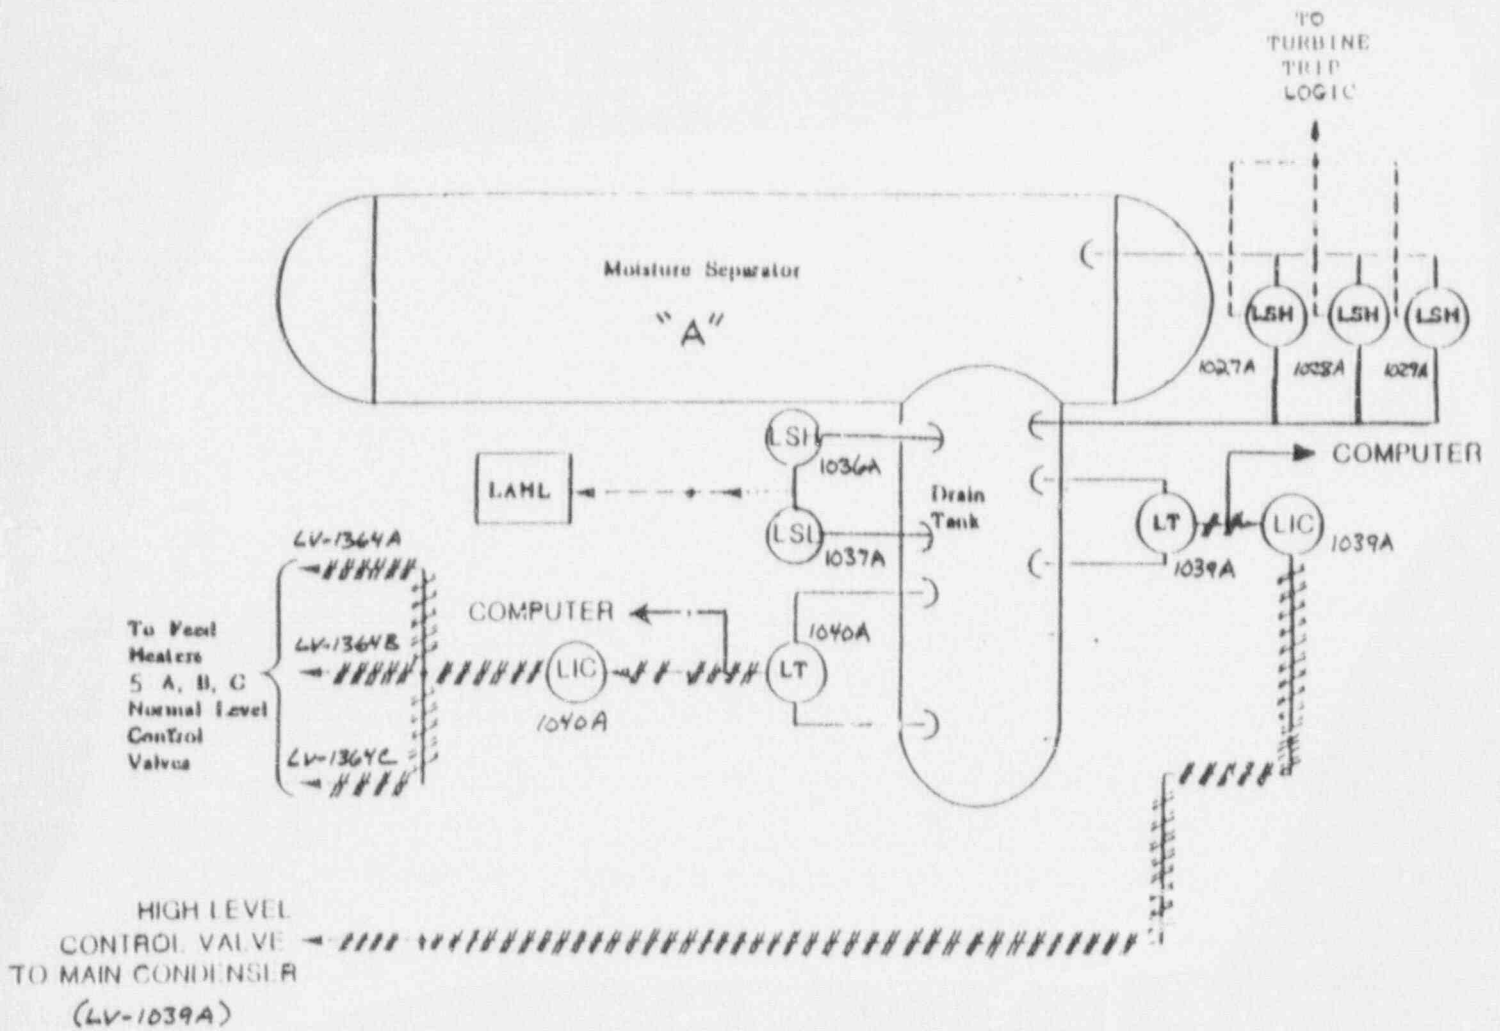
MOISTURE SEPARATOR LEVEL CONTROL SYSTEM

Refer to Attachment 1. Moisture separator level is normally controlled via the cycling of level control valves LV-1364A, B, and C, which route condensate from the Moisture Separator Drain Tank to Feedwater Heaters 5A, B, and C via individual 8" lines. In the event of a high drain tank level, the Emergency Dump Valve opens and drains directly to the Main Condenser via a single 8" line. The cycling of a CIV induces a significant transient on the associated moisture separator, and a swing in level during the course of cycling a CIV is normal and expected, however, not as severe as was experienced in this event.
