Crystal River Unit 3  
Docket No. 50-302

December 20, 1990  
3F1290-12

LICENSEE EVENT REPORT (LER)

TITLE (4) **Lack of Knowledge Causes Auxiliary Nuclear Operator to De-energize Containment Isolation Valve Prior to Being Fully Seated Violating Containment Integrity**

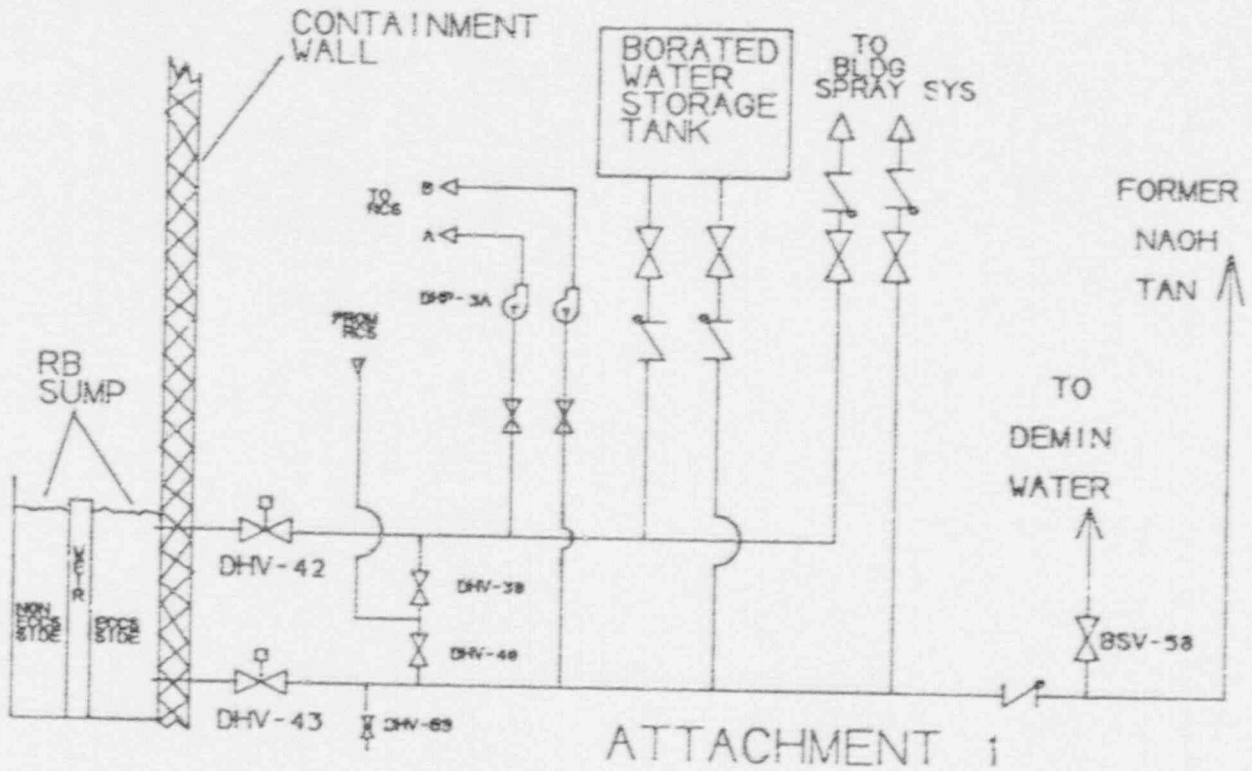
ATTACHMENT 1

On 9/18/90 at 1845, while Crystal River Unit 3 was operating in Mode 1 (POWER OPERATION) at 95% reactor power, valve DHV-43 [BP,ISO] was discovered not fully seated. This valve isolates the Reactor Building (RB) Sump [WK] from the suction header of the "B" Decay Heat Removal System (DHRS) [BP] (see Attachment 1). The valve not being fully seated was a violation of Technical Specification 3.6.1.1 which specifies that Containment Integrity must be maintained in Mode 1. This is reportable under 10CFR 50.73a.2.i.B, 50.73a.2.ii.C, and 50.73a.2.v.D. By 1900 on 9/18/90, the valve was manually seated thus restoring containment integrity. A narrative of circumstances leading up this event follows.
