PRAIRIE ISLAND NUCLEAR GENERATING PLANT
Docket No. 50-282 License No. DPR-42
50-306 DPR-60

Reactor Trip Caused by Inadequate Design
of Main Generator Bus Duct Cooling System

LICENSEE EVENT REPORT (LER)

TITLE (4) Reactor Trip Caused by Inadequate Design of Main Generator Bus Duct Cooling System

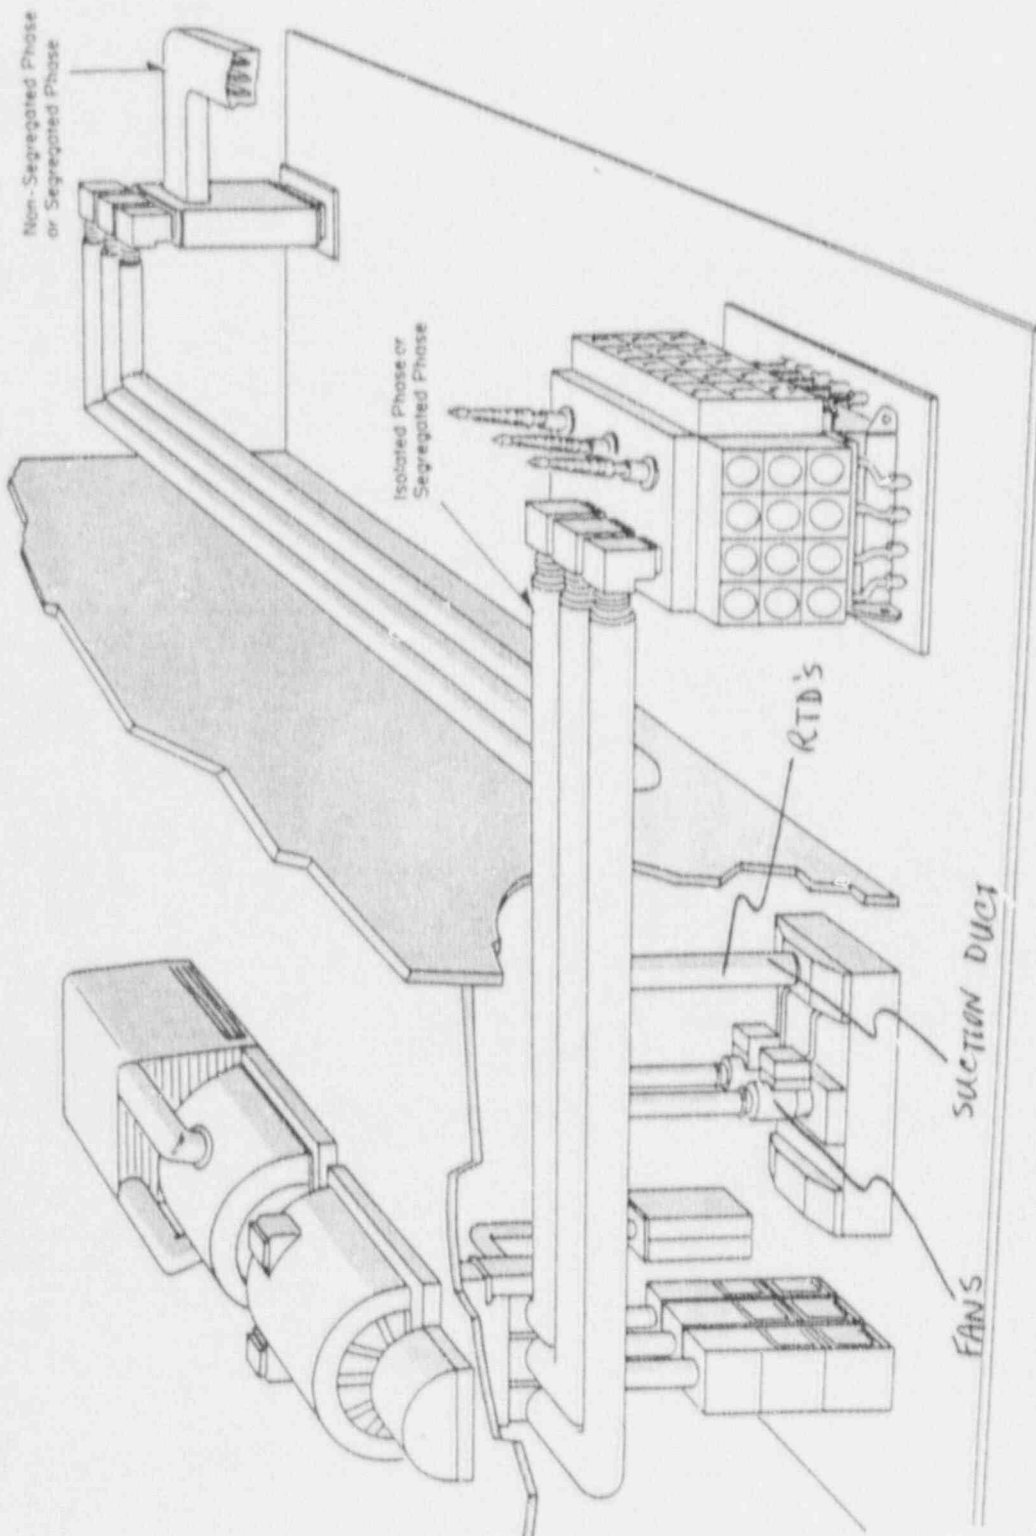
The turbine building operator had determined that there was no bus duct cooling fan running, but bus duct temperature appeared normal. Actual bus duct temperature was highly elevated, but the resistance temperature detectors (RTD) are located in the bus duct cooler suction duct (See attached figure) such that representative bus duct temperature is not sensed if a fan is not running. When the standby fan was started, hot air in the bus ducts was drawn into the suction duct and past the resistance temperature detectors, which then initiated a generator trip on high temperature of 85°C.

Cause of the event is inadequate design of the bus duct cooling control system.

1. Provide a high temperature alarm of 62°C and start the standby bus duct cooling fan, and
2. Trip the main generator on a high temperature of 85°C.

Unfortunately, placement of the bus duct temperature sensors is such that they do not reflect actual temperature in the bus ducts when no fan is running, and there is no annunciation of electrical failure of a running fan. See attached Figure.

Failure of its supply breaker resulted in the loss of No. 11 Bus Duct Cooling Fan.

Following consultation with the corporate electrical group, it was determined that the main generator trip from bus duct high temperature was not needed and has been bypassed.

A modification will be made which provides annunciation when both bus duct cooling fans are off.

Improvements in temperature instrumentation are being studied.
