SUBJECT: DOCKET NO. 50-333
LICENSEE EVENT REPORT: 90-025-00
Service Water Check Valves

LICENSEE EVENT REPORT (LER)

TITLE (4) **Three Service Water to Emergency Service Water Check Valves Fail to Close During Testing Due to Corrosion and Silt Accumulation**

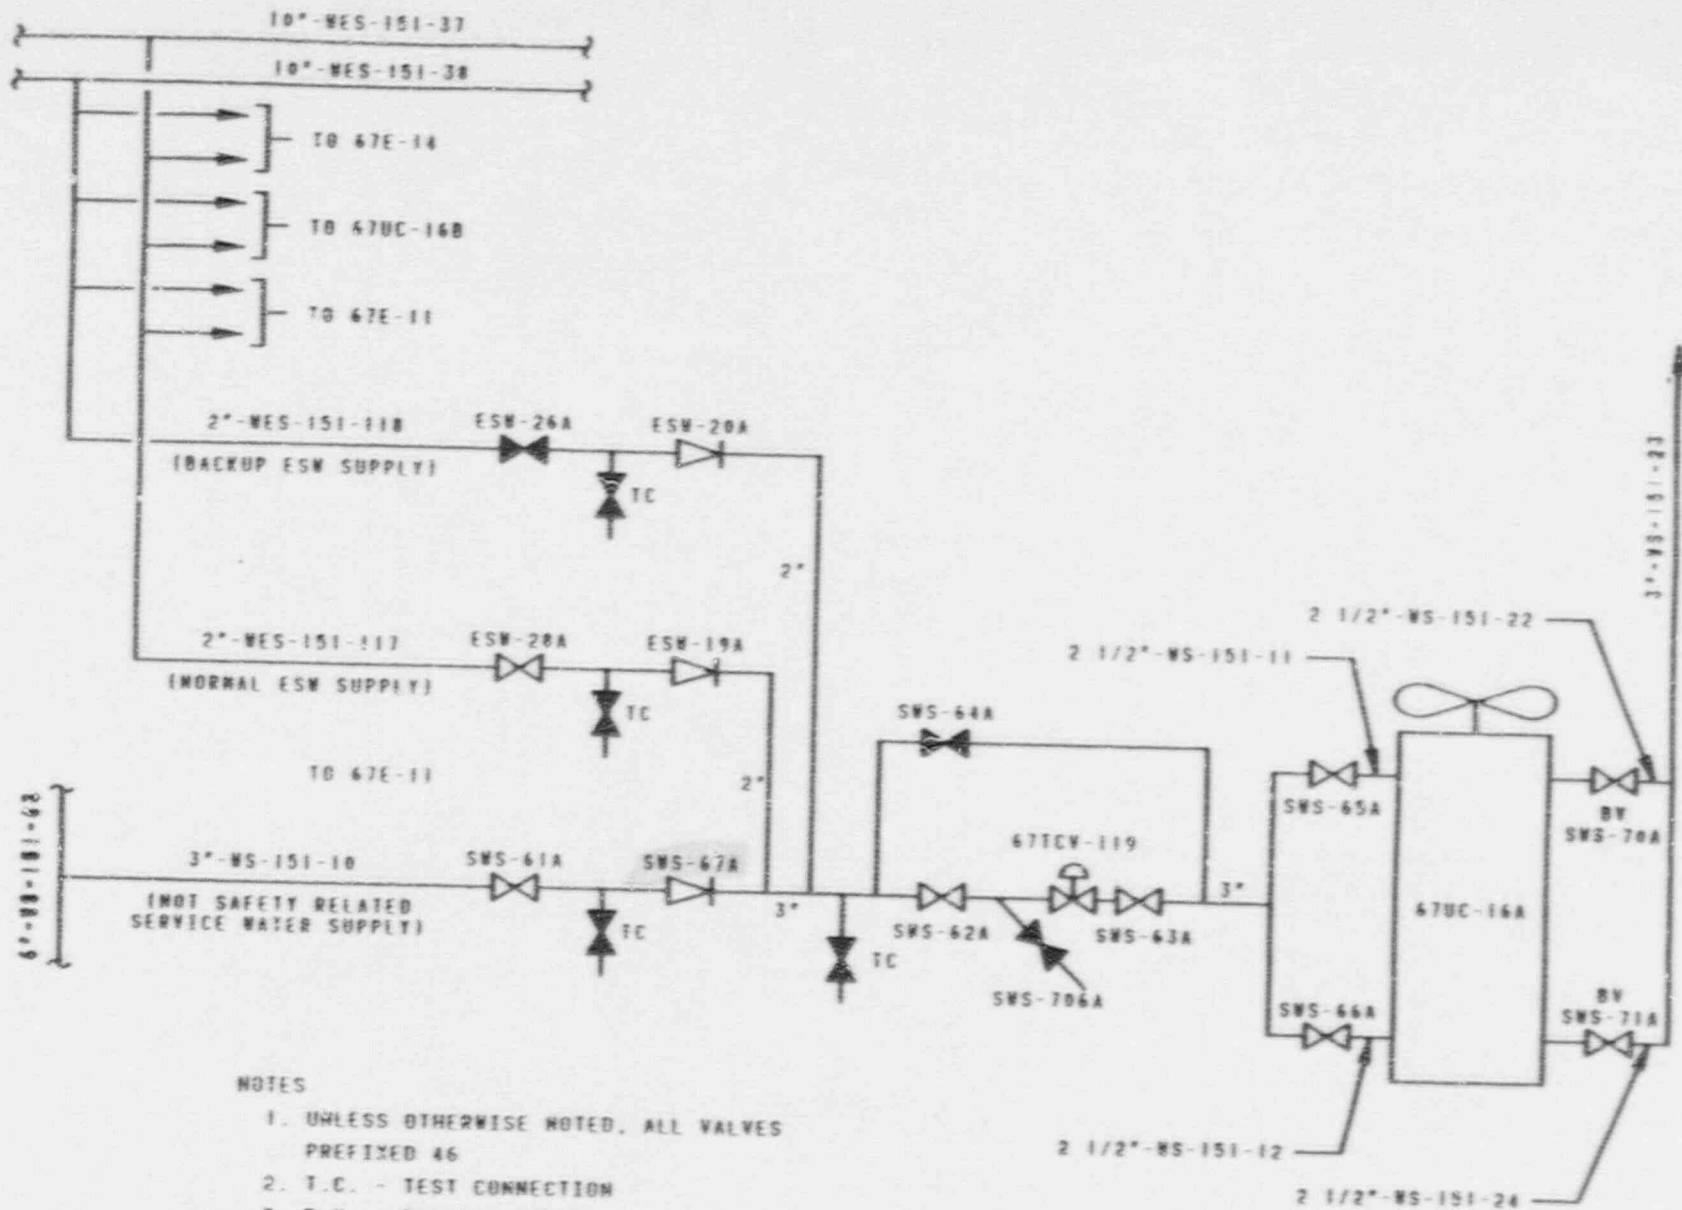
Figure 1 to
LER 90-025-00
Docket No. 50-333

Flow diagrams showing the SWS and ESW supply to each heat exchangers are attached as Figures 1, 2, and 3. The tube side of each heat exchanger is normally provided with service water from a 3-inch line that branches off the SWS main header. Teeing into this line, just downstream of the 3-inch swing check valves (which failed to close in this event), are two 2-inch ESW supply lines. One of these supply lines is normally valved-in and is considered safety-related. The other line is normally valved-out and is not safety-related.

ELECTRIC BAY UNIT COOLERS
67UC-16A

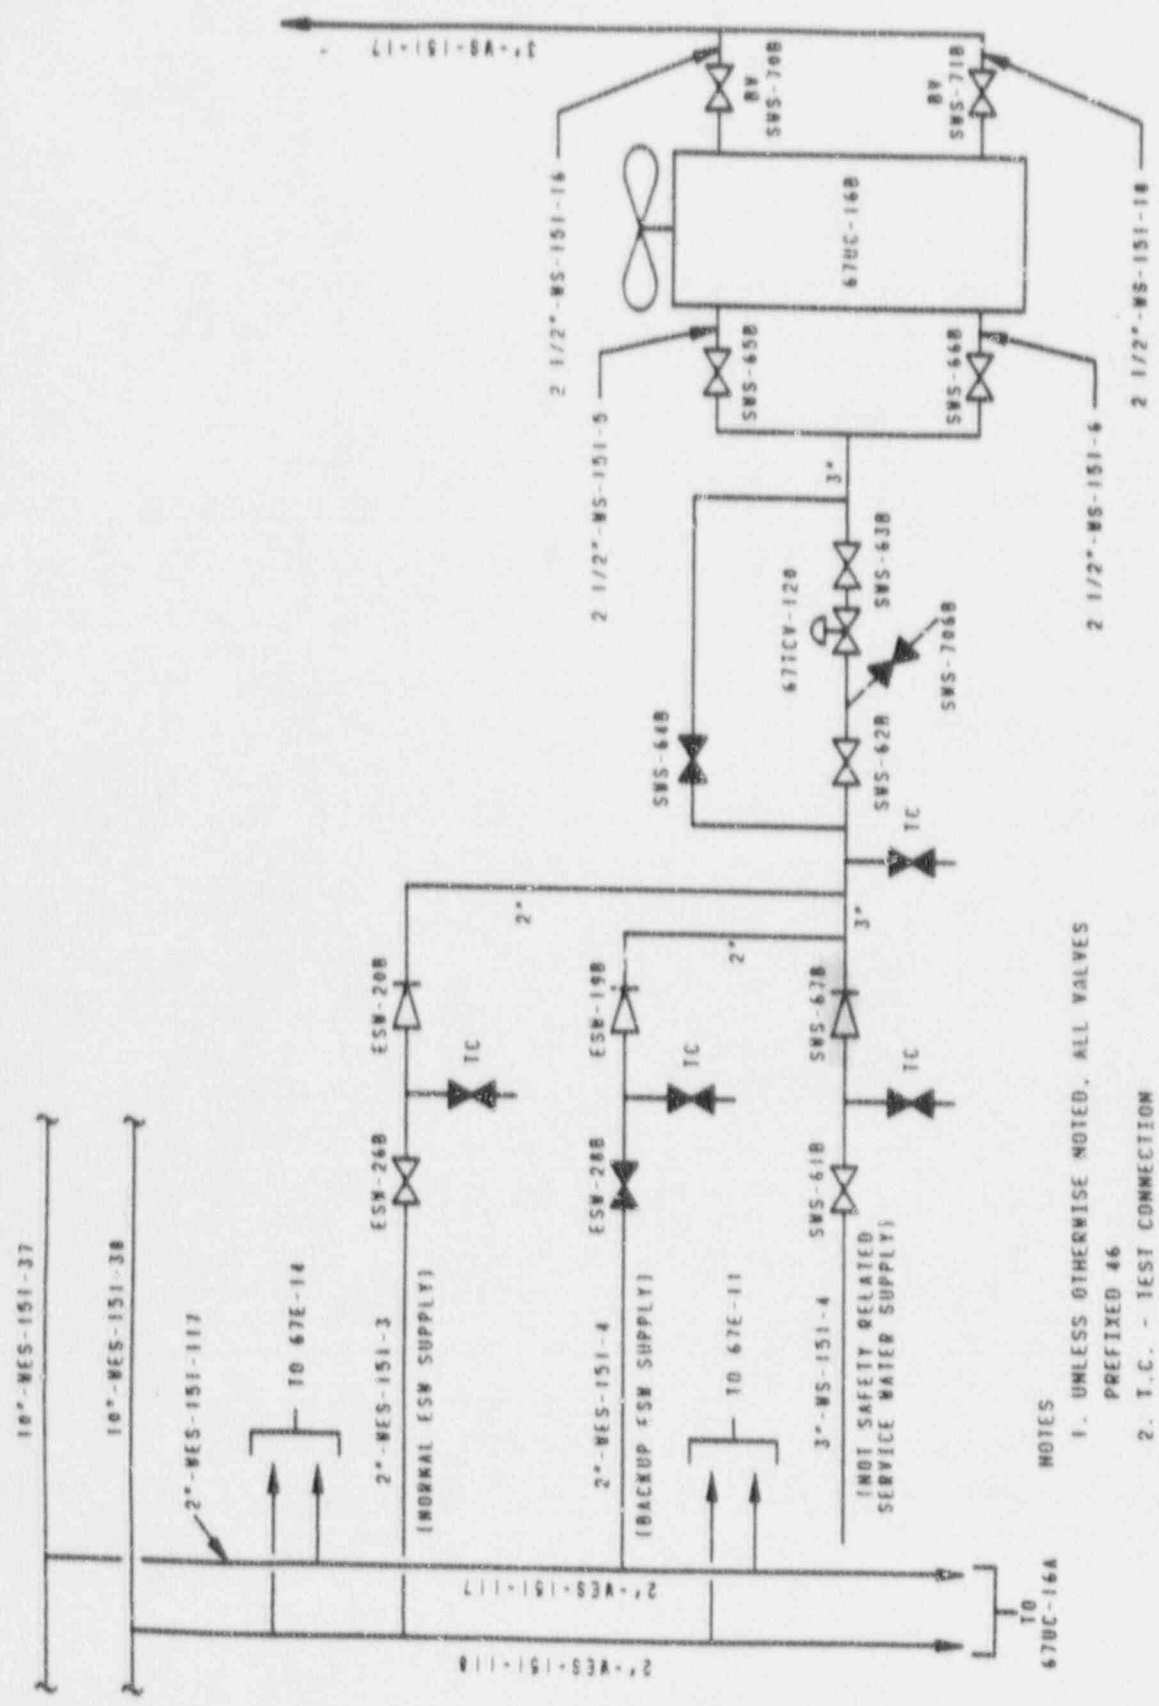
Figure 2 to
 LER 90-025-00
 Docket No. 50-333

ELECTRIC BAY UNIT COOLERS

67UC-16B

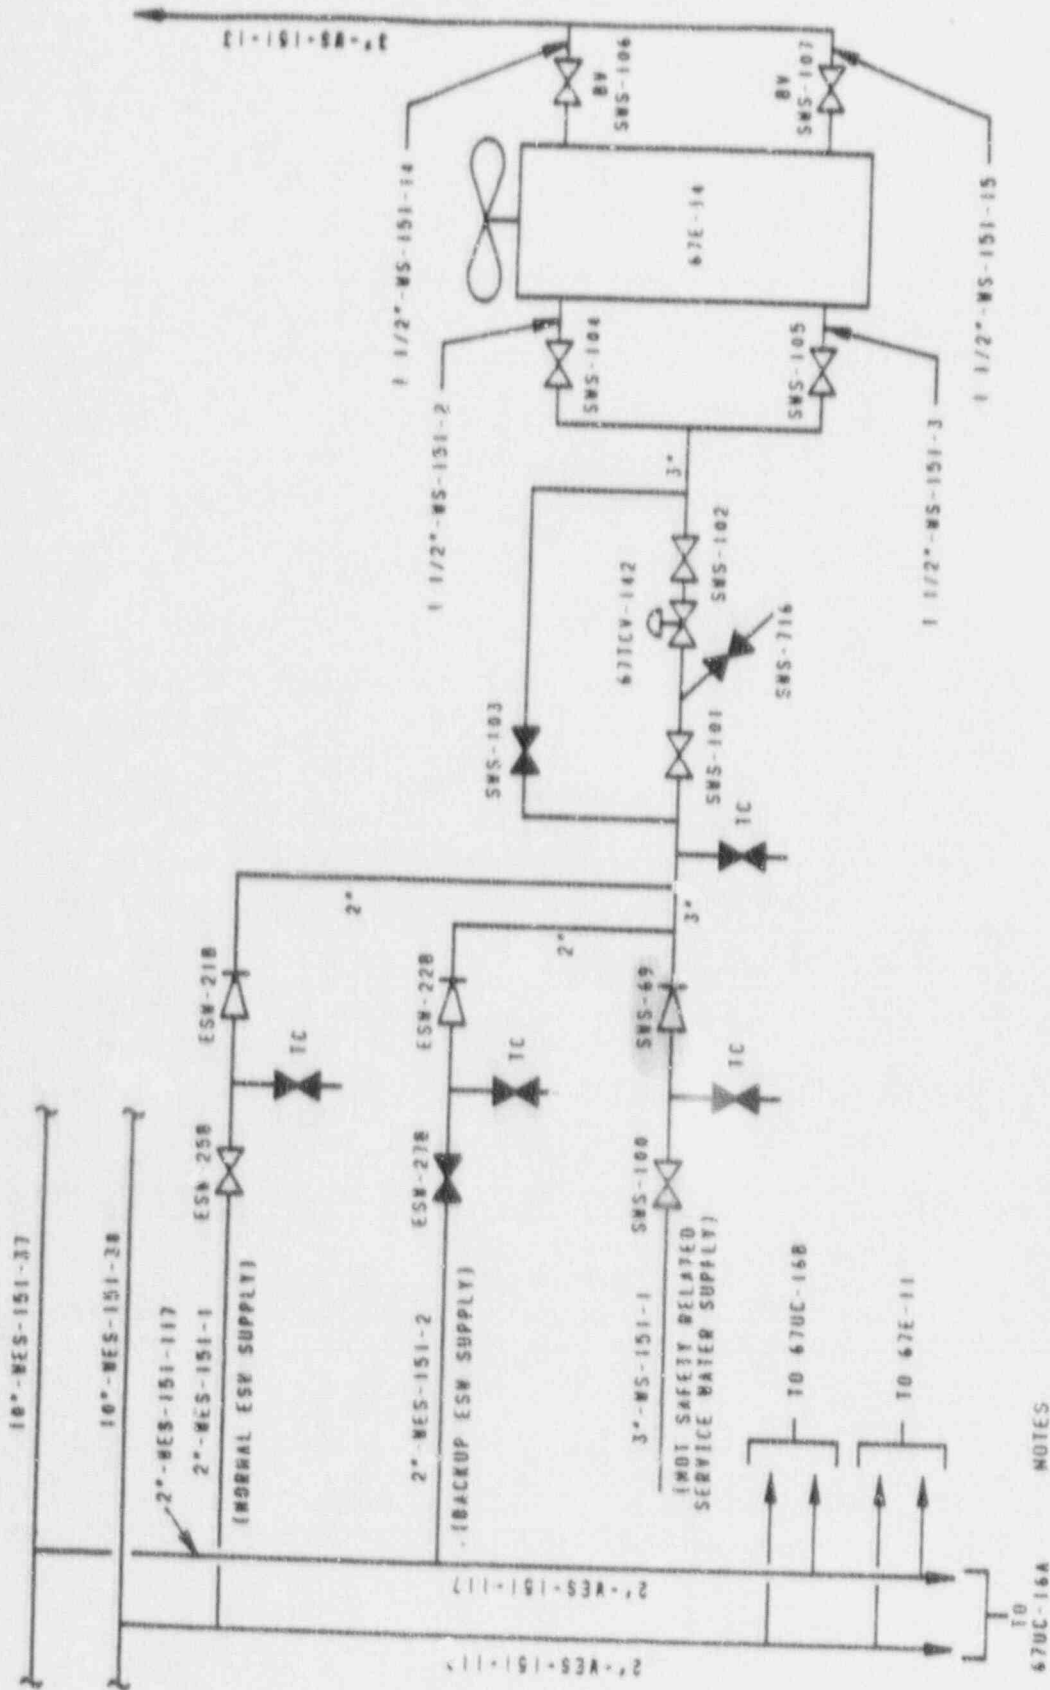
CABLE TUNNEL/SWITCHGEAR ROOM COOLER

67E-14
