NUREG/CR-5280
BNL-NUREG-52178
Vol. 2

Age-Related Degradation of Westinghouse 480-Volt Circuit Breakers

Mechanical Cycling of a DS-416 Breaker
Test Results

Brookhaven National Laboratory

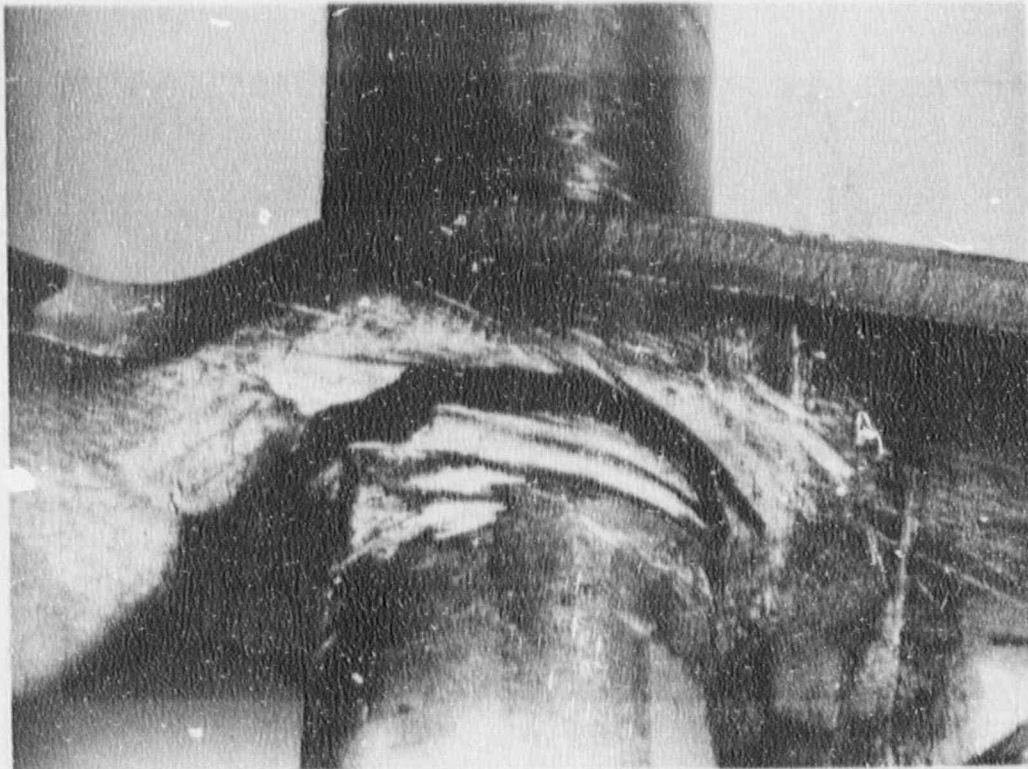
Figure 4-8. Complete Detachment of #3 Pole Lever at 3027 Test Cycle.

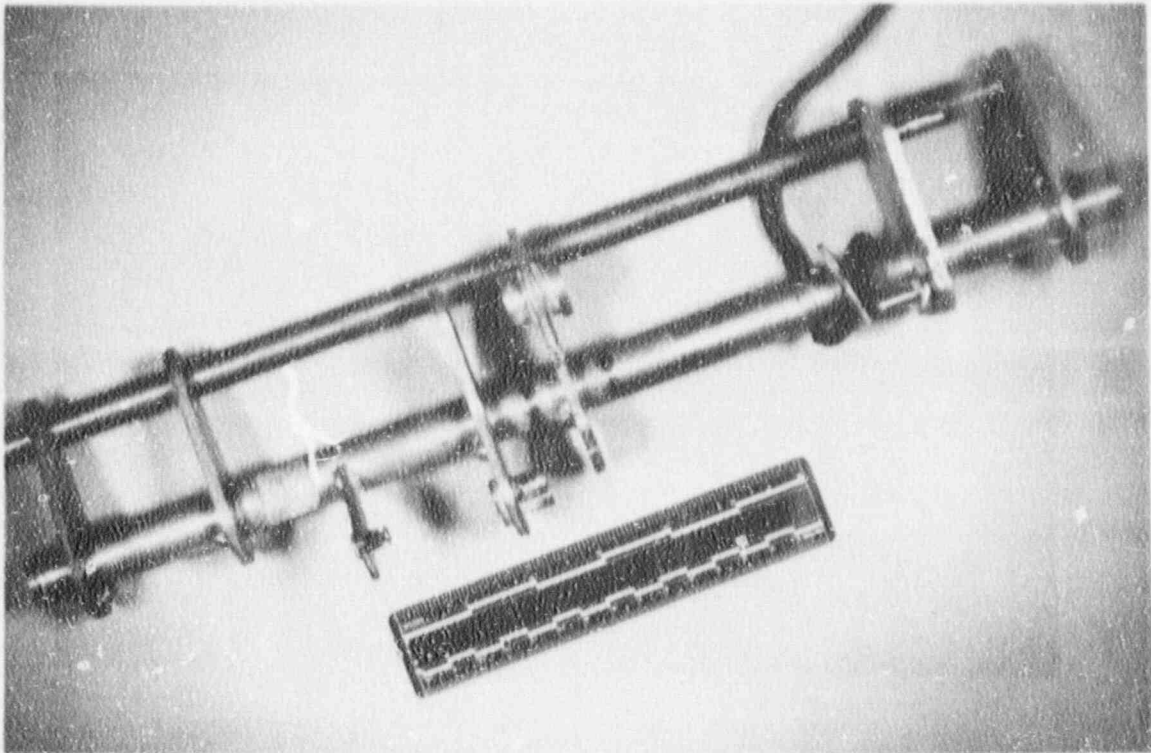
Figure 4-9. Misalignment of Pole Lever #1 from other Levers (#2, #3, #6, and #7).

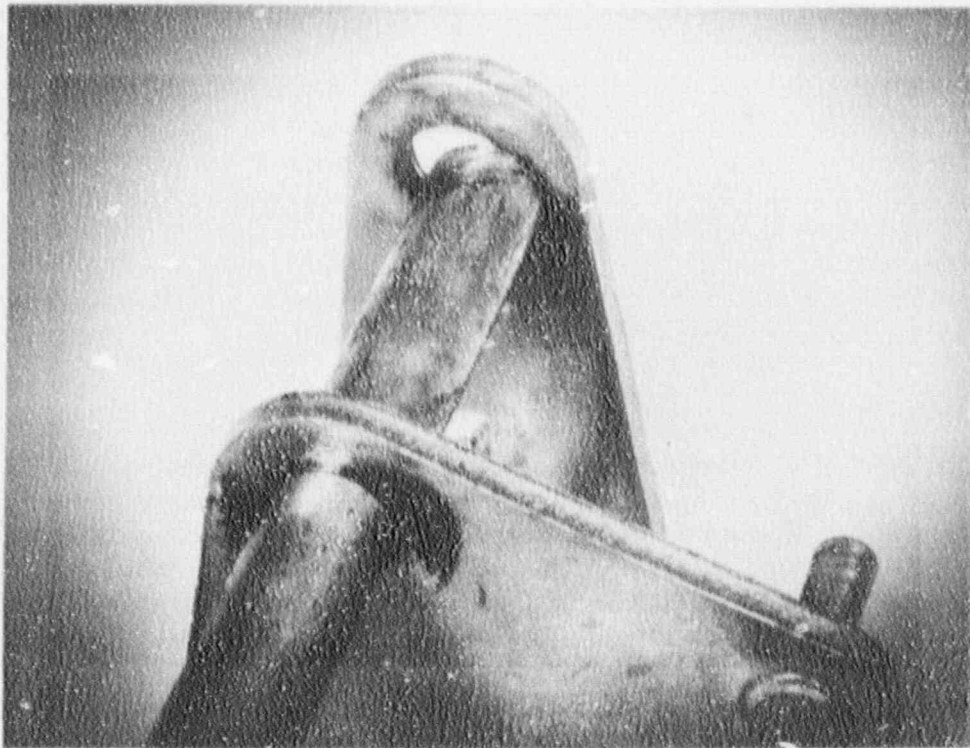
Figure 4-10. Demonstration of the Pole Lever Misalignment Caused by Cracks in Welds #1 and #3.

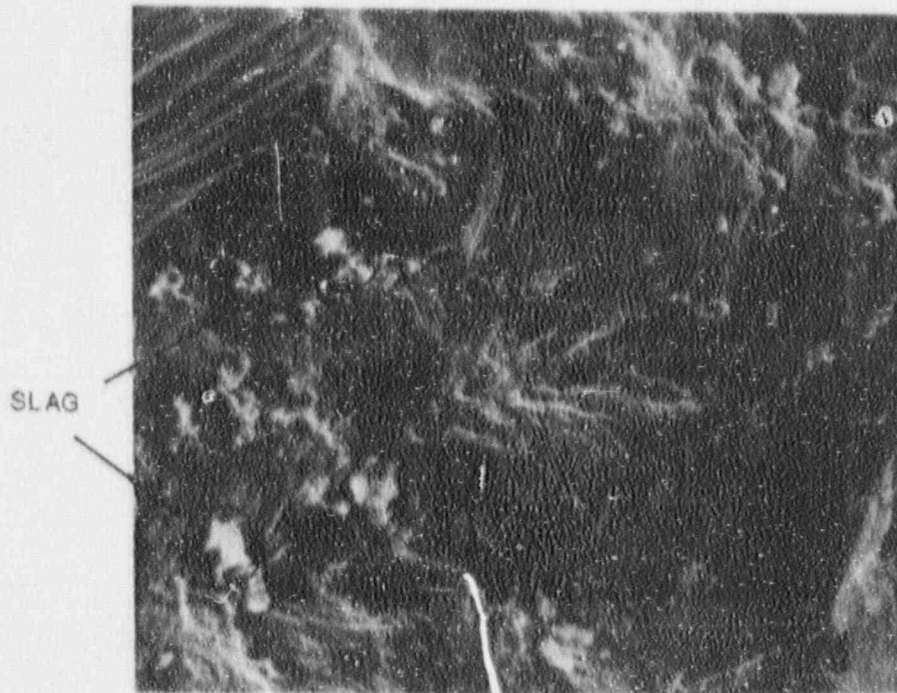
Metallurgical examinations of the fractured weld surfaces of the first shaft showed slag particles in the weld material (see Figure 4.11), that probably had become included during welding. The cracks in this weld started at these locations and later propagated to completely sepa-

Figure 4-11. Failed Weld Showing Slag Inclusions (Marked in Circles)

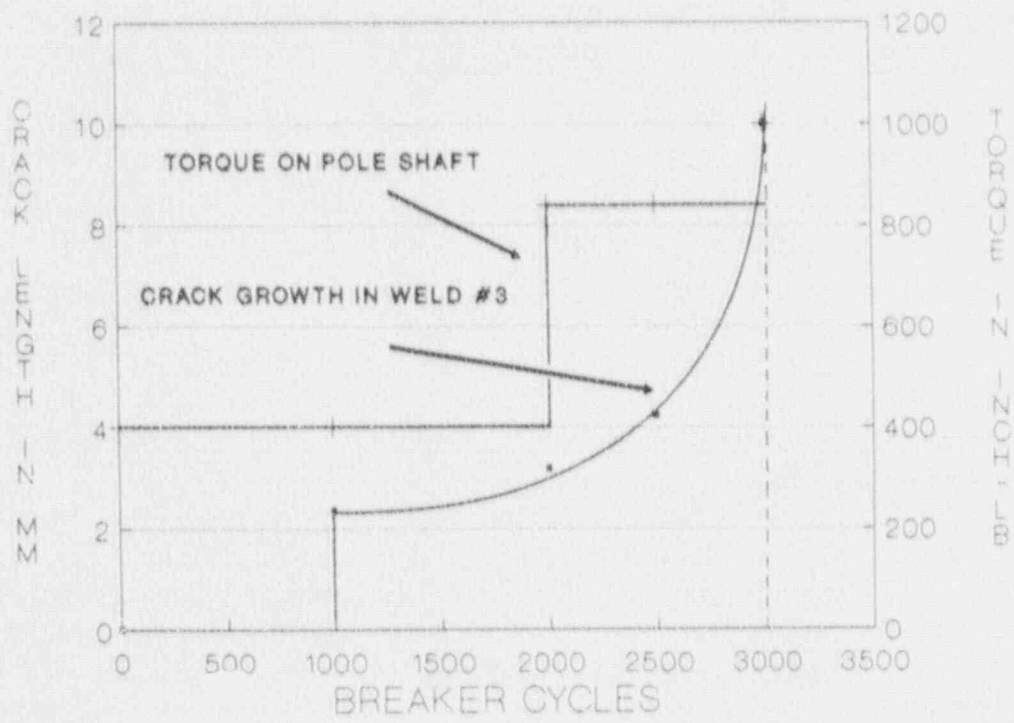
Figure 4-12. Failure of the First Pole Shaft Weld

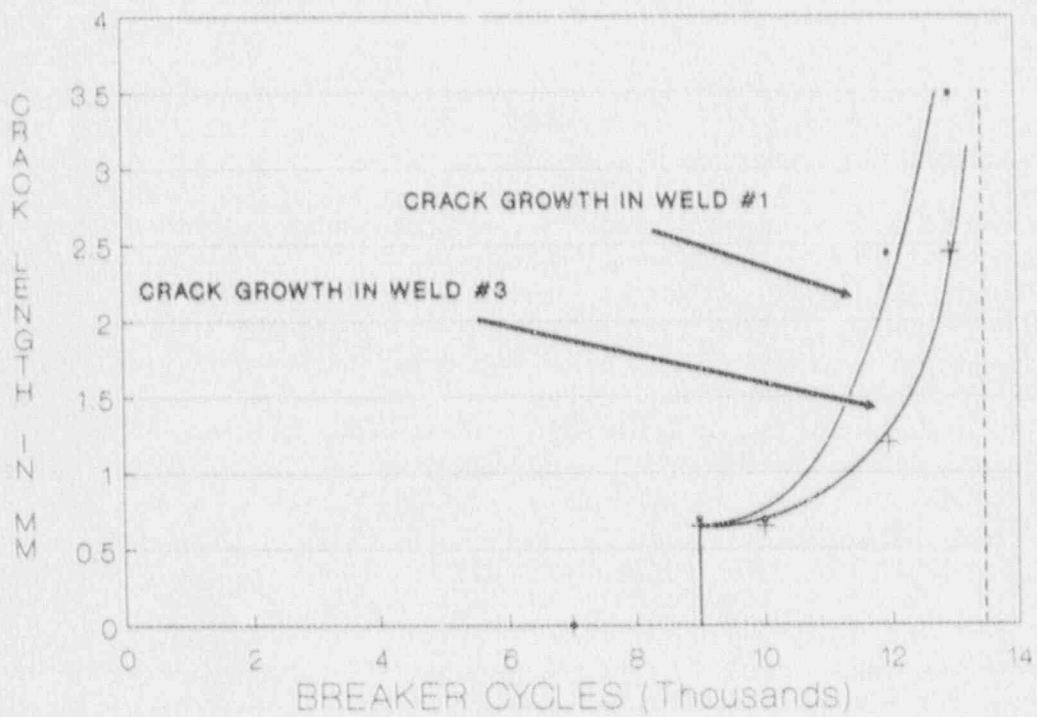
Figure 4-13. Failure of the Second Pole Shaft Weld

The second pole shaft with a 120 degree weld in the #3 lever developed cracks in the #1 and #3 lever welds at about the same time. When these cracks became large at about 13,000 cycles, misalignment of the first two levers was noticed, as shown in Figure 4.10. This probably caused higher torque and bending moments on the phase A pole shaft pin which broke (see Figure 4.26) at 13,593 cycles. The metallurgical examination of the fractured surface revealed that the cracking of this pin was primarily due to an improper heat treatment of the stainless steel. Improper machining might have left raisers which initiated the crack under excessive bending moment and finally the crack propagated intergranularly to break the pin (see Appendix C, section C.2.3).

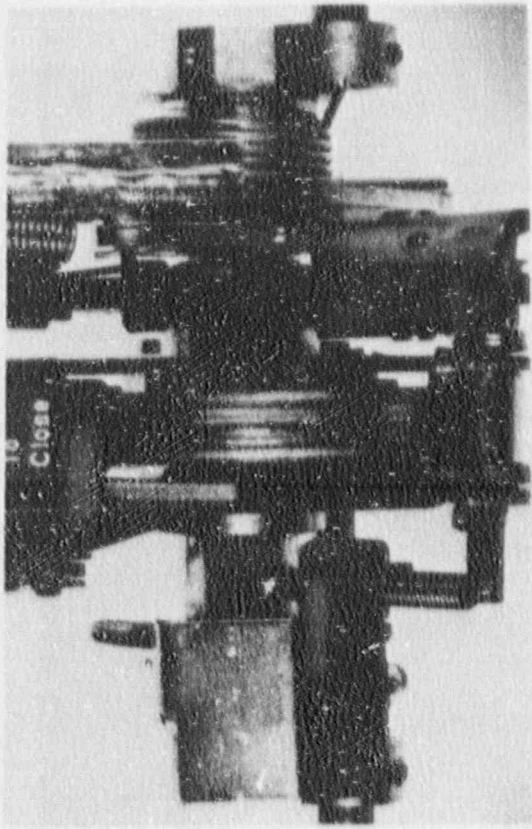
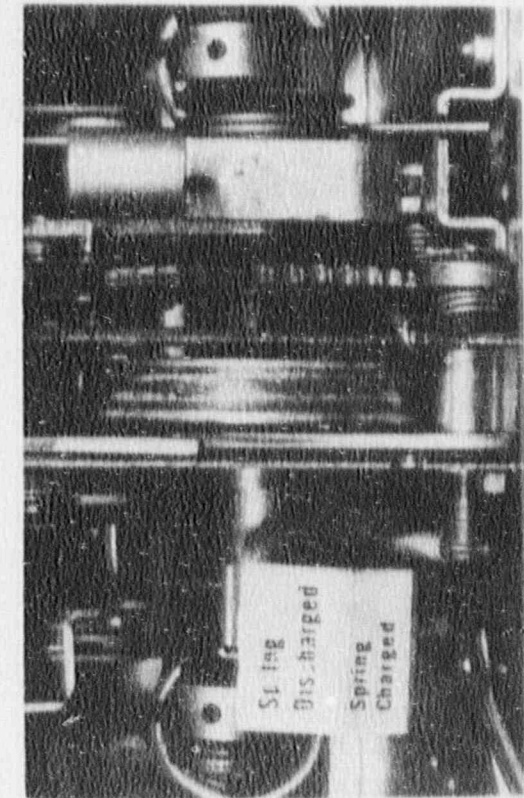
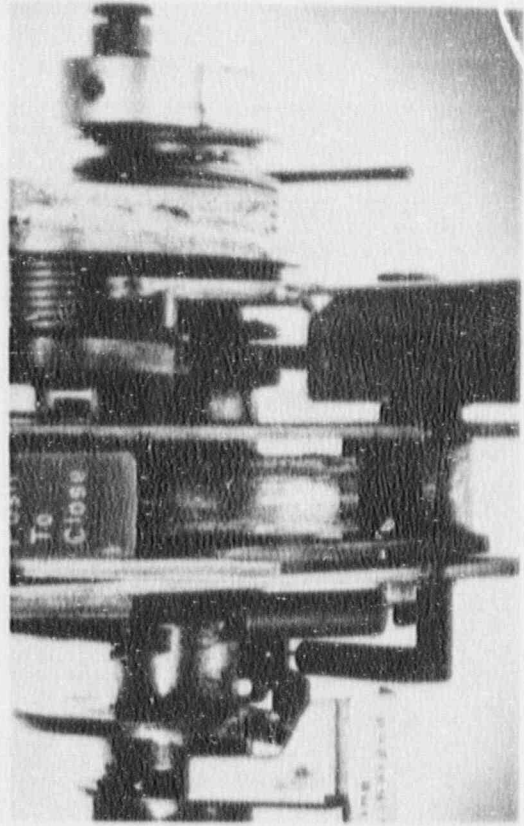
Almost New
(<1000 Cycles)

After 4000 Cycles

End of 13,609 Cycles

Figure 4-14. Wear in the Cam Assembly

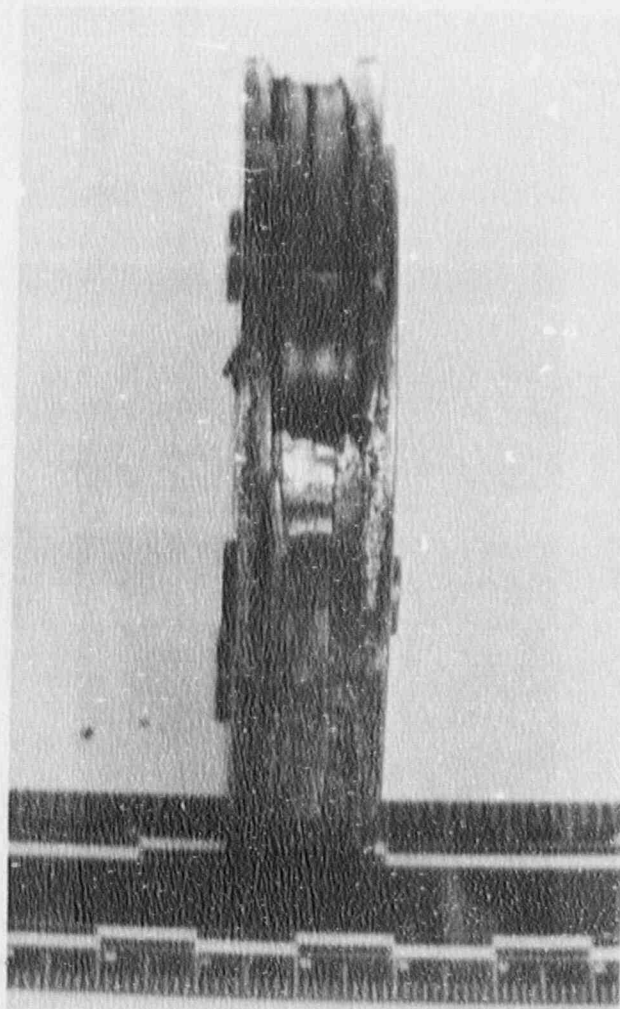
Figure 4-15. Severe Wear in Cam Segments and grooving in stop roller

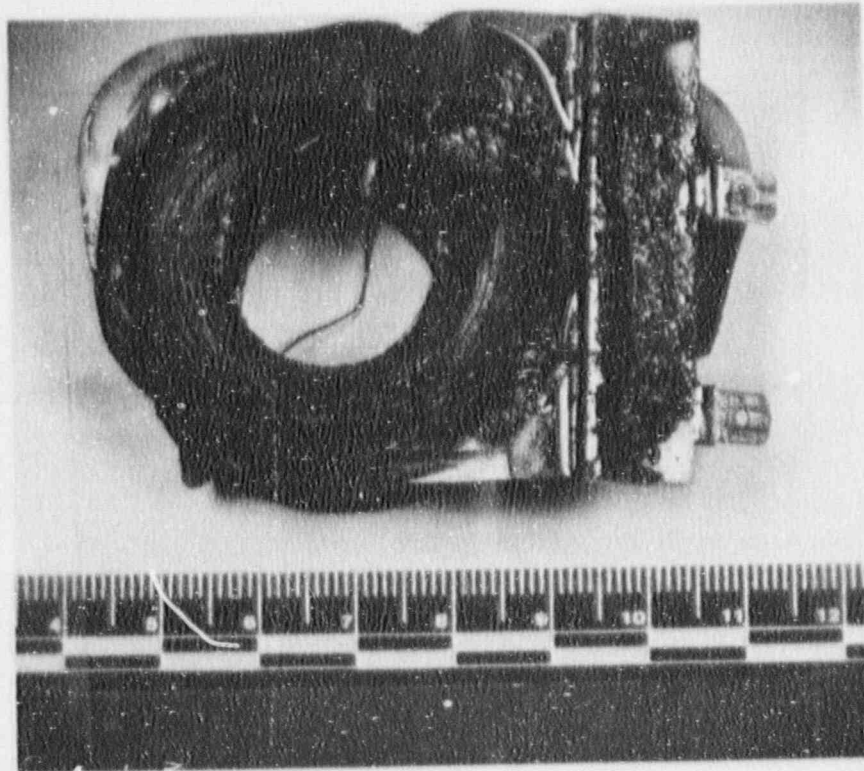
Figure 4-17. Burned Closing Coil After 20,724 Cycles

We conclude that aging in any of these three coils has minimal effects on breaker operation. However, the STA and closing coils are vulnerable to quick burnout due to excessive heat generated by an extended operation, which is primarily caused by the aging of various elements in the operating mechanism and the associated linkages whose binding or sluggish motion caused the coils to burn out instantly.

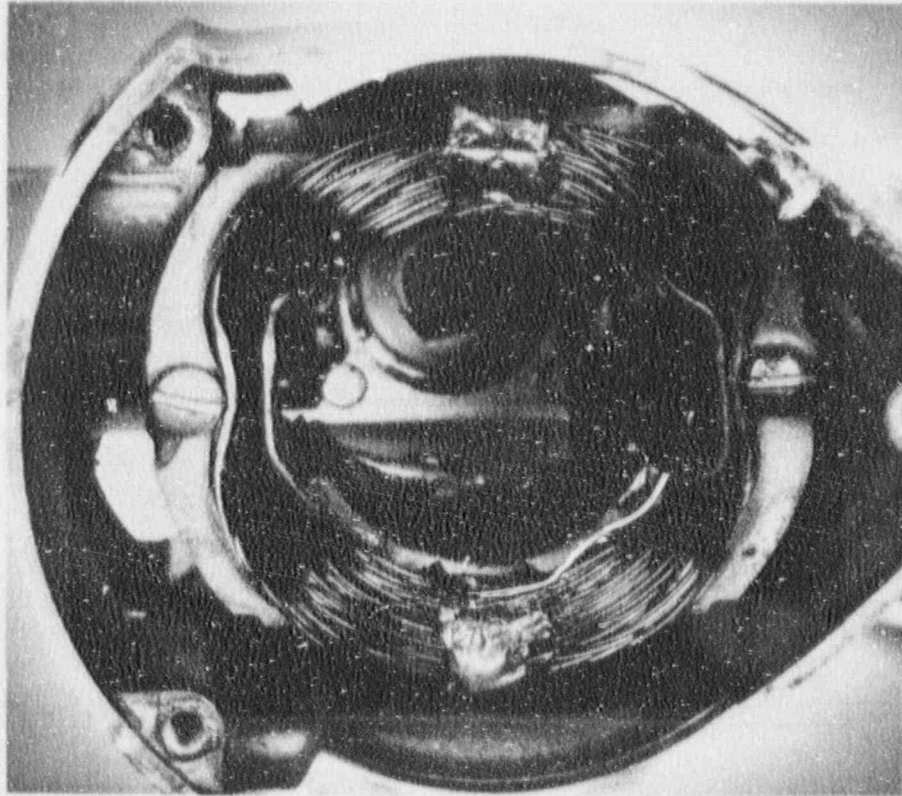
Figure 4-19. Degradation of the Insulation on the Motor Stator

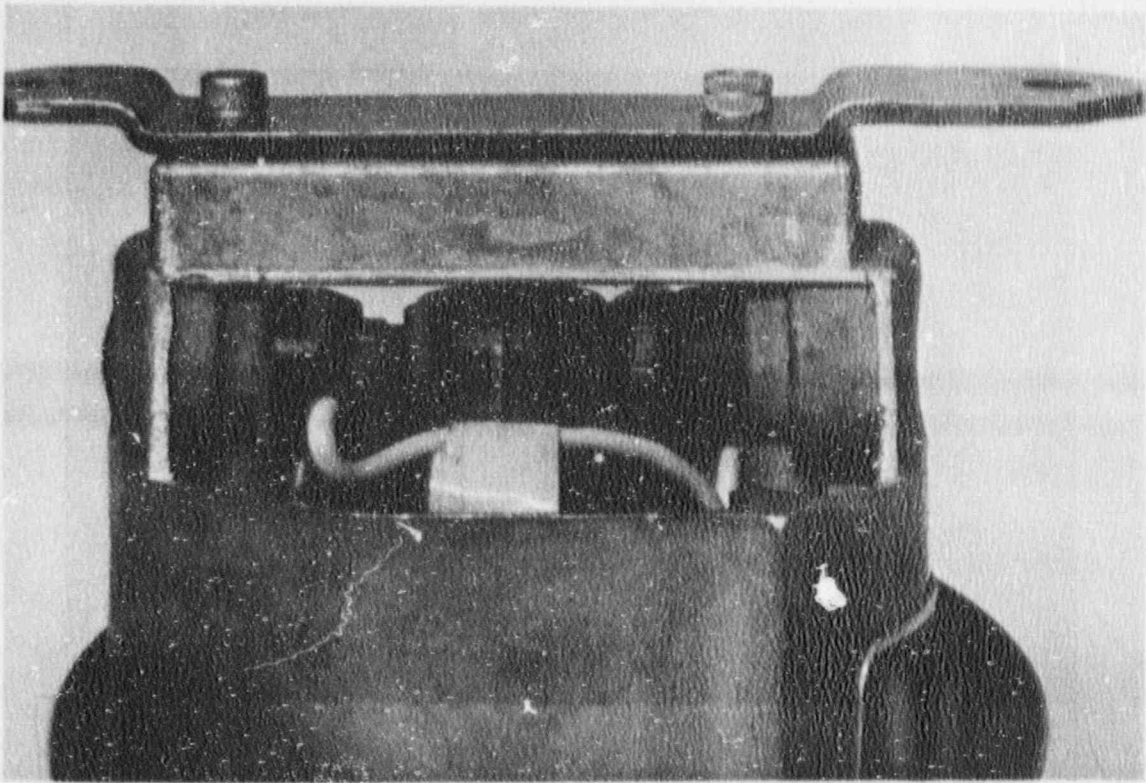
Figure 4-20. Carbon Deposits on Armature Contact Surface

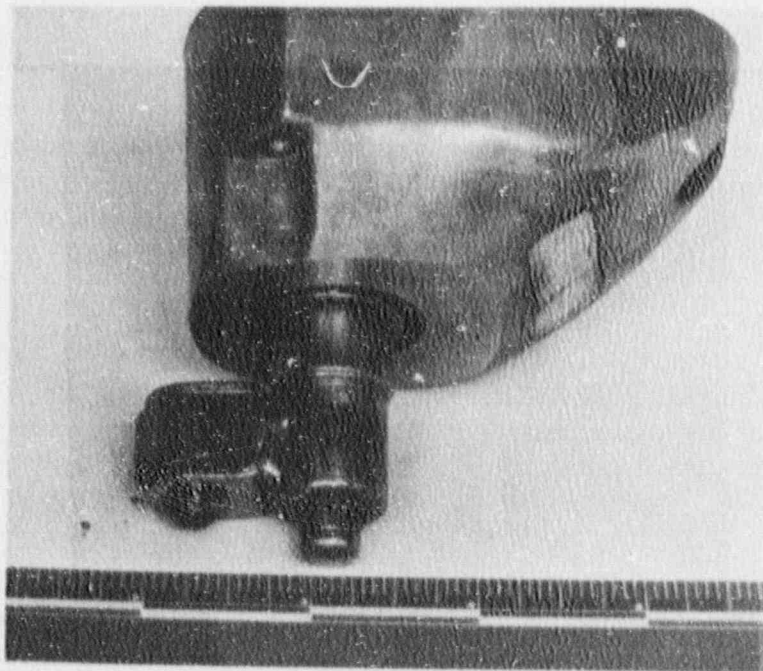
Figure 4-21. Wear on the Motor Crank and Handle

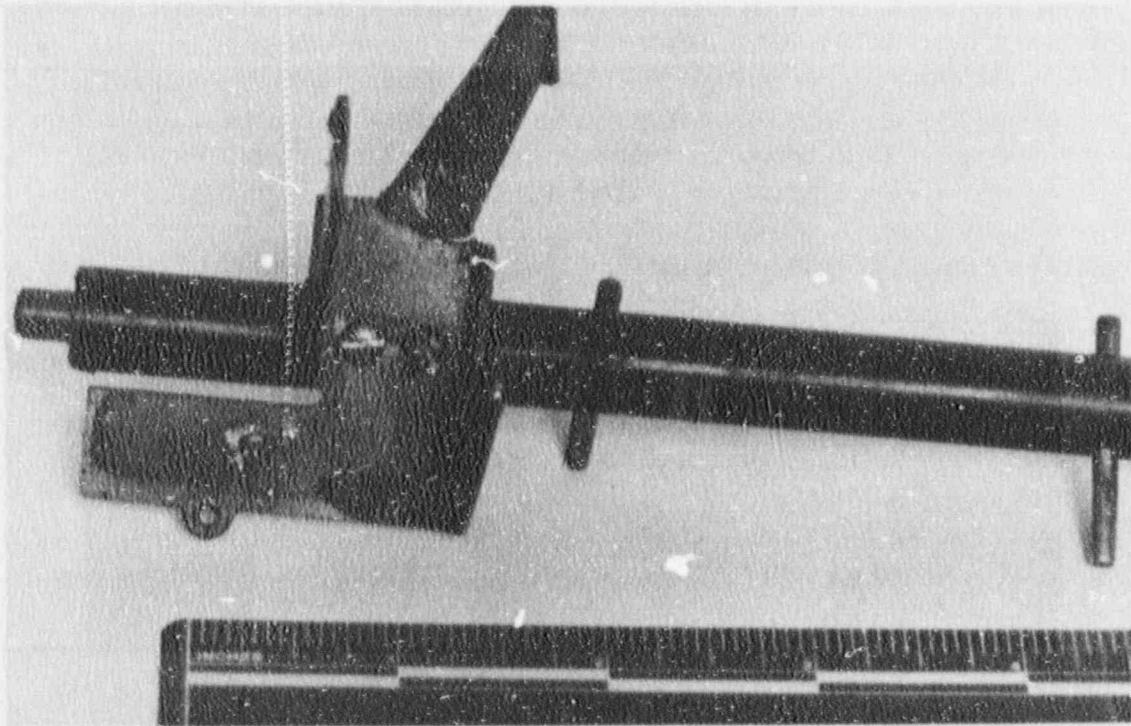
Scanning electron microscope (SEM) examination revealed that cracks started at the sharply angled corner of the wing. Under vibratory motion of the bar, the crack propagated fast like a brittle fracture. Hydrogen embrittlement from the zinc electroplating process is suspected to be the cause. Hydrogen embrittlement can happen when electroplating is done improperly. The proper procedure includes relieving all stresses from the shaft before electroplating and

Figure 4-22. Fracture of the Wing on the Trip Bar

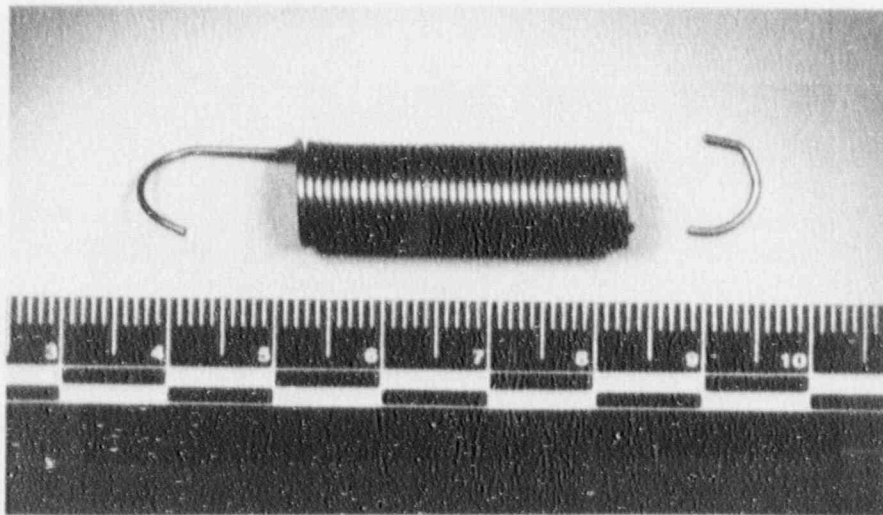
During the test two different vintages of smaller springs were used for the trip indicator and the oscillator reset; one set came with the original breaker and the others were purchased from a current inventory for replacements. The older springs lasted over 13,000 cycles without any deterioration, while one of the newer springs failed after 5861 cycles and the second one after 2286 cycles.

Figure 4-23. Broken Spring of the Trip Indicator Reset

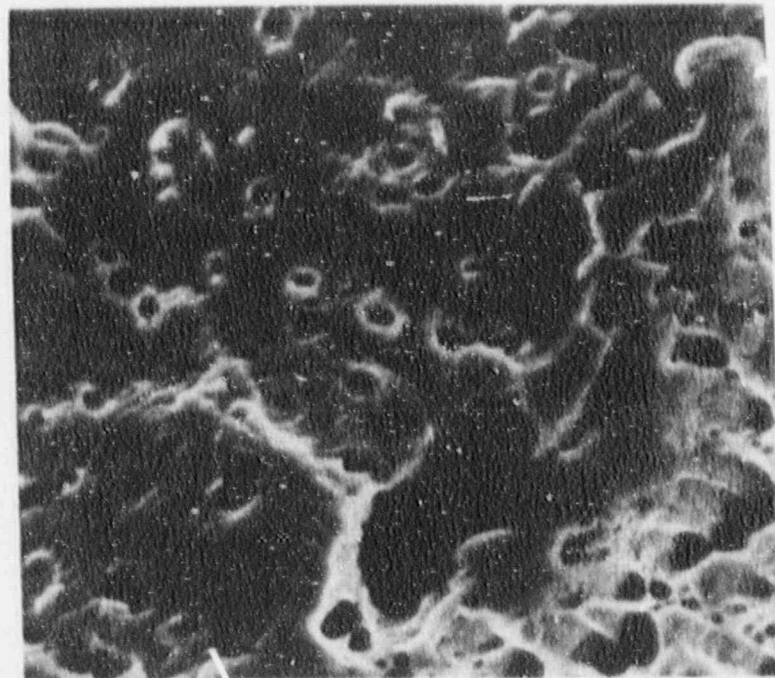
Figure 4-24. Striation Marks on Fractured Spring Surface

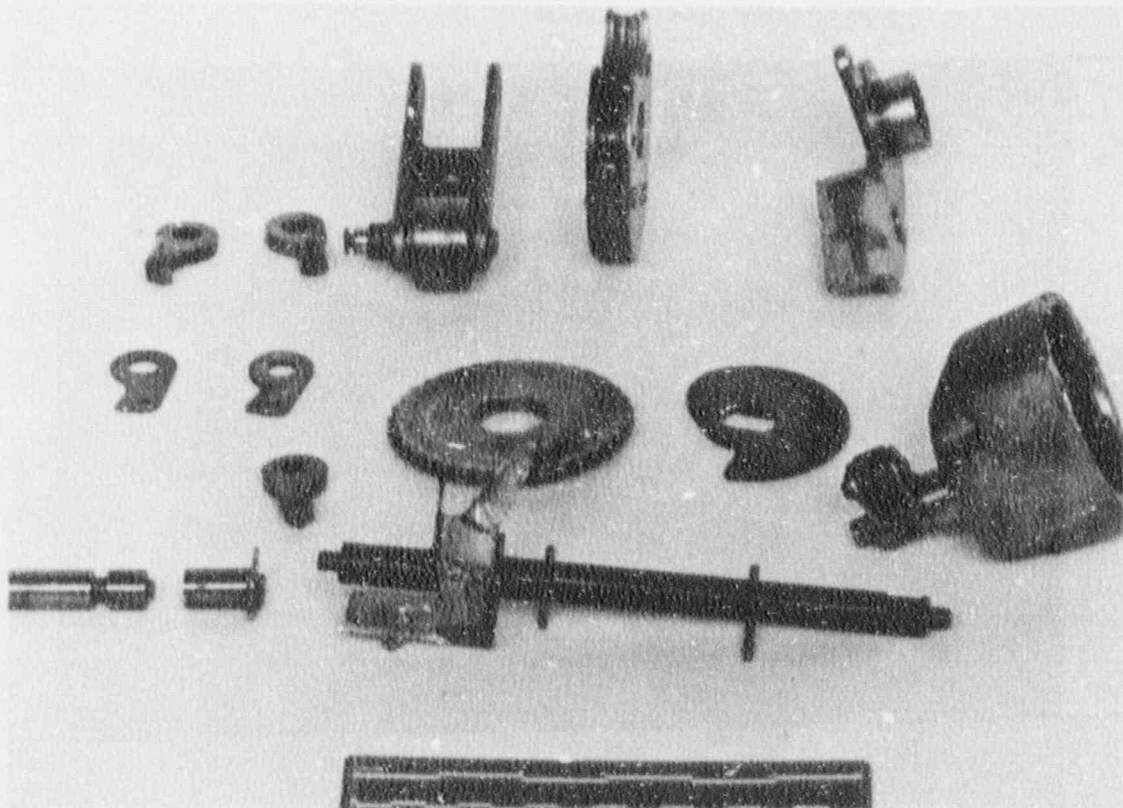
Figure 4-25. Aging in Various Breaker Components

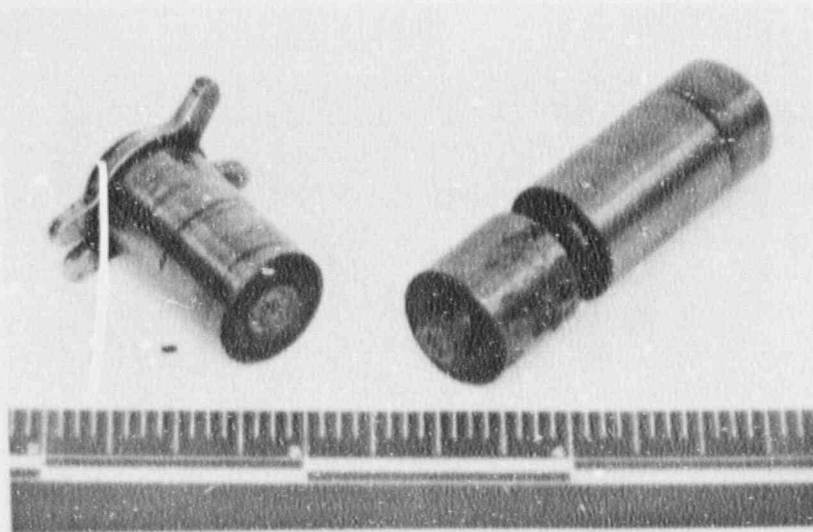
Figure 4-26. Fractured Phase A Pole Pin

- For the pole pin connecting the Phase A of the breaker contacts, smooth corners should be machined, free from surface defects.
- Improper welding practices at the pole shaft levers should be avoided.

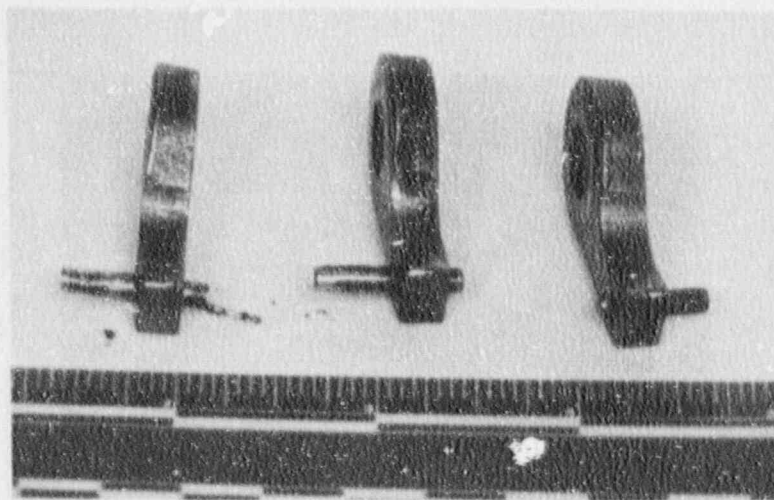
Figure 4-27. Wear in the Ratchet Wheel Pawls

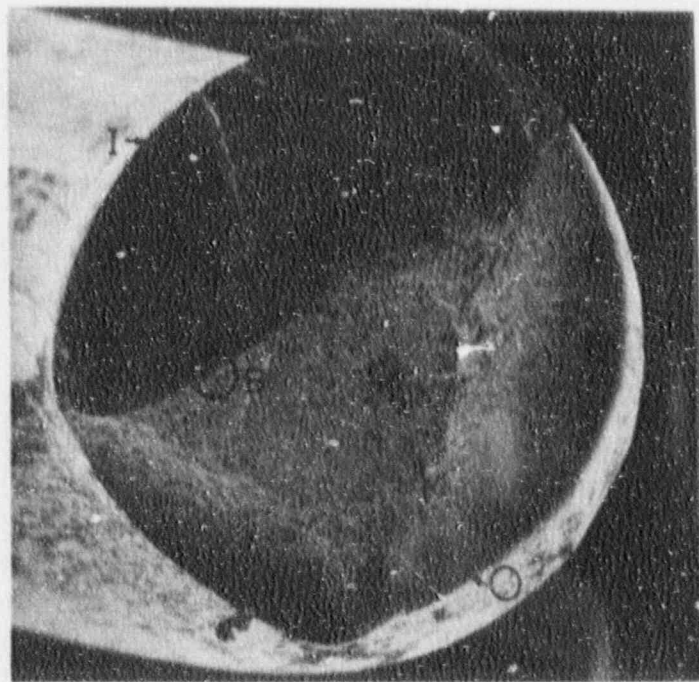
Examinations of the wire surfaces of the bent area (where failure occurred) revealed some subtle differences between the inside surface (marked as I in Fig. C-1) and the outside surface (marked as O in Fig. C-1). The inside surface has shallow surface cracks (Fig. C-3 a), while this kind of cracking is absent on the outside surface although deep drawings marks are clearly visible as (Fig. C-3 b). These marks were formed when the wire was originally made. The shallow, longitudinal cracks on the inside surface were probably developed during the mechanical bending process to make the hook.

Figure C-1. SEM micrograph of the fracture surface of the indicator spring. Mag: 100x.

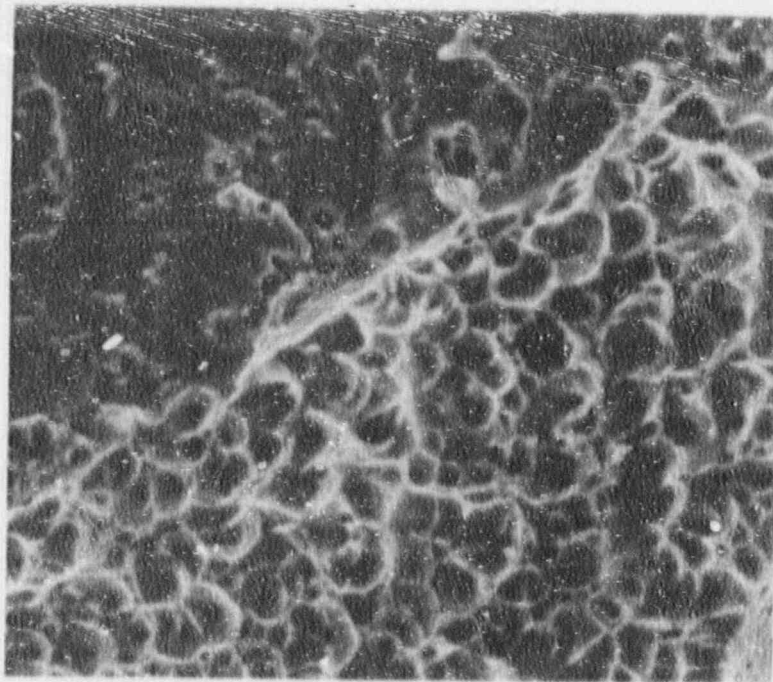
Figure C-2. SEM micrograph shows striation marks in the transition area from fatigue crack growth to final fracture. Mag: 2,000x.

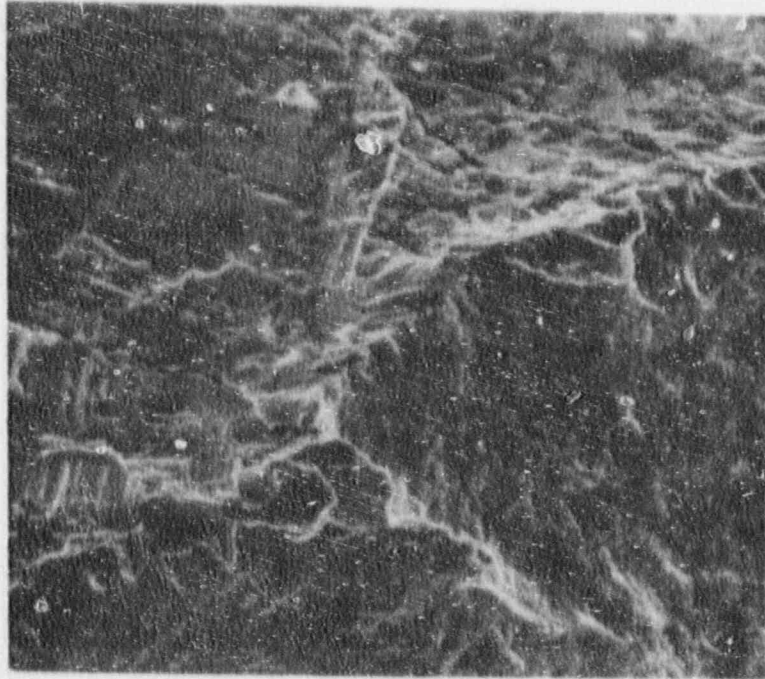
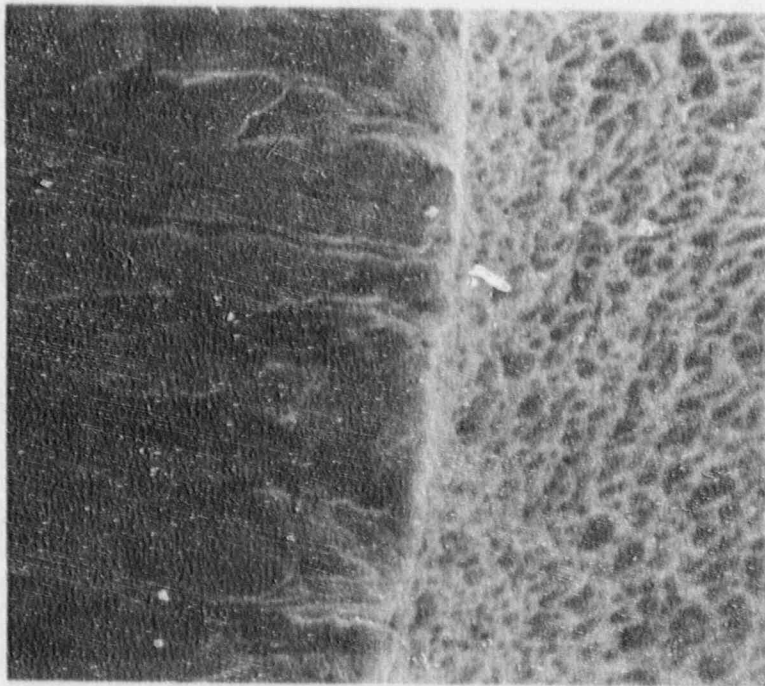
Figure C-3. a) SEM micrograph shows axial surface cracks on the inner surface. Mag: 1,000 x.
b) SEM micrograph shows drawing marks on the outer surface. Mag: 1,000 x.

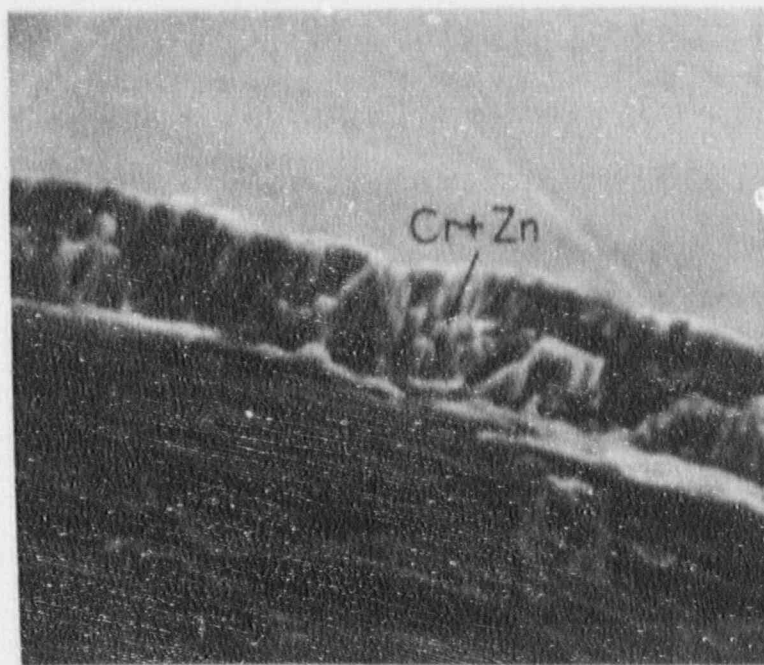
Figure C-6. SEM micrograph of the fracture surface that shows the surface coating. Mag.: 3,000 x.

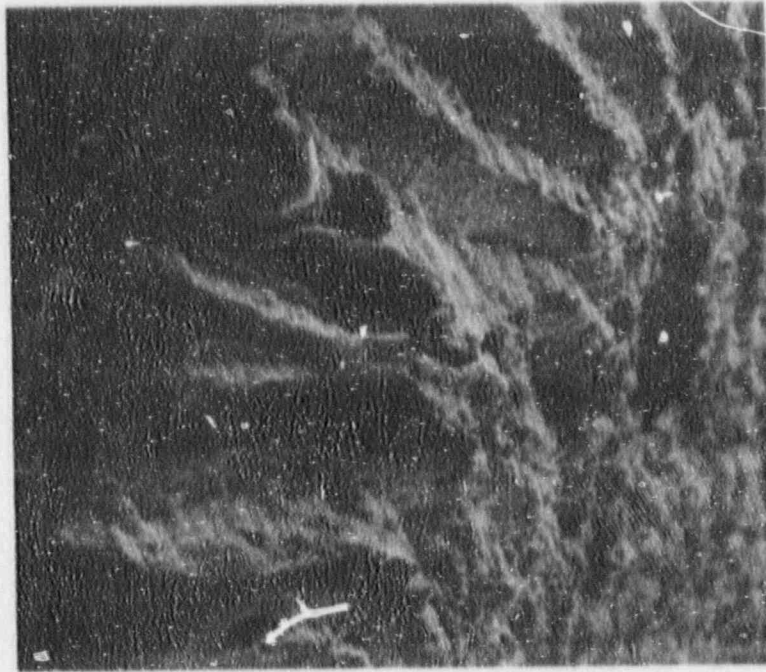
Figure C-8. SEM micrograph of impact marks and steps. Mag.: 500x.

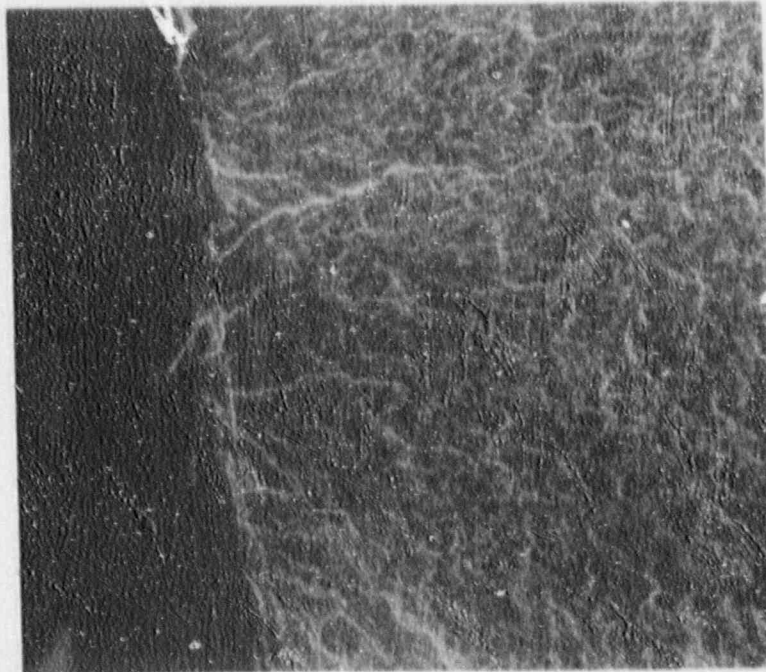
Figure C-9. SEM micrograph of the fatigue crack growth surface shows river marks.
Mag.: 500x.

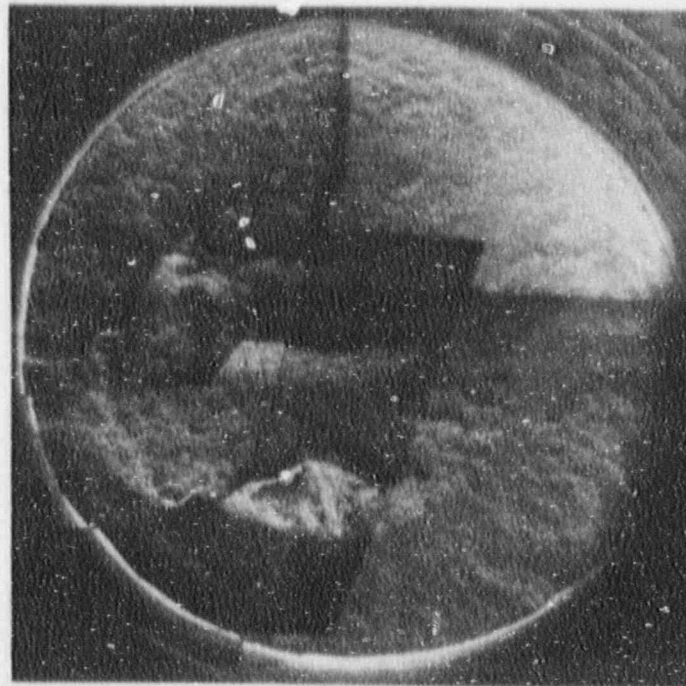
Figure C-11. SEM micrograph of the fracture surface of the failed pin. Mag.: 21.5 x.

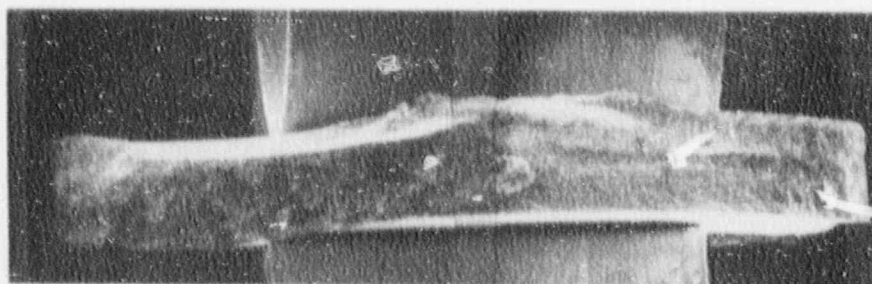
Figure C-13. SEM micrographs of the fracture surface of the trip shaft lever. Mag.: 15x.

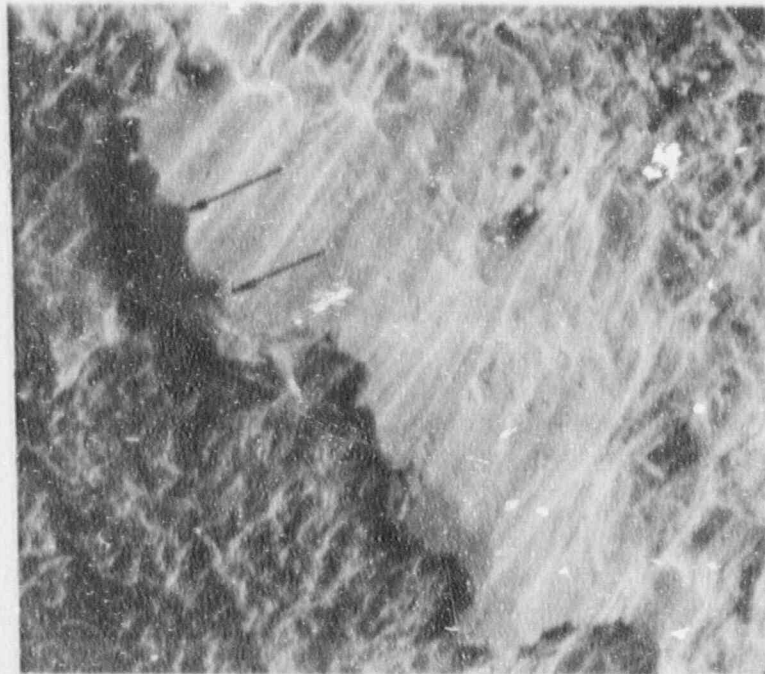
Figure C-14. SEM micrographs of the fatigue fracture surface of the trip shaft lever. Mag.: 100x.

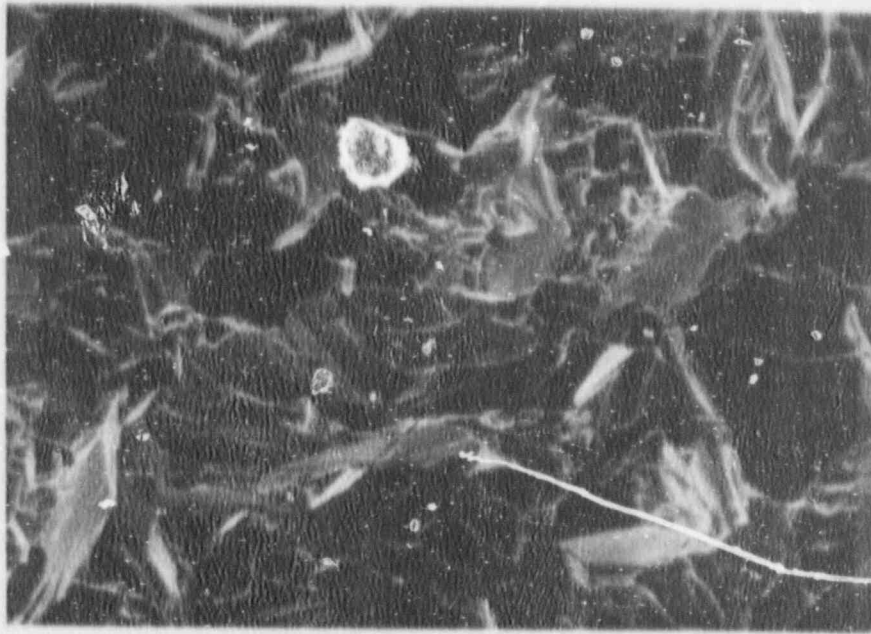
Figure C-15. SEM micrographs of the fast fatigue fracture surface. Mag.: 500x.

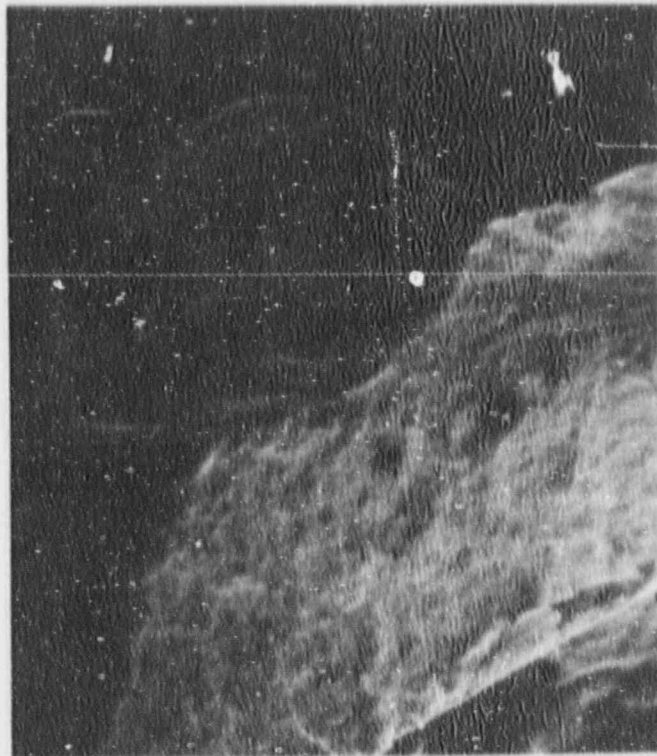
Figure C-16. SEM micrograph of the fracture surface of the weldment. Mag.: 20x.

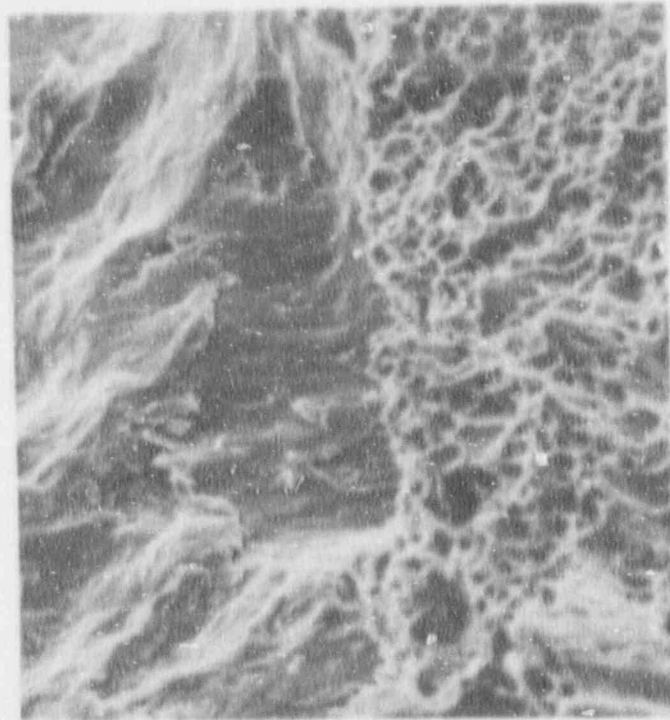
Figure C-17. SEM micrograph shows a transition from fatigue crack growth to final fracture. Mag.: 1,000 x.

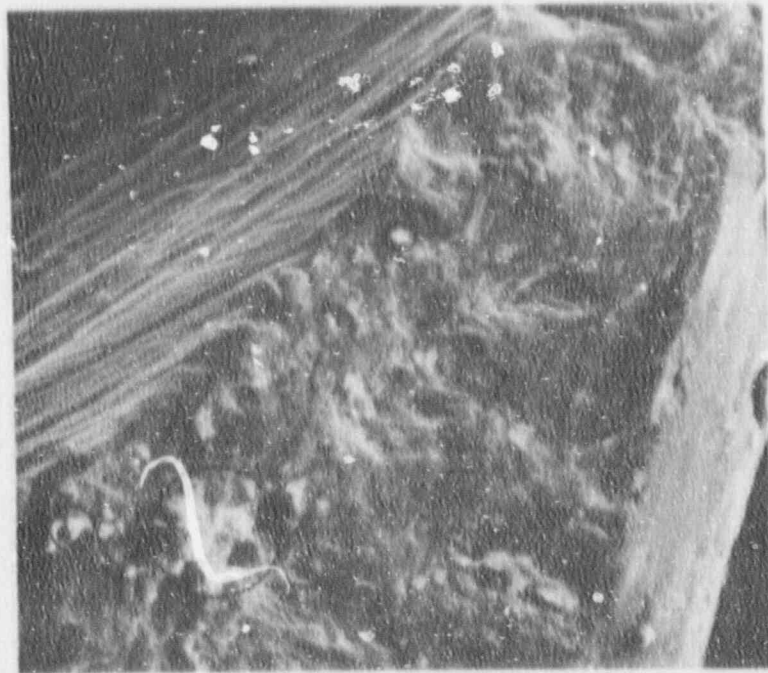
Figure C-18. SEM micrograph shows chevron marks (V's) and the slag inclusions (marked with circles). Mag.: 100 x.
