LIMERICK GENERATING STATION

M. J. McCORMICK, JR., P.E.  
PLANT MANAGER  
LIMERICK GENERATING STATIONDecember 20, 1990  
Docket Nos. 50-352  
50-353  
License Nos. NPF-39  
NPF-85U.S. Nuclear Regulatory Commission  
Attn: Document Control Desk  
Washington, DC 20555SUBJECT: Licensee Event Report  
Limerick Generating Station - Units 1 and 2

Report Number: 2-90-019

TITLE (4) Half-scrum and various isolations resulting from a loss of power to a Reactor Protection System/Uninterruptible Power Supply panel due to inverter damage.

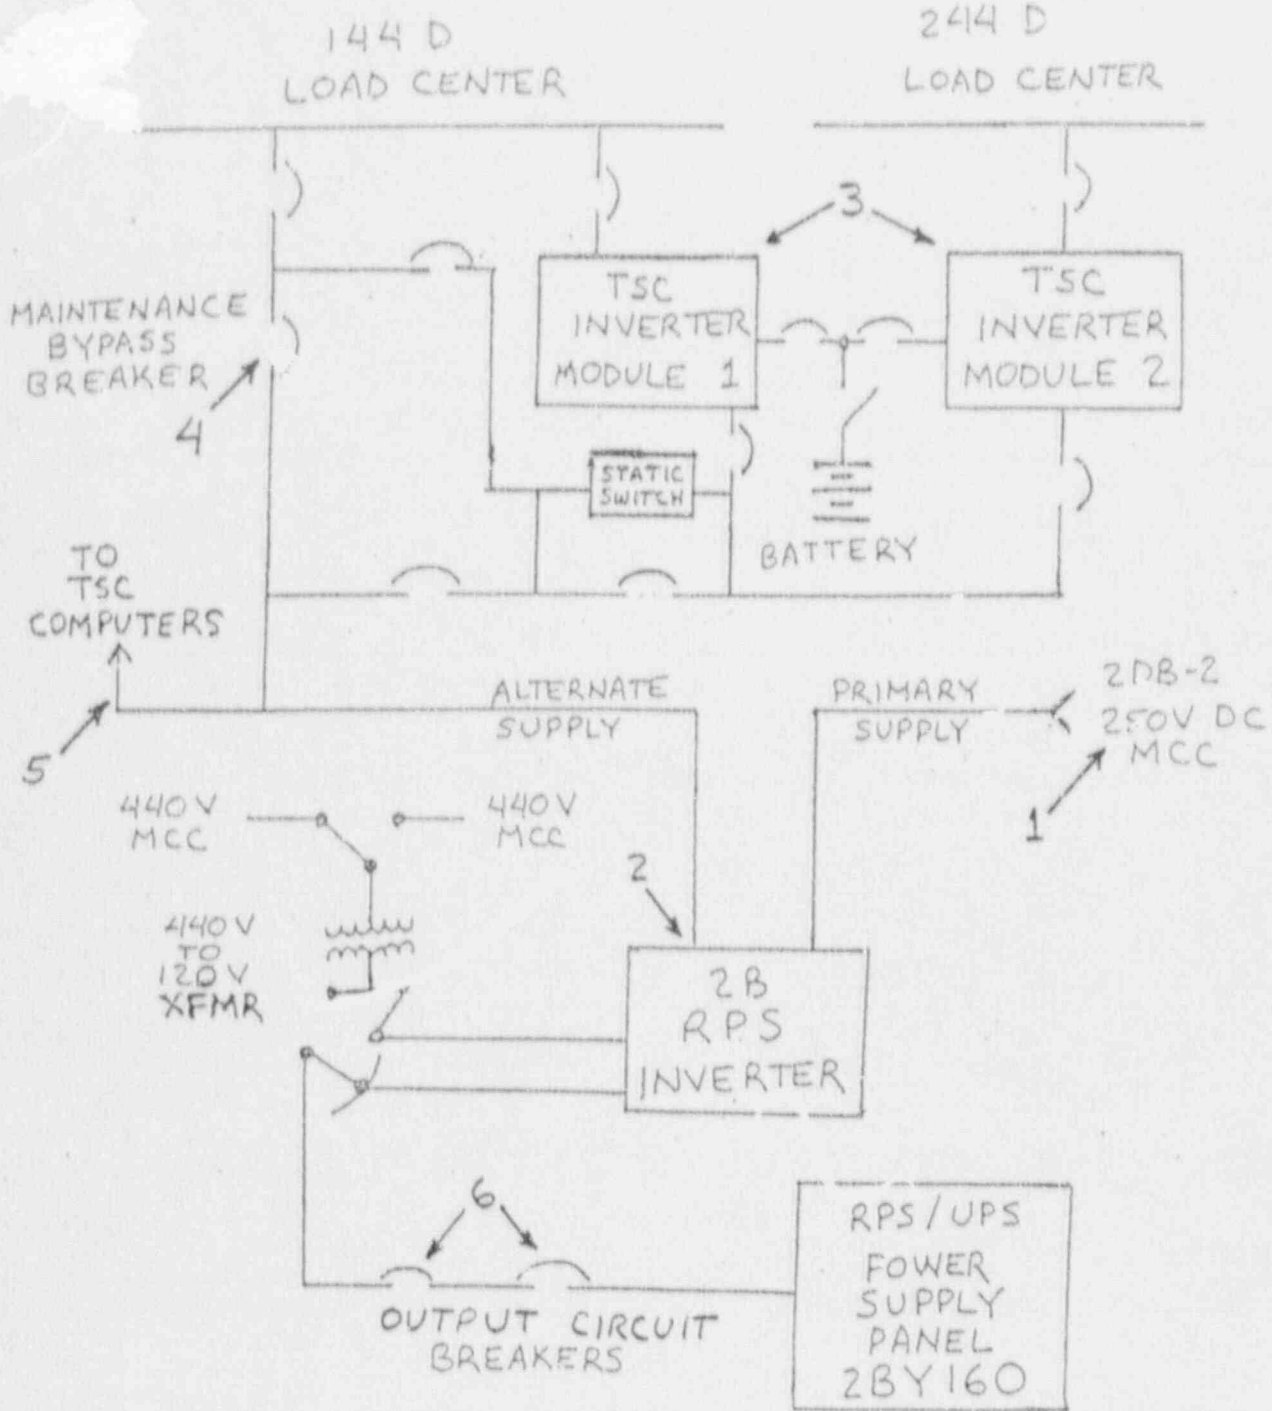
DIAGRAM 1

During normal operation, the static inverters are supplied by a primary (DC) supply (Diagram 1, item 1) and are aligned to an alternate (AC) supply (item 2) as a backup to the primary supply. The static inverters automatically synchronize their output to match the frequency of the alternate (AC) supply. This synchronization precludes voltage transients when switching from the primary to alternate supply. The '2B' RPS static inverter "OUT OF SYNC" light was illuminated indicative of a problem in the phase synchronization circuitry. The synchronization circuit problem had been identified by Operations personnel and an Equipment Trouble Tag (ETT) had been attached to the static inverter. Corrective Maintenance on the static inverter had not yet been performed when this event occurred due to a delay in processing of the ETT. The synchronization problem was caused by a damaged (crimped) connector in the static inverter circuitry.

On November 1, 1990, preparations were being made to perform maintenance on the TSC static inverters (item 3), which act as the alternate supply through the RPS inverter. The Maintenance Bypass Breaker (MBB) (item 4) was closed by Operations personnel to provide the alternate (AC) power to loads normally supplied by the TSC static inverters, including the alternate supply to the RPS static inverters. When the primary supply was removed from the TSC static inverters, the TSC computers (item 5), supplied by the TSC inverters, lost power. It was determined that the MBB was open although it was indicating closed. Per Shift Supervision direction, the MBB was cycled open and closed. This restored the AC power to the loads.

When the alternate supply was restored, the '2B' RPS static inverter automatically attempted to synchronize its output with the alternate supply frequency. Due to the damaged connector in the RPS static inverter circuitry, the output sensed was a square wave-form. The RPS static inverter could not synchronize the square wave output with the sinusoidal wave of the alternate supply. This inability to synchronize resulted in an output condition that tripped the '2B' RPS undervoltage breaker (item 6) and caused the loss of power to the RPS/UPS power distribution panel, 2BY160.

All static inverters were inspected for damaged connectors and no other problems were identified. Preventive and Corrective Maintenance work including repair of the damaged connector was completed on the TSC and RPS static inverters and the alternate power source was restored on November 21, 1990. The routine Preventive Maintenance (PM) work for each static inverter currently inspects for damaged and degraded equipment within the static inverter, including cabling and connectors. This PM work is scheduled for the upcoming first Unit 2 Refueling Outage, currently scheduled to begin in March, 1991. The reason for the MBB indicating closed when it was actually open could not be determined. Subsequent testing demonstrated that the MBB was functioning properly.
